Structural Engineer's Report
Tabulam SES Building

Lot 2 DP 791509

Client: Kyogle Council

April 2010

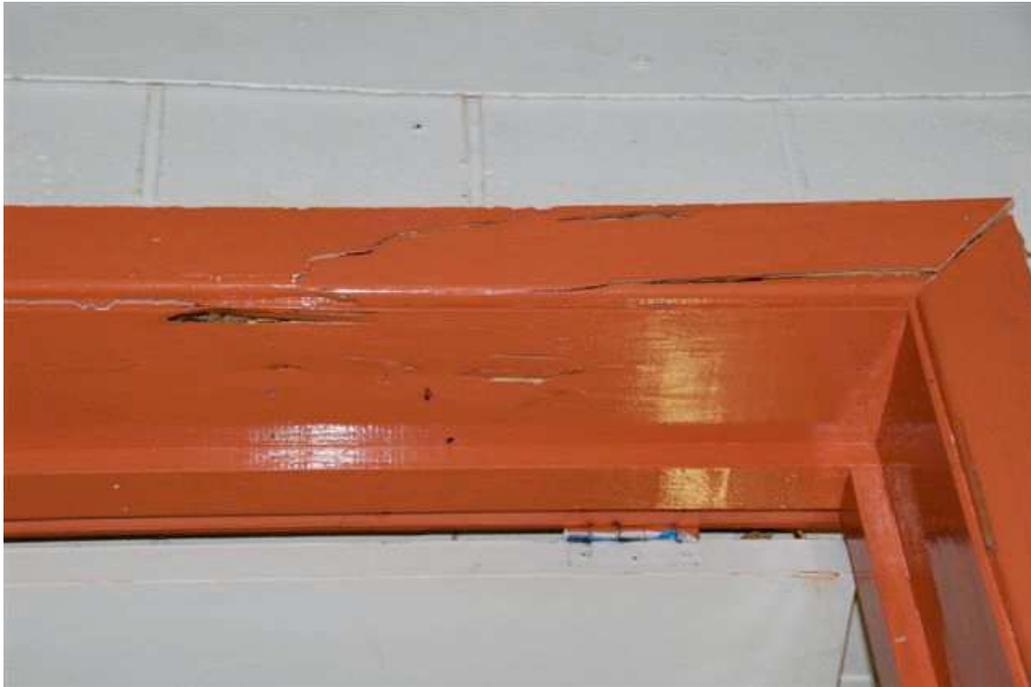
The visual inspection revealed white ant damage in the architrave of the office door and in the battens and quad, which covered the fibre cement sheet joins in the ceiling. There is no evidence of damage in the cement sheet ceiling and there was no noticeable sag in the ceiling indicating that the white ant damage is non-structural.

Photo 3.1 – White ant damage in door architrave

- Replacement of all damaged architrave, ceiling cover strips and quad in the building with treated pine mouldings
- Provision of supplementary support for the rear roller door concrete block header course with a rectangular hollow section galvanised steel frame
- Underpinning of the western wall with hit and miss strip footings

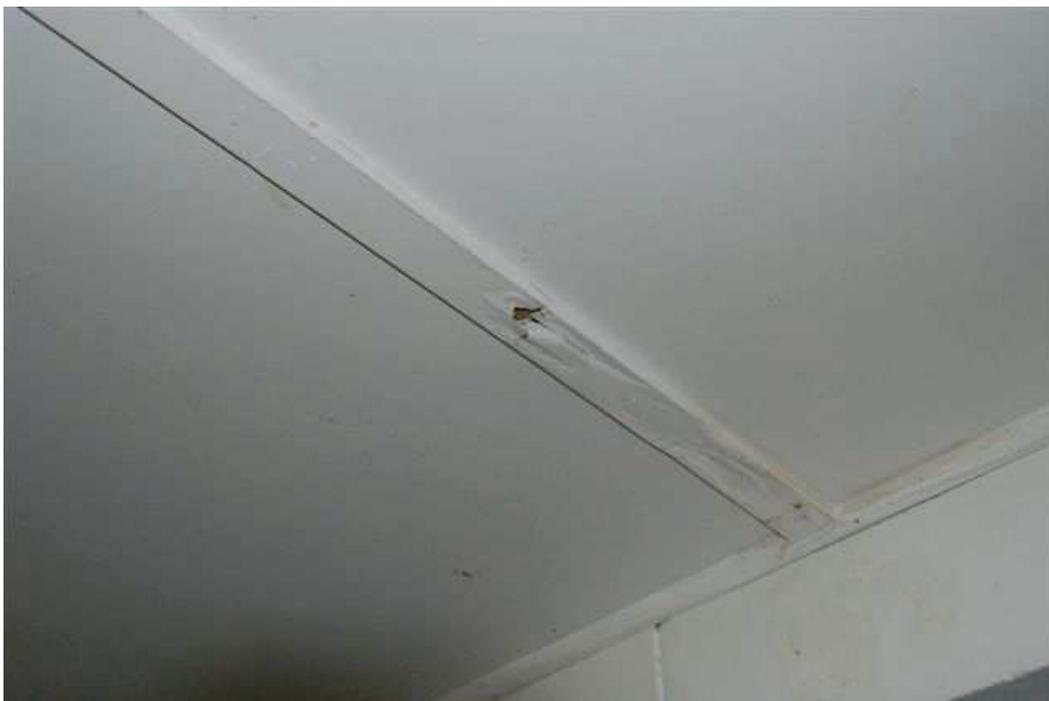
Photo 3.2 – White ant damage in ceiling cover strips

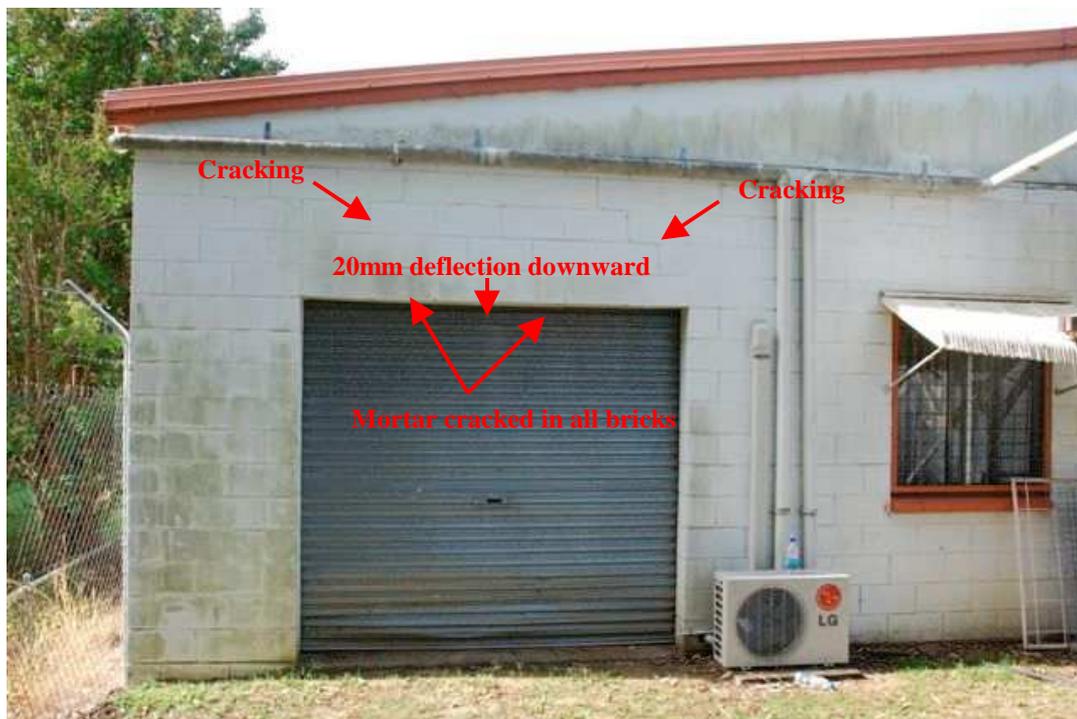
- Cracks on both sides of opening which extends from the outside corners of the opening to the top level of the brick courses
- Crack in mortar in all bottom blocks and there is at least a 20mm deflection across the top of the doorway in the brickwork at mid-span
- The six blocks at the head of the doorway are clearly failing – this is the result of the incorrect use of blocks and inadequate reinforcement – these should have been special header blocks which are designed for use as lintels and have additional reinforcement to account for tensile forces in the bottom of the lintel
- No cracks are evident in the foundation at the base of the door or in the lower brickwork, which indicates that foundation movement has not been a contributing factor to the failure of the doorway structure.

Photo 4.1 – Rear roller door indicating failure locations

Without the use of a temporary support placed by the SES members at mid-span, the failure of the lintel over the roller door would be imminent.

The lintel over the rear roller door has failed and it is only a matter of time before the lintel and the brickwork above suddenly collapses. This will not cause failure of any other part of the structure as the lintel only supports the wall load directly above and no roof members rely upon its strength. A lightweight steel frame constructed of 90 x 90 x 5.0 SHS would be adequate to support the brickwork above the roller door opening.

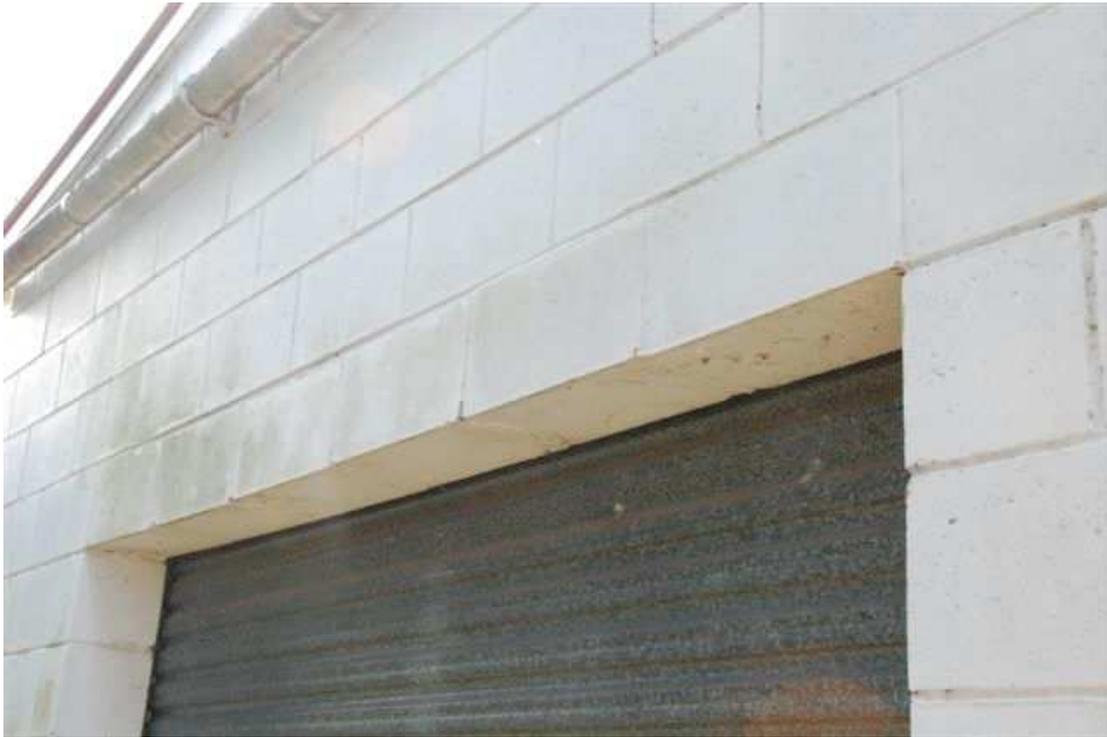
Photo 4.2 – Rear roller door indicating 20mm deflection and cracked mortar

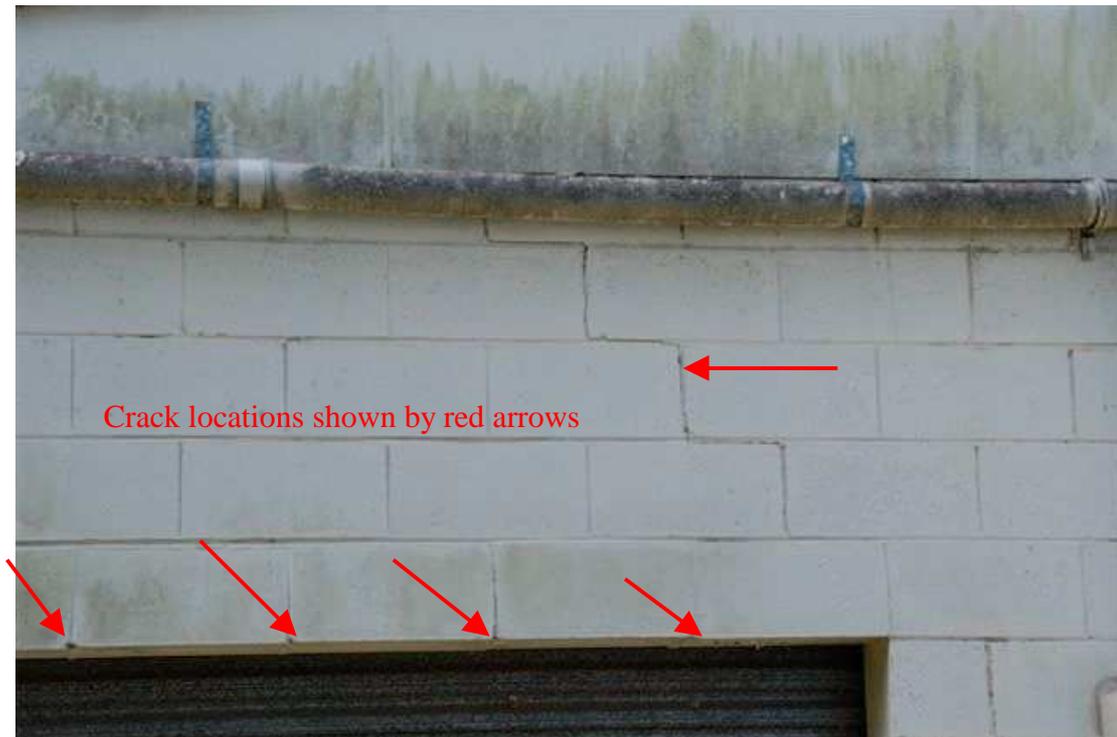
Photo 4.3 – Close up of rear roller door indicating cracked mortar

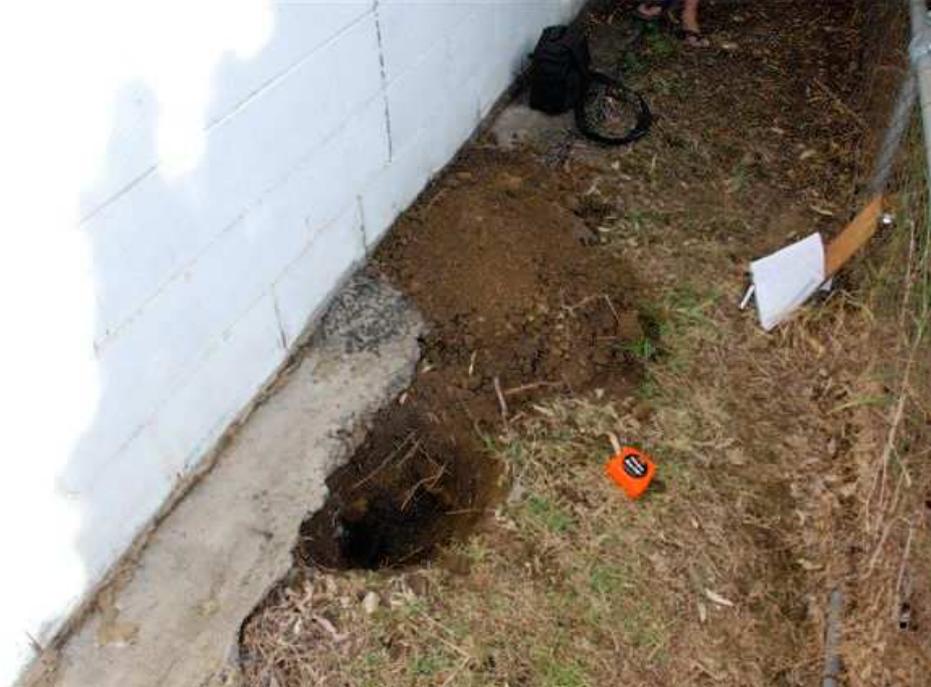
The site inspection revealed that the proposed site was on fill, which had not been adequately compacted, nor had topsoil been removed prior to the placement of the yellow sandy clay fill. This has resulted in a 200mm band of topsoil which overlays a 180mm band of yellow sandy clay fill. The sandy clay overlays the in-situ topsoil on which the strip footing of the building is founded. There is no evidence of landslip on the site but the local drainage on the western side of the site is poor and is retained on the surface for extended periods along this side of the building. This will have some effect on the ability of the soil to support building loads.

Photo 6.1 – Location of test pit showing topsoil removed

The method of underpinning recommended is a tried and proven practice, which has been used on many buildings over the last 25 years in the Kyogle and Casino areas. This involves providing underpin columns which extend 1.0m to 1.5m below the bottom of the existing strip footing and extend 1m along the existing strip footing. Generally, the columns are at least the width of the existing footing but as a minimum 400mm is recommended. The column strips are placed at spacings of 1.5m to 2m along the existing strip footings so that there will be underpin columns at all external corners, which will extend for 1m and then a space of no more than 2m when another underpin column will be placed. This is continued on the external walls of the building, which have shown signs of cracking.

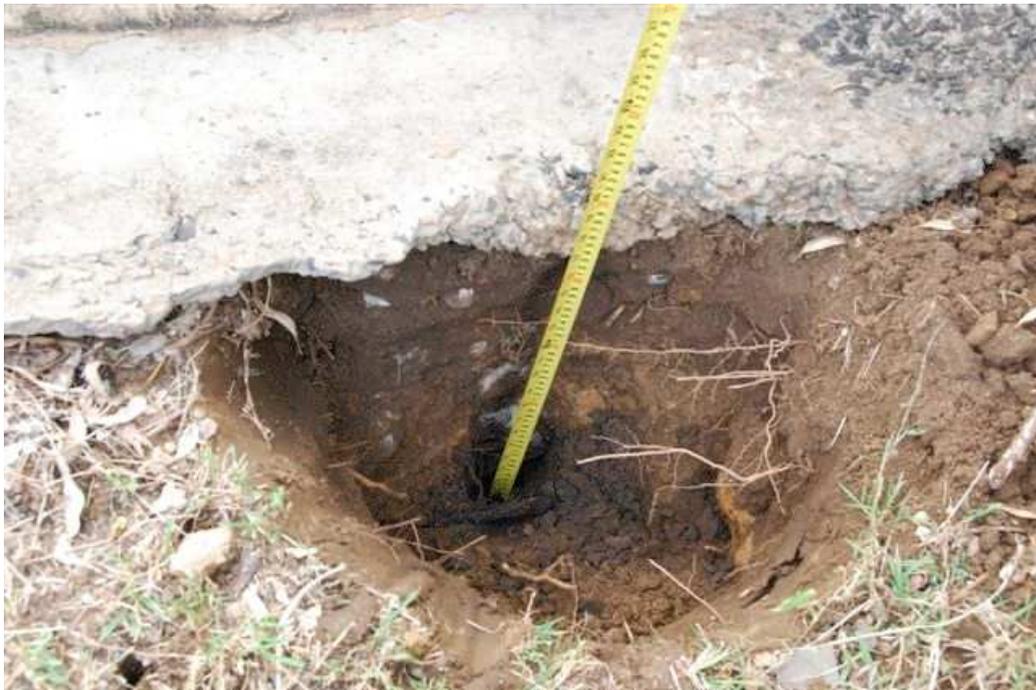
The building pad is elevated 380mm above the surrounding natural surface and the test pit excavation revealed that the site had not been stripped of topsoil prior to placing 180mm of yellow sandy clay fill. Thus the strip footing was founded on topsoil below the layer of sandy clay which has little bearing strength.

Photo 6.2 – Base of footing at bottom of tape bearing on moist topsoil
