ROAD SAFETY AUDIT

EXISTING ROAD

Green Pigeon Road / Walters Road Intersection,
Horseshoe Creek

Kyogle Council

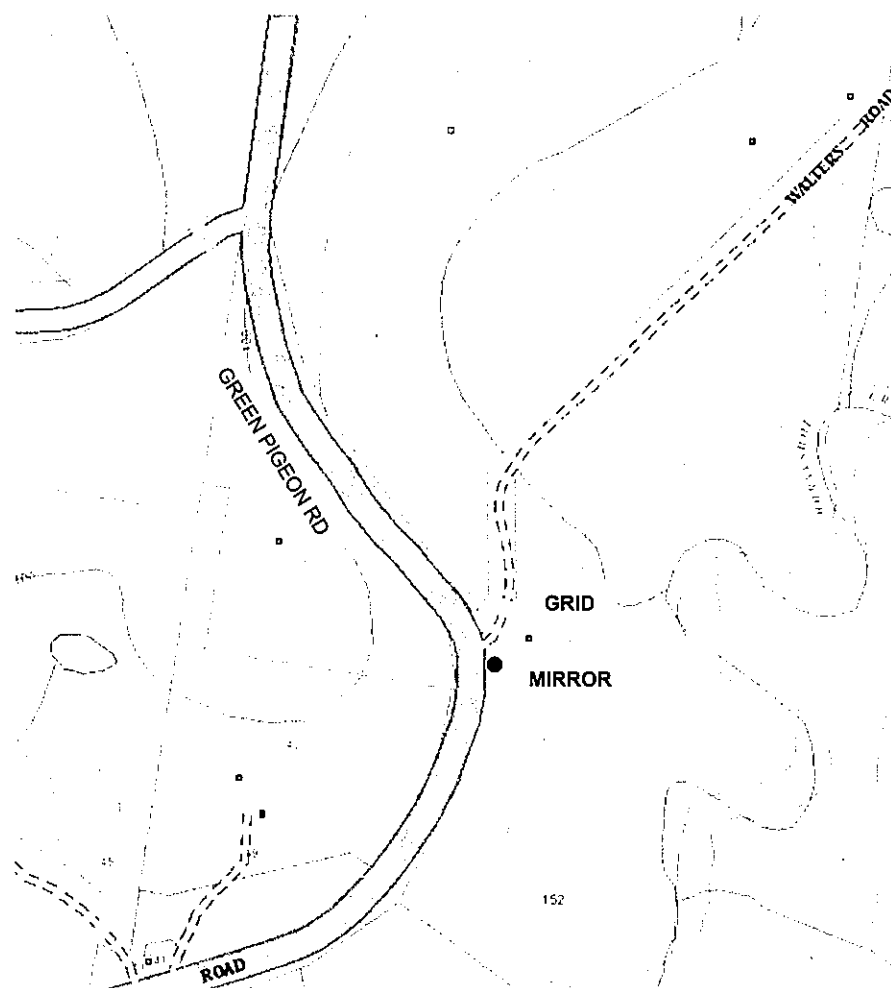
Figure 2: Intersection Layout

- The intersection is located on a tight bend on Green Pigeon Road
- Walters Road intersects at an acute angle, and approaches at a relatively steep grade
- Walters Road is a gravel road
- A convex safety mirror is installed at the intersection
- There is a narrow cattle grid on Walters Road, approx. 20m from the intersection
- From Walters Road, the sight distance to the south is poor. The sight distance to the north is acceptable, however the angle of the approach makes checking line of sight difficult
- On Green Pigeon Road, sight distance for northbound turning vehicles to observe southbound through traffic is poor.
- There is not enough room for two cars to pass in Walters Road at the intersection
- Most vehicles, but especially larger vehicles, would have difficulty turning right out of or left in to Walters Road.
