Mobility Access - 2005

MOBILITY ACCESS -

Management and Implementation Plan 2005

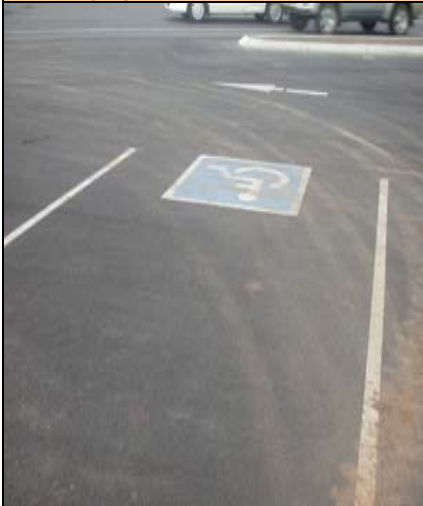
LOCATION Kyogle - Amphitheatre	AUDIT FINDINGS	ACCESS RECOMMENDATIONS	PRIORITY

<p>Parking</p> <ol style="list-style-type: none"> Two designated parking bays located beside entrance pathway Length of parking bay is 5.4 metres Width of parking bay is 2.9 metres - inaccessible (3.2 Mt, preferred width 3.8 Mt) Rear vehicle transfers will encounter cross vehicle traffic Set-down area between parking bays Level gradient Minimal cross fall <p>Pathway</p> <ol style="list-style-type: none"> Pathway width is 1500 mm - accessible 	<p>Parking</p> <p>Though bay width is not to A. S. there is an adjacent set-down area -</p> <ol style="list-style-type: none"> The space used when transferring from the rear of a vehicle is 7.8 Mt (see photo - Library) and therefore passengers will be in the line of cross vehicle traffic. Though not required by A.S. - recommend 'keep clear' ground signage located at vehicle flow <p>Pathway</p> <p>No recommendation</p>	<p>Parking</p> <ol style="list-style-type: none"> High

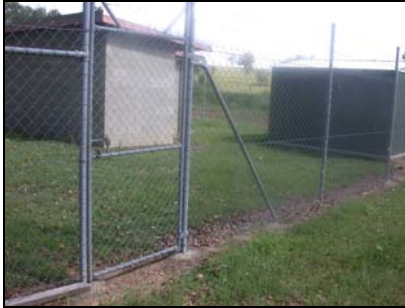
Parking <ol style="list-style-type: none"> 1. No designated parking bay 2. General parking area 3. Gateway width is 940 mm Note: Attendant brings animals to front gate for all visitors	Parking No recommendation

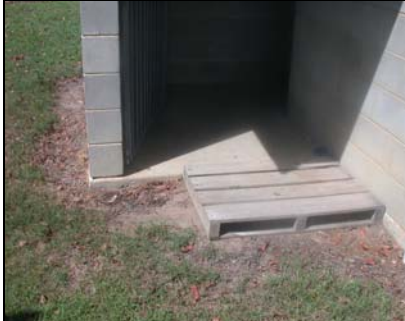
Entrance <ol style="list-style-type: none"> 1. Wooden crate acts as a mat 2. Ground surface muddy when wet 3. Doorway width is 1025 mm Internal passageway <ol style="list-style-type: none"> 1. Internal passageway width is 1000 mm 2. Directional change - diagonal width is 1065 mm 	Entrance <ol style="list-style-type: none"> 1. Remove wooden crate 2. Construct a paved area at entrance Internal passageway No recommendation	Entrance <ol style="list-style-type: none"> 1. High 2. Medium

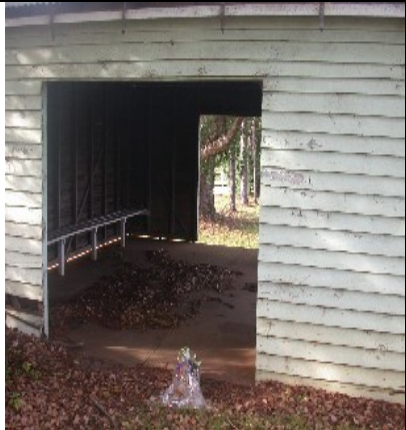
Shelter 1. The shelter's interior has a large amount of leaf litter 2. The shelter's exterior has not been maintained 3. No roof guttering Shelter Entrance 1. Shelter has a 75 mm lip at front entrance and two steps of differing heights at side entrance	Shelter 1. Clean shelter interior 2. Replace roof guttering Shelter Entrance 1. Construct a step ramp to address the concrete pad's lip (front) 2. Paint step nosing with high contrast/luminance colour (safety yellow)	Shelter 1. Maintenance 2. Maintenance Shelter Entrance 1. Low 2. High

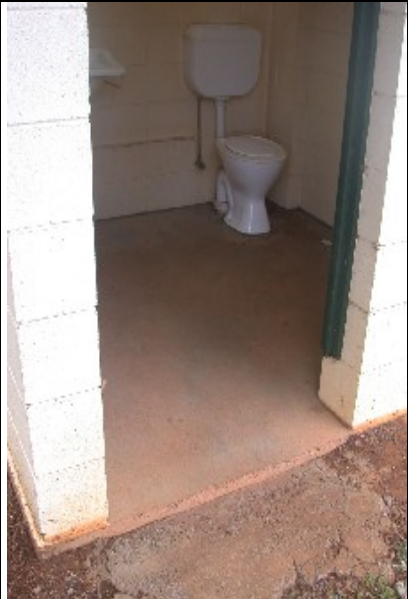
LOCATION Kyogle Cemetery	AUDIT FINDINGS	ACCESS RECOMMENDATIONS	PRIORITY

Toilet <ol style="list-style-type: none"> 1. Toilet facility suitable to be upgraded for ambulant disabilities only 2. There is no directional signage to toilet facility 3. No sexual orientation signage 4. Entrance has an uneven step ramp 5. Inward swinging door 6. Door opening width is inaccessible for wheelchairs 7. Door closure pressure is light 8. Circulation space is inaccessible for wheelchairs 9. No grab rails 10. No toilet roll holder 11. A wash basin is located within the toilet cubicle 12. The wash basin has a twist tap 13. The toilet cubicle has no colour contrast/luminance - floor to wall 14. No mirror, soap dispenser, hand dryer, shelf or clothes hook 	Toilet <ol style="list-style-type: none"> 1. Install unisex signage 2. Construct doorway step ramp 3. Install side grab rail 4. Install toilet roll holder 5. Install flick tap 6. Address colour contrast between wall and floor 7. Install cubicle accessories (findings point 14) 	Toilet <ol style="list-style-type: none"> 1. Medium 2. High 3. High 4. Maintenance 5. High 6. Medium 7. Medium

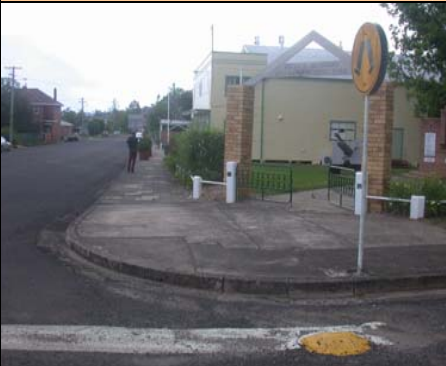
Parking 1. No designated parking bay Curb cut 1. No curb cut at entry/exit points of pedestrian crossing	Parking 1. Allocate a designated parking bay (with ground and elevated signage) in close proximity to Cenotaph Curb cut 1. Construct curb cut, at entry/exit points of pedestrian crossing	Parking 1. Low Curb cut 1. High

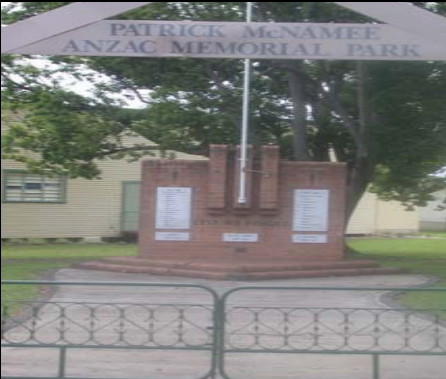
Pathway 1. Pathway to the cenotaph	Pathway No recommendation

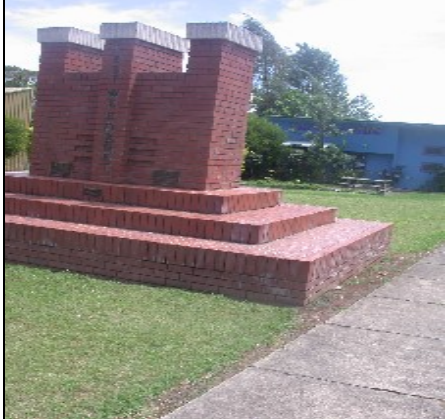
LOCATION Kyogle - Cenotaph	AUDIT FINDINGS	ACCESS RECOMMENDATIONS	PRIORITY

Parking 1. No designated parking bay	Parking 1. Allocate a designated parking bay (with ground and elevated signage) in close proximity to Cenotaph/Youth Centre	Parking 1. Low

Pathway (also Youth Centre) 1. Onset of pathway is uneven 2. Pathway is cracked and uneven (12 metres)	Pathway 1. Address uneven onset to pathway 2. Replace 12 metres of the pathway 3. Extend a concrete area in front of Cenotaph from the pathway for wheelchairs	Pathway 1. High 2. High 3. Medium

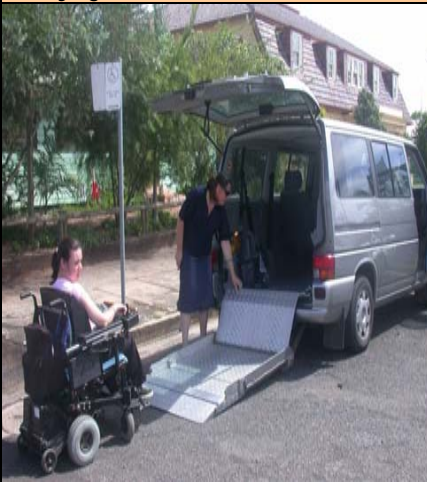
LOCATION	AUDIT FINDINGS	ACCESS RECOMMENDATIONS	PRIORITY
Kyogle - Council Chambers

<p>Parking (Also Library)</p> <ol style="list-style-type: none"> Two designated parking bays - Stratheden & Bloore Streets

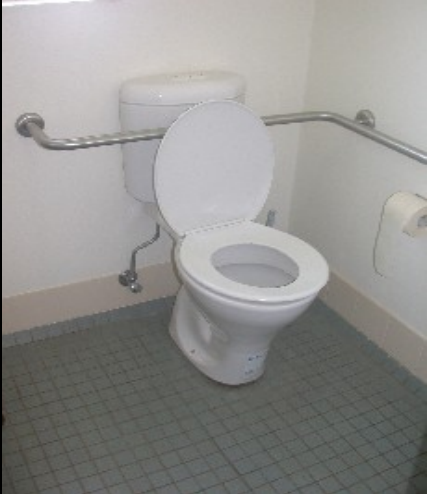
LOCATION Kyogle - Council Chambers	AUDIT FINDINGS	ACCESS RECOMMENDATIONS	PRIORITY

Toilet - Ground Floor -Female <ol style="list-style-type: none"> Two accessible doorways (entrance and cubicle) Door swings outward Door pressure is heavy Doors are colour contrasted to surroundings Circulation space in front of bowl is inaccessible Front of bowl to rear of wall is inaccessible Circulation space beside bowl is accessible Seat height is accessible Side and rear grab rails Flushing control height is accessible Wash basin is outside cubicle though height is accessible Taps are twist control No shelf inside cubicle 	Toilet - Ground Floor - Female <ol style="list-style-type: none"> Install a bi-directional hinge to entrance and cubicle doors Adjust door pressures Install flick taps Address circulation space in front of bowl Install shelf inside cubicle 	Toilet- Ground Floor - Female <ol style="list-style-type: none"> High High High Low Low

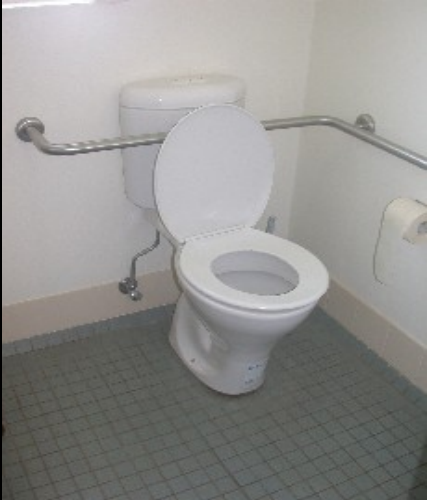
Toilet - Ground Floor -Male <ol style="list-style-type: none"> Two accessible doorways (entrance and cubicle) Door swings outward Entrance door pressure is heavy Doors are colour contrasted to surroundings Circulation space in front of bowl is accessible Front of bowl to rear of wall is inaccessible Circulation space beside bowl is inaccessible Seat height is accessible Side and rear grab rails Flushing control height is accessible Wash basin is outside cubicle though height is accessible Taps are twist control No shelf inside cubicle 	Toilet - Ground Floor - Male <ol style="list-style-type: none"> Install a bi-directional hinge to entrance and cubicle doors Adjust entrance door pressure Address circulation space beside bowl Address distance from bowl to rear wall Install flick taps Install cubicle shelf 	Toilet - Ground Floor - Male <ol style="list-style-type: none"> High High High Low High Low

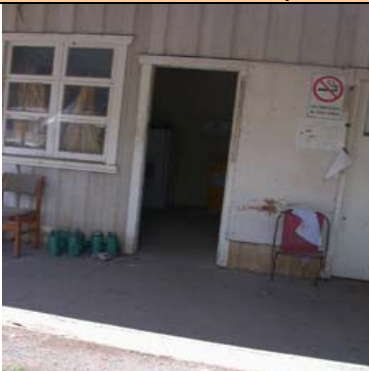
Entrance - Staff 1. One doorway width is 700 mm 2. All other doorways widths are 760 mm	Entrance - Staff 1. Address the 700 mm doorway width	Entrance - Staff 1. Medium

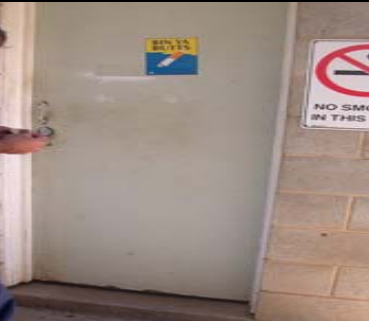
Entrance - Office 1. Entrance has an 80 mm doorway lip 2. Doorway width is 760 mm	Entrance - Office 1. Paint entrance lip with high contrast/luminance colour (safety yellow) Or Install a lip cover	Entrance - Office 1. High

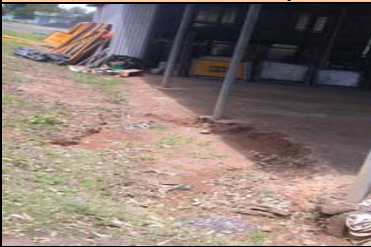
Storage shed 1. Uneven ground surface	Storage shed 1. Address uneven ground surface	Storage shed 1. Low

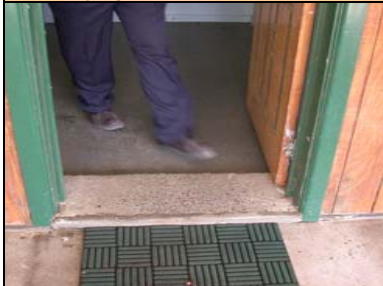
General 1. Public access areas and staff only areas are not defined Entrance - Office 1. Entrance doorway width does not meet 'regular' A.S. 2. Entrance lip has no contrasting colour, though a tactile mat is present (one side)	General 1. Define public access boundaries from authorised personnel area Entrance - Office 1. Construct an accessible door entrance 2. Paint raised concrete doorway lip with high contrast/luminance	General 1. High Entrance - Office 1. Medium 2. High

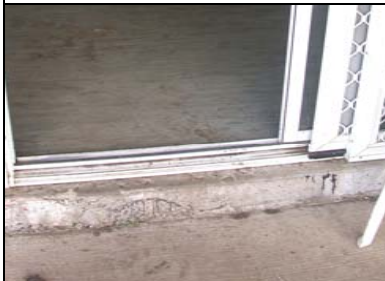
Entrance - Lunchroom 1. Entrance step	Entrance - Lunchroom 1. Paint step nosing with high contrast/luminance colour (safety yellow) or construct a step ramp	Entrance - Lunchroom 1. Medium

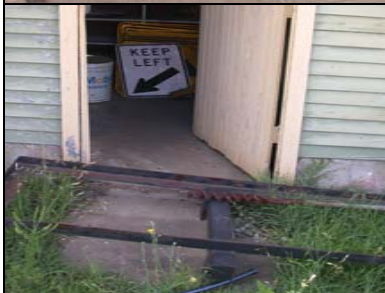
Storage shed 1. Obstacles at the entrance	Storage shed 1. Remove obstacles from entrance	Storage shed 1. High

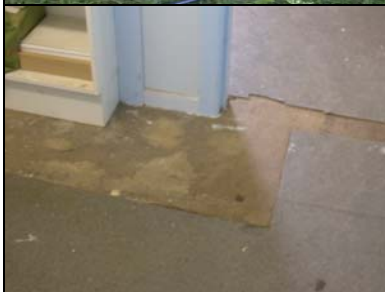
Interior - Office 1. Floor coverings not continuous	Interior - Office 1. Address gaps in floor covering behind front counter - trip hazard	Interior - Office 1. Low

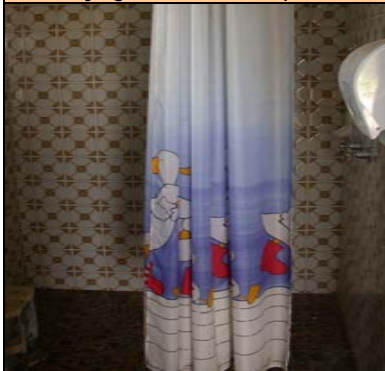
Shower <ol style="list-style-type: none"> 1. No accessible features 2. Doorway width is 720 mm 	Shower <ol style="list-style-type: none"> 1. Address bathroom doorway width to meet with regular A.S. or access standards if staff member uses a wheelchair 	Shower <ol style="list-style-type: none"> 1. Low

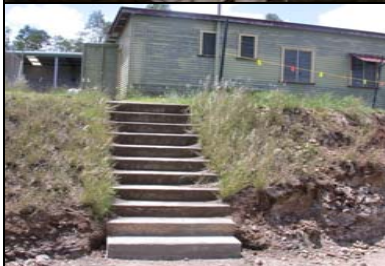
Toilet - Regular Male/female <ol style="list-style-type: none"> 1. Path of travel to toilet facilities is via 10 steps 2. No handrails on stairs 3. No colour contrast on step nosing 	Toilet - Regular Male/female <ol style="list-style-type: none"> 1. Construct handrails to stairs 2. Paint step nosing with high colour contrast/luminance (safety yellow) 	Toilet - Regular <ol style="list-style-type: none"> 1. High 2. High

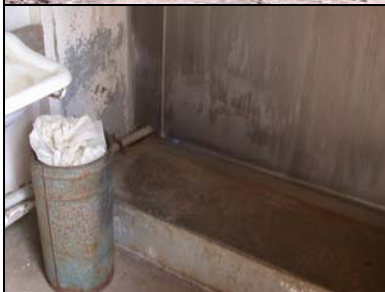
Toilet - Regular Male/female General <ol style="list-style-type: none"> 1. Low level of cleanliness 2. Female staff must enter past urinal to a female "adopted" cubicle 3. No exterior door - open doorway leads directly to urinal 	Toilet - Regular Male/female General <ol style="list-style-type: none"> 1. Address the level of cleanliness 2. Construct separate entrance to the female "adopted" cubicle 3. Install outer door - privacy to urinal 	Toilet - Regular <ol style="list-style-type: none"> 1. Maintenance 2. High 3. High

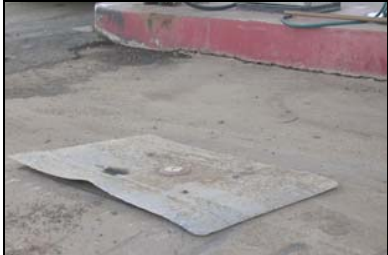
Driveway - Petrol Pump Area 1. Metal cover is not flush with ground surface	Driveway - Petrol Pump Area 1. Address metal cover - trip hazard	Driveway 1. Medium

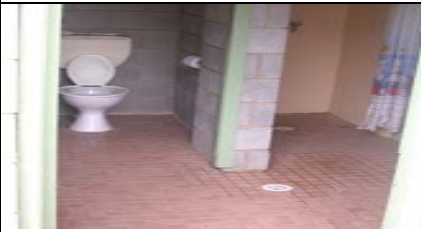
Toilet/Shower 1. Entrance doorway width is 760 mm	Toilet/Shower No recommendation providing no staff member uses a wheelchair

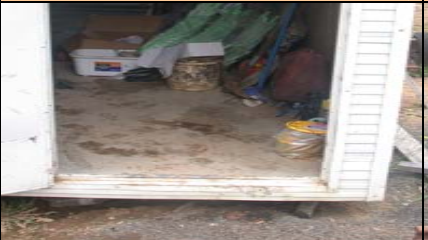
Storage Area (1) 1. No step at entrance	Storage Area (1) 1. Construct step at entrance	Storage Area (1) 1. Medium

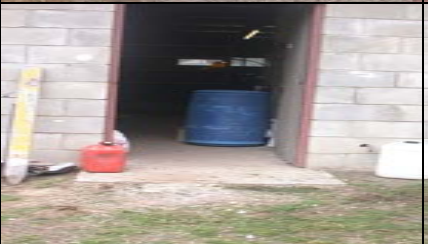
Storage Area (2) 1. Uneven ground surface at entrance	Storage Area (2) 1. Address uneven ground surface at entrance	Storage Area (2) 1. Low

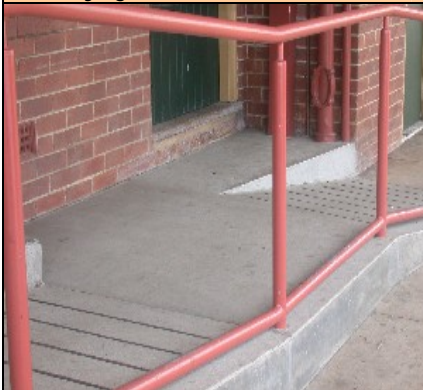
Parking - (also Library/Council Chambers) Ramp <ol style="list-style-type: none"> 1. Gradient 1:14 2. Curb rail on ramp 3. Top handrail height is 900 mm 4. No handrail at a height of 700 mm 5. Tactile strips on ramp gradients 	Parking - (also Library/Council Chambers) Ramp <ol style="list-style-type: none"> 1. Install handrail at 700 mm 	Ramp <ol style="list-style-type: none"> 1. Medium

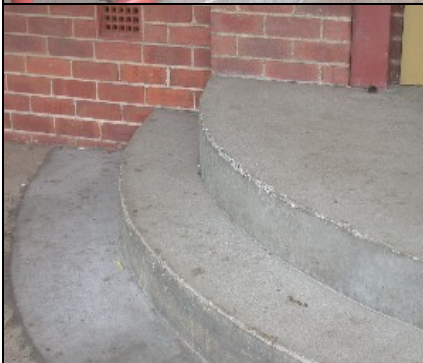
Stairs <ol style="list-style-type: none"> 1. No handrail on stairs 2. No colour contrast or tactile strip on step nosing 3. No TGSi 	Stairs <ol style="list-style-type: none"> 1. Install handrail to wall 2. Paint step nosing with high contrast/luminance colour (safety yellow) or install tactile strips or TGSi at entry/exit points of stairs 	Stairs <ol style="list-style-type: none"> 1. High 2. High

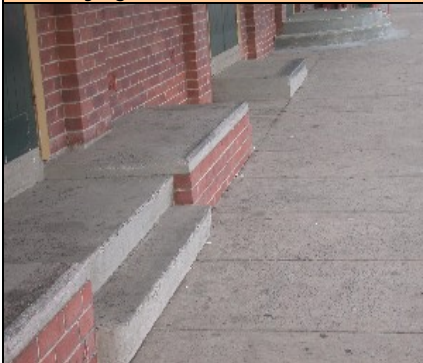
Stairs 1. No colour contrast or tactile strip on step nosing	Stairs 1. Paint step nosing with high contrast/luminance colour (safety yellow) or install tactile strip	Stairs 1. Medium

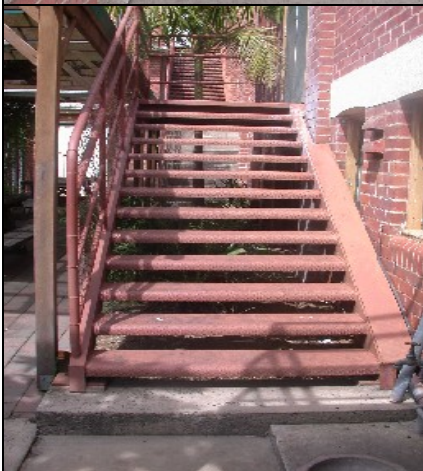
Stairs 1. Handrail on one side of stairs 2. No colour contrast on step nosing	Stairs 1. Install wall handrail 2. Paint step nosing with high contrast/luminance colour (safety yellow)	Stairs 1. Medium 2. Medium

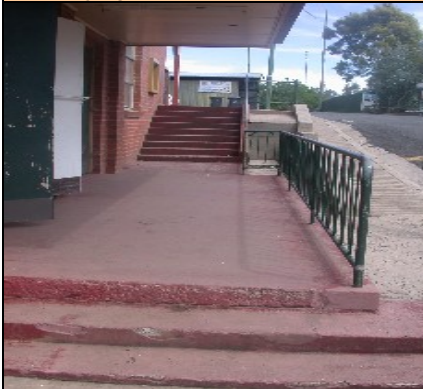
Path of Travel to Supper Room <ol style="list-style-type: none"> 1. Single handrail on stairs 2. No colour contrast or tactile strip on step nosing 3. No TGSIs at entry/exit points on steps 	Path of Travel to Supper Room <ol style="list-style-type: none"> 1. Install wall handrail 2. Paint step nosing with high contrast/luminance colour (safety yellow) or install tactile strips 3. Install TGSIs at entry/exit points on steps 	Path of Travel to Supper Room <ol style="list-style-type: none"> 1. High 2. High 3. Low

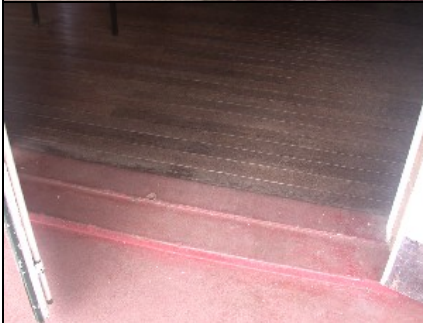
Entrance - Supper Room <ol style="list-style-type: none"> 1. No colour contrast on entrance lip - 40 mm 	Entrance - Supper Room <ol style="list-style-type: none"> 1. Paint entrance lip with high contrast/luminance colour (safety yellow) or install a lip cover 	Entrance Supper Room <ol style="list-style-type: none"> 1. High

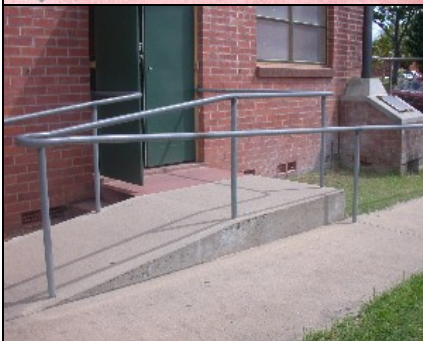
Ramp - Supper Room <ol style="list-style-type: none"> 1. Top handrail 2. No handrail at 700 mm height 3. No curb rail 	Ramp - Supper Room <ol style="list-style-type: none"> 1. Install handrail at 700 mm height 2. Install TGSIs at entry/exit points of ramp 3. Install curb rail 	Ramp Supper Room <ol style="list-style-type: none"> 1. Medium 2. Low 3. Low

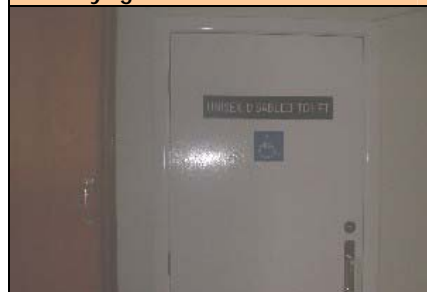
Toilet - Unisex Supper Room & Auditorium <ol style="list-style-type: none"> 1. Toilet door has access symbol 2. Colour contrast of door to wall is low 	Toilet - Unisex Supper Room & Auditorium <ol style="list-style-type: none"> 1. Paint door architrave with a high contrast/luminance colour 	Toilet - Unisex Supper Room & Auditorium <ol style="list-style-type: none"> 1. Medium

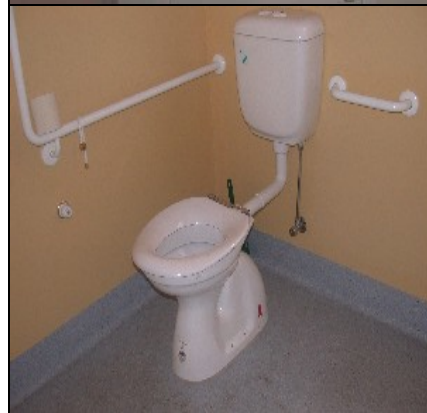
Toilet - Unisex - Supper Room & Auditorium <ol style="list-style-type: none"> 1. Door swings outward 2. Door pressure is medium 3. Circulation space in front of bowl is accessible 4. Front of bowl to rear of wall is accessible 5. Circulation space beside bowl is accessible 6. Seat height is accessible 7. Side and rear grab rails 8. Flushing control height is accessible 9. Taps are twist control 10. No shelf inside cubicle 11. No baby change table 	Toilet - Unisex - Supper Room & Auditorium <ol style="list-style-type: none"> 1. Install shelf - height 900 - 1100 mm 2. Install fold up baby change table 	Toilet - Unisex Supper Room & Auditorium <ol style="list-style-type: none"> 1. Low 2. High

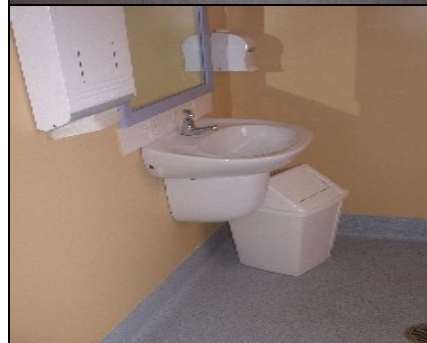
Toilet Wash Basin Supper Room & Auditorium <ol style="list-style-type: none"> 1. Wash basin is inside cubicle - height is accessible 2. Tap has twist control 	Toilet Wash Basin Supper Room & Auditorium <ol style="list-style-type: none"> 1. Install flick tap control 	Toilet Wash Basin Supper Room & Auditorium <ol style="list-style-type: none"> 1. Medium

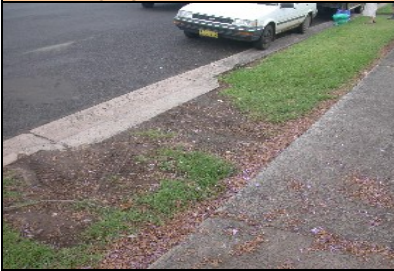
Parking No designated bay Curb Cut 1. Gap between curb cut and footpath	Parking No recommendation Curb Cut 1. Extend concrete (curb cut) to meet footpath	Curb Cut 1. Low

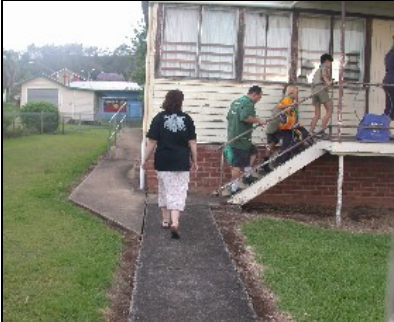
Pathway 1. Pathway width is 920 mm 2. Two sets of stairs at front entrance 3. Step treads are weathered	Pathway 1. Widen pathway to 1000 mm (1200 mm preferred) 2. Minimise maintenance - remove 2 nd set of stairs (not connected to entrance pathway)	Pathway 1. Medium 2. Maintenance

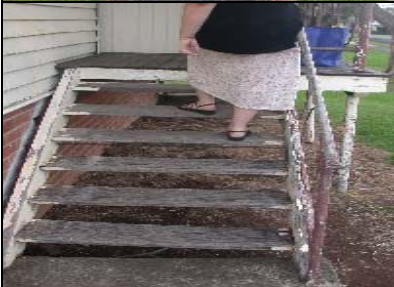
Stairs - Main 1. Handrails one side only 2. Stair risers are open 3. No colour contrast or tactile strip on step nosing 4. No TGSI	Stairs - Main 1. Install handrail to wall 2. Enclose stair risers 3. Paint step nosing with high contrast/luminance colour (safety yellow) or install tactile strip 4. Install TGSI at entry/exit points of stairs	Stairs - Main 1. Medium 2. High 3. High 4. Low

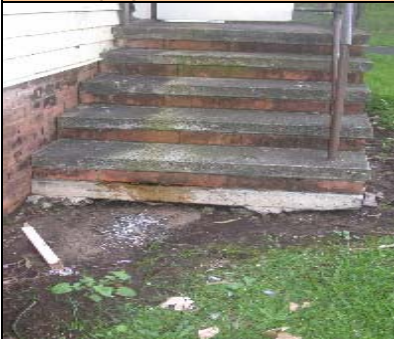
Stairs - Side 1. Bottom step missing - drop is 260 mm	Stairs - Side 1. Remove side stairs 2. Create a stable door (1/3, 2/3) permanently closed bottom half of the door <i>(Stable door will allow cross ventilation to the room and allow light to enter)</i>	Stairs - Side 1. Maintenance 2. Maintenance

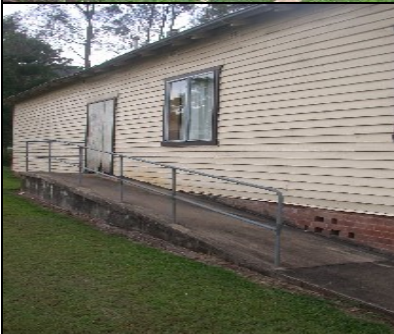
Ramp 1. Gradient is accessible 2. Handrails (double) on one side at 900 & 700 mm heights 3. No TGSI	Ramp 1. Install handrails to wall 2. Install TGSI at entry/exit points of ramp	Ramp 1. Low 2. Low

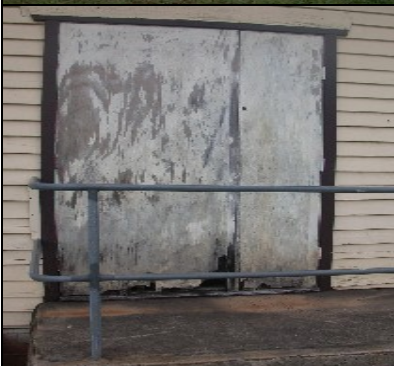
Entrance via Ramp 1. Door damaged by water from roof guttering 2. No exit signage or crash bars	Entrance via Ramp 1. Replace roof guttering 2. Replace door 3. Designate as the emergency exit path of travel 4. Install crash bars	Entrance via Ramp 1. Maintenance 2. Maintenance 3. High 4. Medium

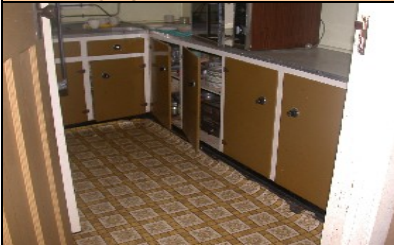
Kitchen 1. Floor coverings lifting	Kitchen 1. Adhere or remove floor covering	Kitchen 1. Maintenance

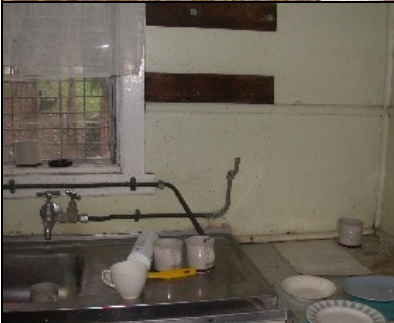
Hot Water Unit 1. Unit is missing	Hot Water Unit 1. Install hot water unit	Hot Water Unit 1. Medium

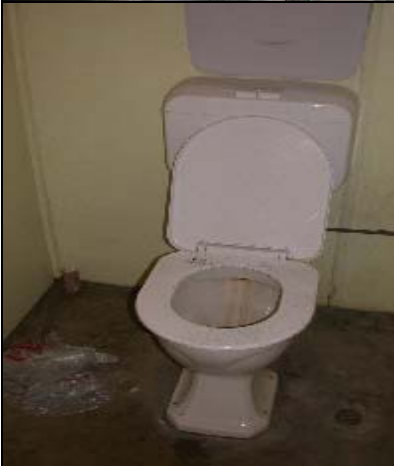
Toilet 1. Low level of cleanliness 2. No grab rails	Toilet - 1. Address low level of cleanliness 2. Install grab rail on side wall	Toilet 1. Maintenance 2. High

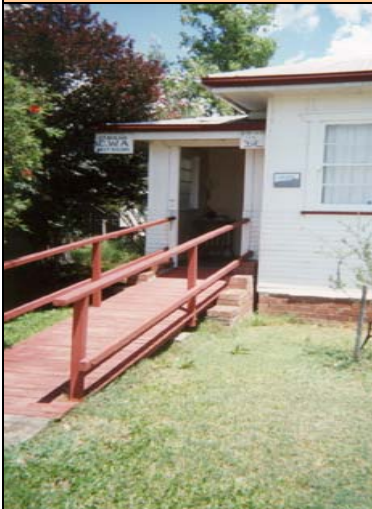
<p>Parking No designated bay</p> <p>Ramp</p> <ol style="list-style-type: none"> 1. Horizontal distance between handrails is 800 mm - inaccessible (1000 mm preferred 1200 mm) 2. Double handrails - both sides, heights are 880 mm & 320 mm - does not meet A.A.S. 3. No TGSI <p>Entrance</p> <ol style="list-style-type: none"> 1. Gateway width is 800 mm - accessible 2. Two doorway widths are 760 mm <p>Interior</p> <ol style="list-style-type: none"> 1. Smooth floor surface (Some traction to the floor surface has been added though still classed as slippery) 	<p>Parking No recommendation</p> <p>Ramp</p> <ol style="list-style-type: none"> 1. Widen width of ramp 2. Adjust heights of handrails 3. Install TGSI at entry/exit points of ramp <p>Entrance</p> <ol style="list-style-type: none"> 1. Construct accessible doorway widths <p>Interior</p> <ol style="list-style-type: none"> 1. Address smooth floor surface 	<p>Ramp</p> <ol style="list-style-type: none"> 1. Medium 2. Medium 3. Low <p>Entrance</p> <ol style="list-style-type: none"> 1. Medium <p>Interior</p> <ol style="list-style-type: none"> 1. Medium

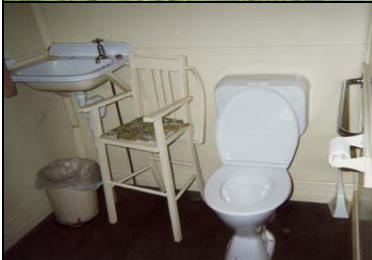
<p>Toilet</p> <ol style="list-style-type: none"> 1. Passageway to toilet is 1030 mm - accessible 2. Doorway width is 760 mm 3. Side grab rail only 4. Wash basin impedes side of bowl access 5. Twist tap on wash basin 	<p>Toilet Suitable for ambulant disabilities</p> <ol style="list-style-type: none"> 1. Install flick tap 	<p>Toilet</p> <ol style="list-style-type: none"> 1. Medium

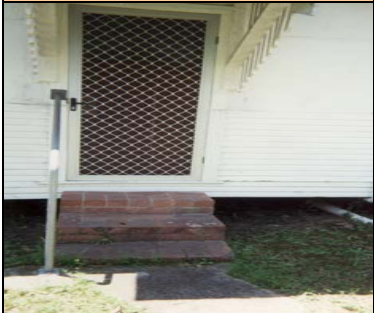
Rear Stairs 1. Doorway width is 760 mm 2. Handrail one side of stairs 3. No colour contrast or tactile strip on step nosing	Rear Stairs 1. Install 2 nd handrail 2. Paint step nosing with high contrast/luminance colour (safety yellow) or install tactile strip 3. Construct accessible doorway width	Rear Stairs 1. Medium 2. High 3. Medium

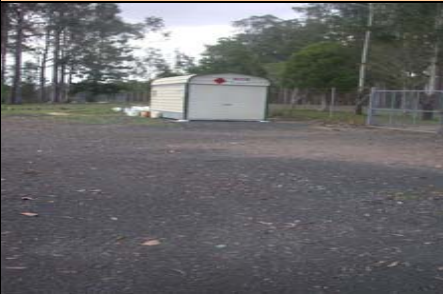
Parking 1. No signed parking area Hazardous Waste Storage 1. Path of travel to storage container is level 2. Ground surface is firm with some loose aggregate	Parking No recommendation Hazardous Waste Storage No recommendation

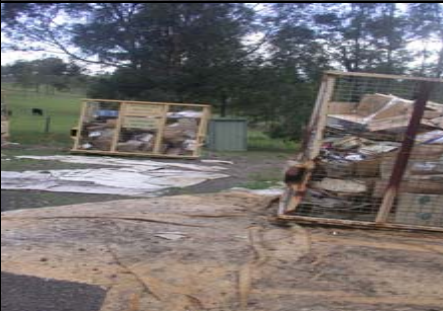
Recyclables 1. The positioning of the recyclable containers cannot be adapted for access; the high side of the containers are positioned for removal trucks	Recyclables 1. Install signage stating that staff will assist with unloading recyclables	Recyclables 1. Medium

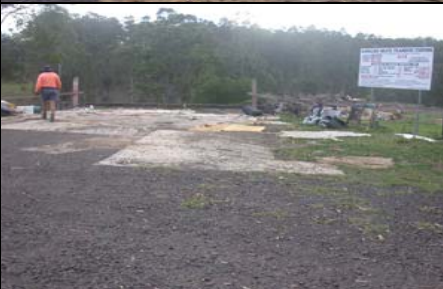
Household Waste 1. No barrier at the landing edge	Household Waste 1. Construct safety rail at landing edge	Household Waste 1. Medium

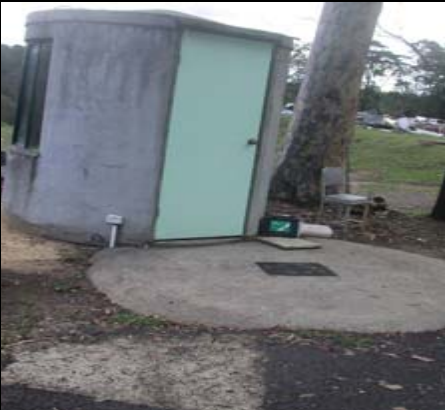
Office 1. The attendant's vehicle is usually parked on the circular concrete pad, however if this did not occur, it would be desirable to highlight the change in the ground level	Office 1. Paint edges of circular concrete pad with high contrast/luminance colour (safety yellow)	Office 1. Low

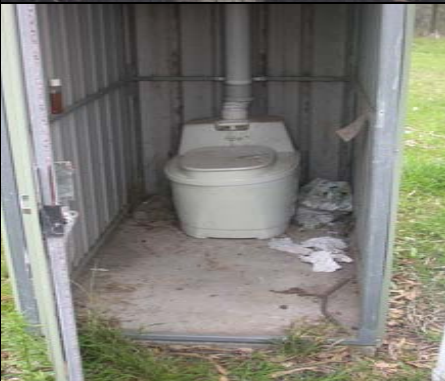
Toilet Regular 1. Composting toilet 2. The toilet facility is accessed via a moderately sloped unsealed track 3. No grab rails	Toilet Regular 1. Construct pathway to toilet facility addressing the gradient of the path 2. Install side grab rail 3. Install unisex signage on toilet door	Toilet Regular 1. Low 2. Low 3. Low

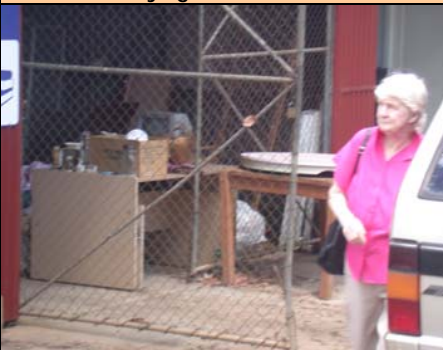
Parking <ol style="list-style-type: none"> 1. No signed parking area 2. No designated bay 3. The space outside the reusable shop is also be used for delivering hazardous waste to the hazardous waste storage container Reusable Shop <ol style="list-style-type: none"> 1. Wire gate poses an obstacle for the target group with low vision - if when open, does not rest against solid wall 	Parking <ol style="list-style-type: none"> 1. Construct a firm ground surface in front of reusable shop Reusable Shop <ol style="list-style-type: none"> 1. Paint wire gate with high contrast/luminance colour (safety yellow) 	Parking <ol style="list-style-type: none"> 1. Medium Reusable Shop <ol style="list-style-type: none"> 1. High

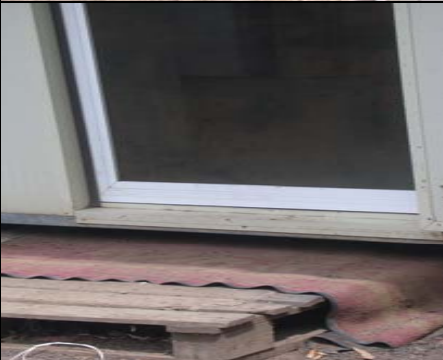
Entrance (Office) <ol style="list-style-type: none"> 1. A wooden crate serves as a step 	Entrance (Office) <ol style="list-style-type: none"> 1. Remove wooden crate 2. Construct concrete step 3. Paint step nosing with high contrast/luminance colour (safety yellow) 	Entrance (Office) <ol style="list-style-type: none"> 1. High 2. High 3. High

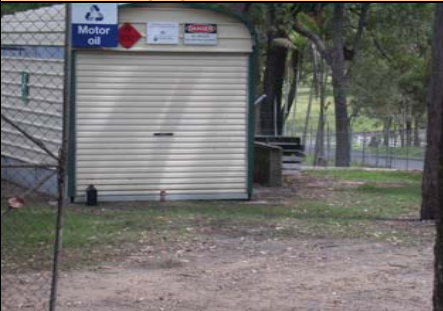
Hazardous Waste 1. Ground surface leading to the hazardous waste storage container is noted to be slippery when wet	Hazardous Waste 1. Construct pathway to the hazardous waste storage container (also see parking recommendation)	Hazardous Waste 1. High

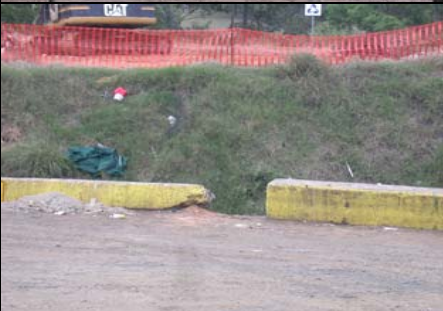
Household Waste 1. Low barrier at the landing edge	Household Waste 1. Construct safety rail at landing edge	Household Waste 1. High

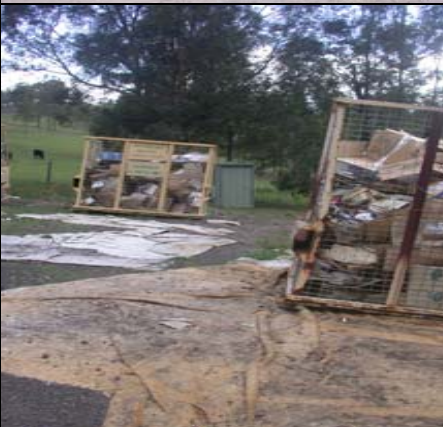
Recyclables 1. The positioning of the recyclable containers cannot be adapted for access; the high side of the containers are positioned for removal trucks	Recyclables 1. Install sign stating that staff will assist with unloading	Recyclables 1. Medium

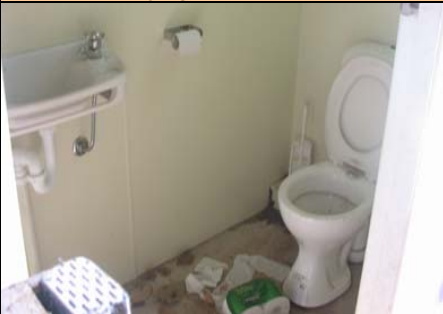
Public Toilet 1. No accessible features	Public Toilet 1. Install unisex signage on toilet door 2. Install grab rails to assist those with ambulant disabilities	Public Toilet 1. Low 2. Medium

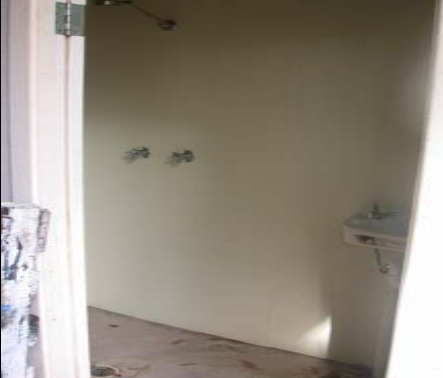
Public Shower 1. No accessible features	Public Shower 1. Install grab rail to assist those with ambulant disabilities	Public Shower 1. Low

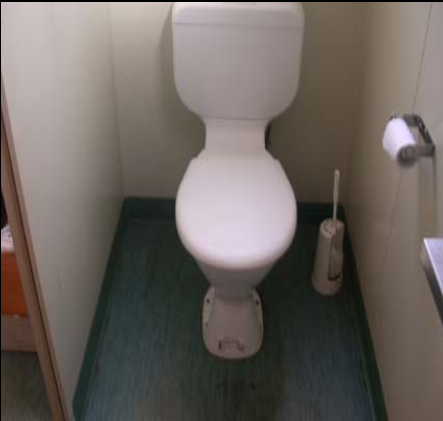
<p>Toilet - Staff</p> <ol style="list-style-type: none"> Two doorways into facilities Both doorway widths are 700 mm (Does not meet regular Australian Standards) One door swings inward One door swings outward

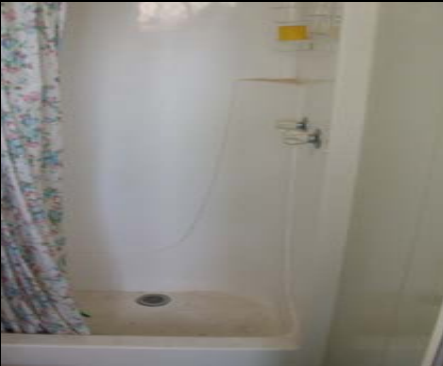
<p>Shower - Staff</p> <ol style="list-style-type: none"> No accessible features 	<p>Shower - Staff</p> <p>No Recommendations providing no member of staff uses a wheelchair</p>

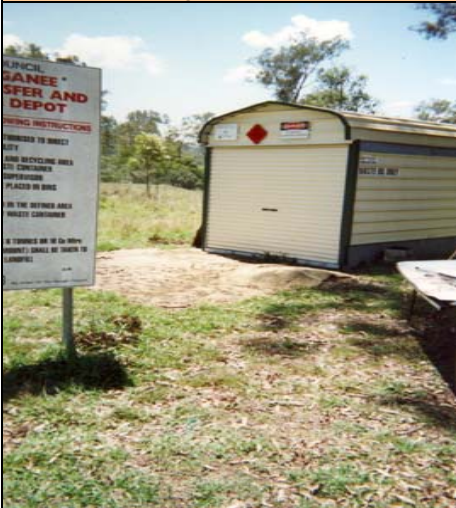
Hazardous Waste 1. No pathway to hazardous waster container	Hazardous Waste 1. Construct pathway to hazardous waster container or ensure firm ground surface that is not slippery when wet	Hazardous Waste 1. Low

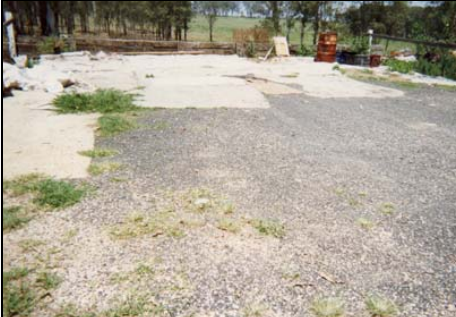
Household Waste 1. No barrier at the landing edge	Household Waste 1. Construct safety rail at landing edge	Household Waste 1. Medium

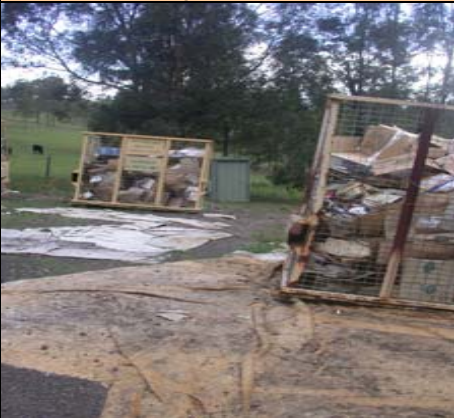
Recyclables 1. The positioning of the recyclable containers cannot be adapted for access; the high side of the containers are positioned for removal trucks	Recyclables 1. Install sign stating that staff will assist with unloading	Recyclables 1. Low

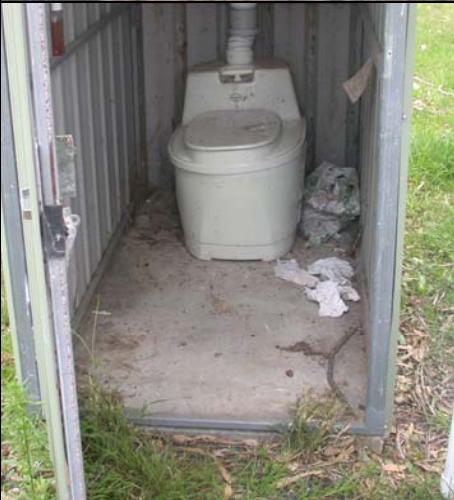
Toilet 1. Composting Toilet 2. No signage 3. No grab rails	Toilet 1. Install unisex signage on toilet door 2. Install side grab rail	Toilet 1. Low 2. Low

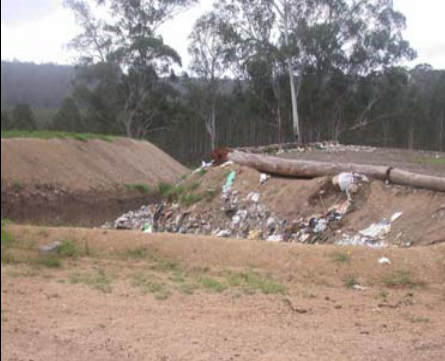
Household Waste 1. No barrier at the landing edge	Household Waste 1. Construct safety rail at landing edge	Household Waste 1. High

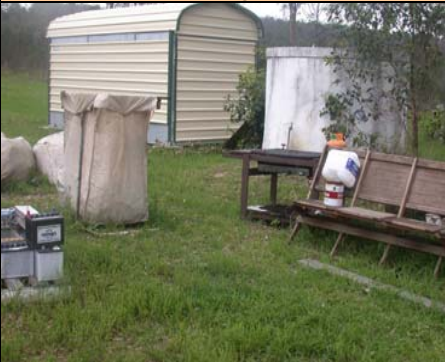
Hazardous Waste <ol style="list-style-type: none"> 1. Objects may act as obstacles to the path of travel 2. No pathway 	Hazardous Waste <ol style="list-style-type: none"> 1. Construct pathway to hazardous waste container or ensure firm ground surface is not slippery when wet 	Hazardous Waste <ol style="list-style-type: none"> 1. Low

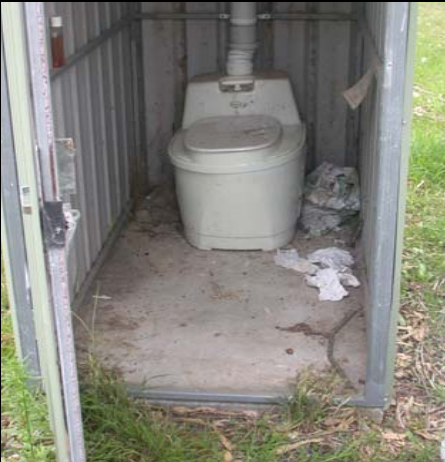
Toilet Regular <ol style="list-style-type: none"> 1. Composting toilet 2. No grab rails 3. No closing device on door 	Toilet Regular <ol style="list-style-type: none"> 1. Construct pathway to toilet facility 2. Install unisex signage on toilet door 3. Install grab rail 4. Install closing device on door 	Toilet Regular <ol style="list-style-type: none"> 1. Low 2. Low 3. Low 4. Low

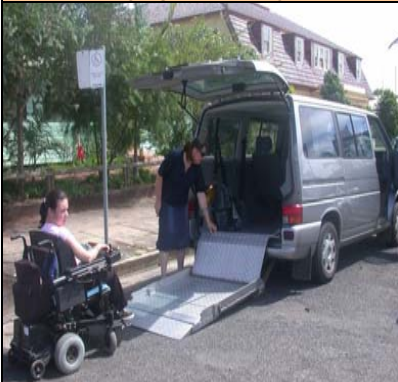
<p>Parking (Repeated in Council Chamber Table)</p> <p>1. Two designated parking bays - Stratheden and Bloore Strs</p> <p>Stratheden Street</p> <p>1. Two blue upright access symbol signs - front and side of bay</p> <p>2. No ground access symbol signage</p> <p>3. No ground parking bay demarcation</p> <p>4. Parking bay has some cross fall</p> <p>5. Rear transfers fall across vehicle laneway traffic</p> <p>6. Most convenient and used parking bay</p> <p>Bloore Street (Suitable for Ambulant Disabilities)</p> <p>1. Two blue upright access symbol signs - front and side of bay</p> <p>2. No ground access symbol</p> <p>3. Parking bay is on sloped ground and has some cross fall</p> <p>4. Parking bay width is 2.4 Mt, length is 6.7 Mt</p>	<p>Parking</p> <p>Stratheden Street</p> <p>1. Paint ground access symbol</p> <p>2. Paint ground parking bay demarcation</p> <p>3. Address cross vehicle traffic hazard from laneway by relocating 3.2 Mt of curb guttering and lengthening parking bay to 7.8 Mt into adjacent grassed area</p> <p>Bloore Street</p> <p>1. Paint ground access symbol</p> <p>2. Adjust bay width and length (3.2 x 7.6)</p>	<p>Parking</p> <p>Stratheden Street</p> <p>1. High</p> <p>2. High</p> <p>3. High</p> <p>Bloore Street</p> <p>1. High</p> <p>2. Medium</p>

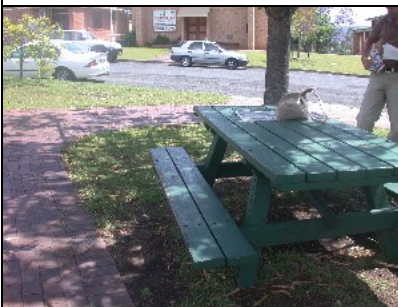
<p>Picnic Table</p> <p>1. No shelter over picnic table (shaded)</p> <p>2. No concrete pad</p> <p>3. No table edge access</p>	<p>Picnic Table</p> <p>1. Relocate table to edge of pathway</p> <p>2. Remove 800 mm in the centre of seat closest to allow knee clearance and table edge access</p>	<p>Picnic Table</p> <p>1. Medium</p> <p>2. High</p>

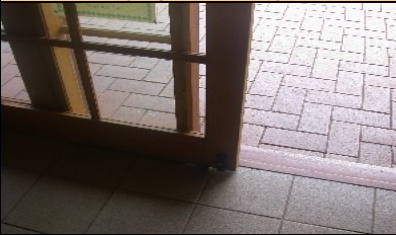
Entrance <ol style="list-style-type: none"> Automatic sliding door Entrance doorway is width is 790 mm No TGSi 	Entrance <ol style="list-style-type: none"> Adjust door block Install TGSi 	Entrance <ol style="list-style-type: none"> Low Low

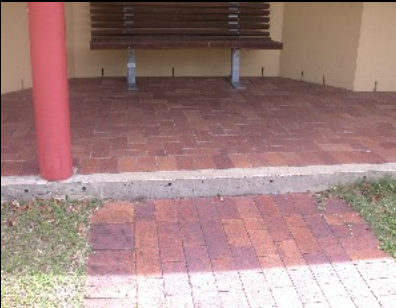
Path of Travel - to Toilets <ol style="list-style-type: none"> Step on path of travel 	Path of Travel - to Toilets <ol style="list-style-type: none"> Construct a step ramp 	Path of Travel to Toilets <ol style="list-style-type: none"> High

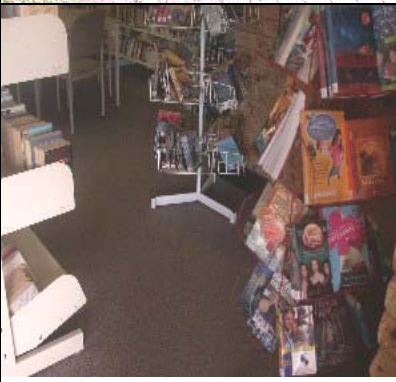
Path of Travel - Internal <ol style="list-style-type: none"> Path of travel is inaccessible (Aisle widths 1100 - 900 mm and book stands) Low pile carpet supports access Book shelf top heights range between 1640 to 1300 mm 	Path of Travel - Internal <ol style="list-style-type: none"> Adjust aisle widths to 1000 mm (1200 mm preferred) Relocate mobile book stands away from aisle ends 	Path of Travel - Internal <ol style="list-style-type: none"> High High

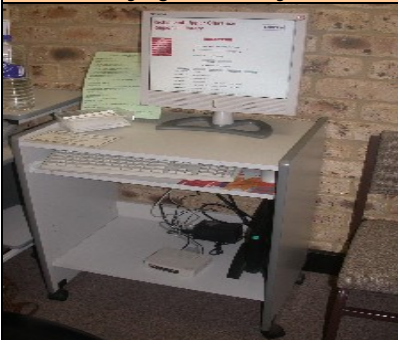
Desk <ol style="list-style-type: none"> 1. Catalogue desk height is 790mm - accessible 2. Computer desk height is 700mm - inaccessible 3. No knee clearance 	Desk <ol style="list-style-type: none"> 1. Install a height adjustable computer and catalogue desks which provide accessible knee clearances 	Desk <ol style="list-style-type: none"> 1. High

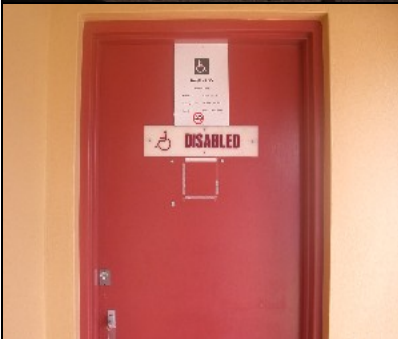
Toilet Signage <ol style="list-style-type: none"> 1. Toilet facilities located externally at the rear of the building. 2. No directional signage to toilet facilities on building 3. No MLak signage on toilet door 	Toilet Signage <ol style="list-style-type: none"> 1. Install directional signage with access and MLak symbols to: <ol style="list-style-type: none"> a) Library interior b) In the park - at parking bay signs c) On the corner of Stratheden Street and Summerland Way 2. Install MLak key symbol on toilet door 	Toilet Signage <ol style="list-style-type: none"> 1. High (a.b.c) 2. High

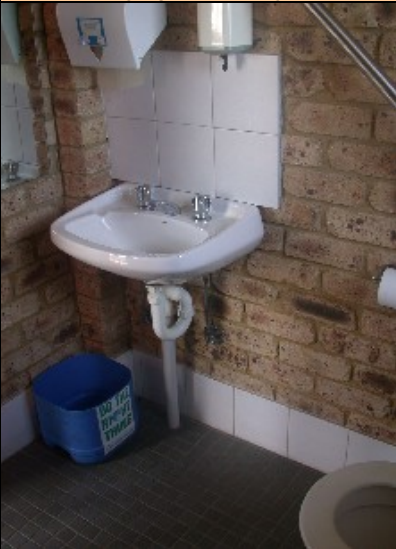
<p>Toilet - Most utilized facility</p> <ol style="list-style-type: none"> 1. Single door swing inwards 2. Doorway width is 760 mm 3. Medium door pressure 4. Side and rear grab rails height is 1000 mm - inaccessible 5. Wash basin has twist taps 6. Colour contrast on door and walls to floor 7. Circulation space in front of bowl is inaccessible 8. Circulation space beside bowl is accessible 9. Circulation space between bowl and wash basin is inaccessible 10. Front of bowl to rear wall is inaccessible 11. Toilet seat height is inaccessible 12. Soap and paper dispenser height is inaccessible 13. Light switch height is inaccessible 14. No shelf 	<p>Toilet</p> <ol style="list-style-type: none"> 1. Install a bi-directional hinge to cubicle door 2. Construct accessible doorway width 3. Reposition grab rails at (800/810 mm) 4. Install flick tap control 5. Due to minimal circulation space in front of basin and bowl, reposition wash basin to below mirror, install half sized wash basin 6. Adjust toilet bowl height 7. Adjust toilet bowl distance from rear wall 8. Adjust height of soap and paper dispensers 9. Adjust height of light switch 10. Install shelf-height 900 - 1100 mm 	<p>Toilet</p> <ol style="list-style-type: none"> 1. High 2. High 3. High 4. High 5. High 6. High 7. Medium 8. High 9. Medium 10. Low

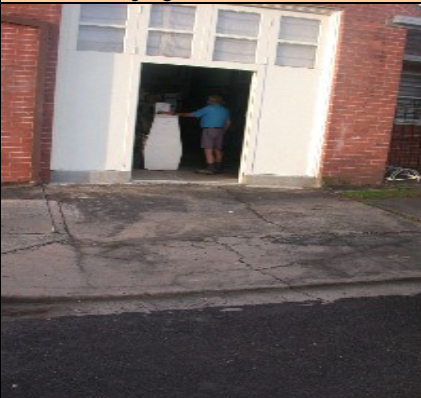
Parking (Also Swimming Pool) <ol style="list-style-type: none"> 1. No designated parking bay 2. Curb ramp located at the pool maintenance gateway 	Parking <ol style="list-style-type: none"> 1. Allocate a parallel designated parking bay (3.2 wide, 7.8 length with ground and elevated signage) in close proximity to curb ramp located at the pool maintenance gateway 	Parking <ol style="list-style-type: none"> 1. High

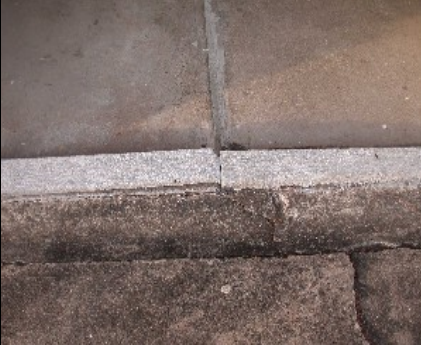
Entrance <ol style="list-style-type: none"> 1. Uneven ground surface 2. Loose concrete strip 	Entrance <ol style="list-style-type: none"> 1. Address uneven ground surface 2. Address loose concrete strip 	Entrance <ol style="list-style-type: none"> 1. High 2. High

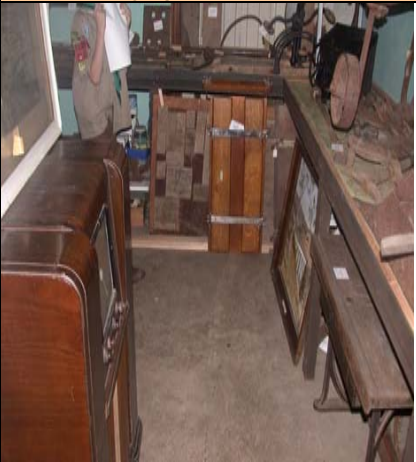
Aisle <ol style="list-style-type: none"> 1. Aisle widths are 740 mm and 1050 mm 2. Space available for the contents impede access 	Aisle <ol style="list-style-type: none"> 1. Relocate contents 	Aisle <ol style="list-style-type: none"> 1. High

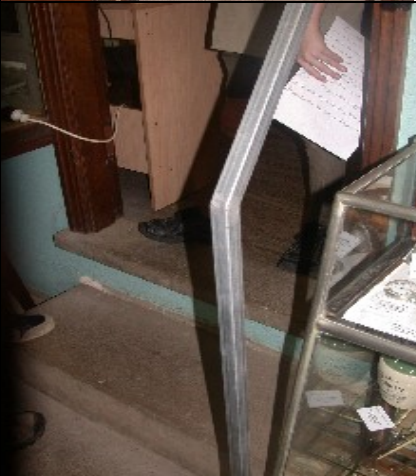
Stairs <ol style="list-style-type: none"> 1. Stairs are narrow 2. Handrail one side 3. No colour contrast or tactile strip on step nosing 	Stairs <ol style="list-style-type: none"> 1. Paint step nosing with high contrast/luminance colour (safety yellow) or install tactile strips 	Stairs <ol style="list-style-type: none"> 1. High

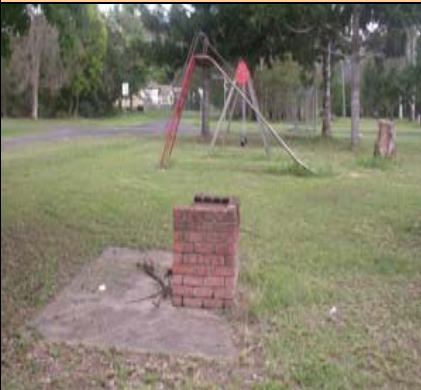
Parking 1. No designated parking bay Pathway 1. No pathway exists between facilities Playground equipment 1. Old style slippery dip is 2440 mm from ground 2. Slippery dip has no ground soft fall BBQ 1. BBQ height is 730 mm - accessible Toilet 1. No toilet facilities	Parking No recommendation Pathway No recommendation Playground equipment 1. Place ground soft fall under slippery dip BBQ No recommendation Toilet No recommendation	Play Equip. 1. Maintenance

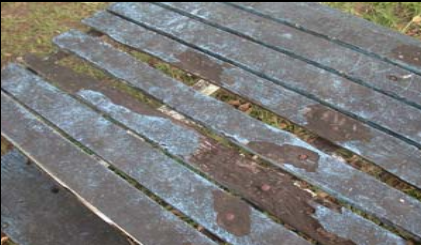
Picnic Table 1. Table top damaged, seat loose

Picnic Table 1. Repair table and seat	Picnic Table 1. Maintenance

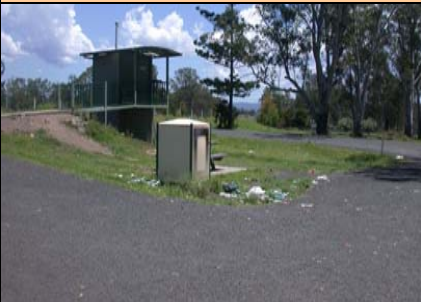
General 1. Rubbish bins overflowing Parking 1. No designated parking bay	General 1. Address rubbish and litter strewn from bins Parking 1. Allocate a designated parking bay (with ground and elevated signage) in close proximity to the facilities	General 1. Maintenance Parking 1. Low

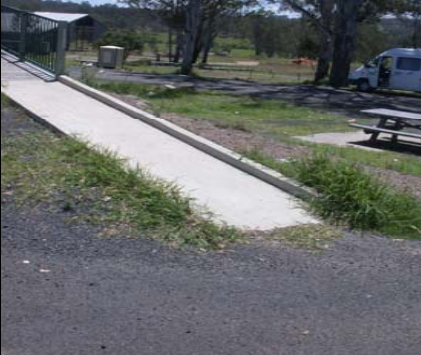
Ramp 1. Ramp has an edge curb 2. Handrails on one side which does not extend to the entire length of the ramp 3. Width of ramp between edge curbs is 1000 mm (1200 mm preferred) 4. Width of ramp of the handrail section is 1100 mm	Ramp 1. Install handrails on both sides and extending the entire length of the ramp	Ramp 1. Medium

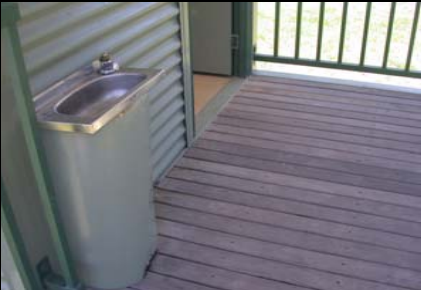
Wash Basin 1. Wash basin on landing 2. Wash basin height is 680 mm - inaccessible	Wash Basin 1. Relocate wash basin inside cubicle 2. Adjust height of wash basin	Wash Basin 1. Low 2. Medium

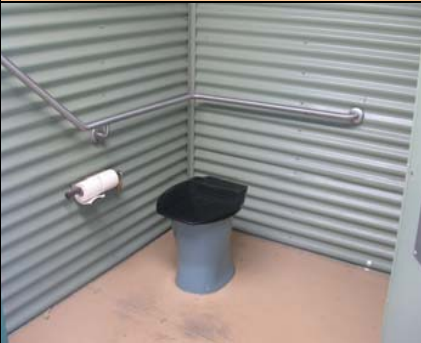
Toilet <ol style="list-style-type: none"> 1. No wash basin inside cubicle 2. Toilet bowl height is 400 mm - inaccessible 3. Toilet roll holder height is 500 mm - inaccessible 4. Grab rail height is 800 mm - accessible 	Toilet <ol style="list-style-type: none"> 1. Install wash basin inside cubicle 2. Adjust height of toilet bowl 3. Adjust height of toilet roll holder 	Toilet <ol style="list-style-type: none"> 1. Low 2. High 3. High

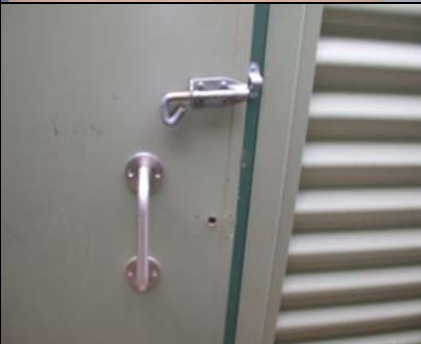
Toilet Door <ol style="list-style-type: none"> 1. Door opening/closing pressure is light 2. Door swings inwards Signage <ol style="list-style-type: none"> 1. No access symbol on door 2. No access symbol on street signage 	Toilet Door <ol style="list-style-type: none"> 1. Install bi- directional hinge to door Signage <ol style="list-style-type: none"> 1. Install access symbol on door 2. Install street signage with access symbol 	Toilet Door <ol style="list-style-type: none"> 1. High Signage <ol style="list-style-type: none"> 1. High 2. High

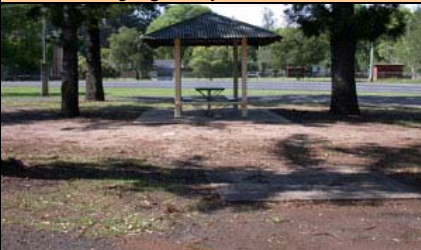
LOCATION Kyogle Apex Park	AUDIT FINDINGS	ACCESS RECOMMENDATIONS	PRIORITY

Parking 1. No designated parking bay Pathway 1. No pathway from picnic shelter to BBQ	Parking No recommendation Pathway 1. Construct pathway between picnic shelter and BBQ	Pathway 1. Low

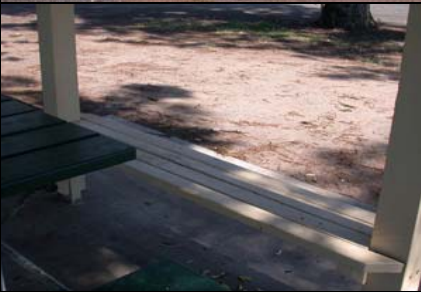
Picnic Table 1. Picnic table height is 800 mm - accessible 2. Knee clearance is accessible 3. Seating between shelter support (and table)	Picnic Table 1. Remove one seat between shelter supports to allow table end access (ample circulation space available) 2. Extend table top to allow knee clearance from table legs	Picnic Table 1. High 2. High

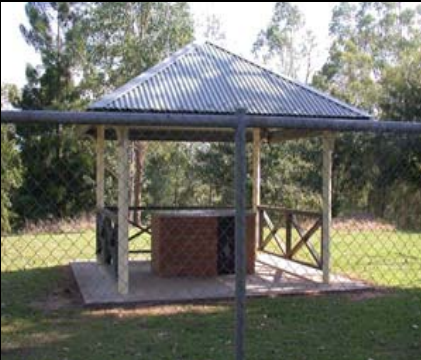
BBQ 1. BBQ height is 920 mm - inaccessible 2. Metal fence in front of BBQ - height is 1840 mm Signage 1. No signage to toilet facilities (Signage to the Visitor Information Centre will direct people away from the Recreation Park facilities that are in a neglected state).	BBQ 1. Lower BBQ height 2. Remove metal fence (path of travel) Signage 1. Install directional signage to accessible toilet facilities (Visitor Information Centre)	BBQ 1. Low 2. High Signage 1. High
