Mobility Access - 2005

MOBILITY ACCESS -

Management and Implementation Plan 2005

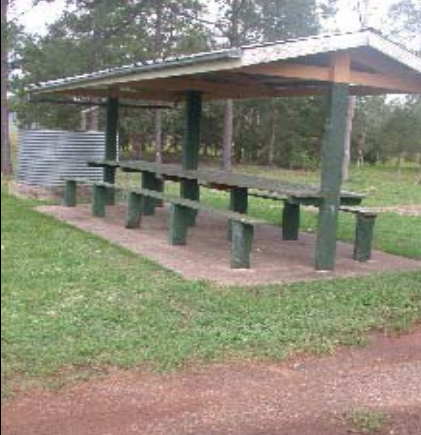
Parking 1. No designated parking bay Picnic Table 1. Table height is accessible 2. Table knee clearance is accessible BBQ 1. No BBQ Toilet 1. No toilet facilities Rubbish Bin 1. No rubbish bin	Parking No recommendation Picnic Table 1. Remove one half of seat to allow table edge access (Ensure concrete pad's circulation space from table edge is 1200 mm) BBQ No recommendation Toilet No recommendation Rubbish Bin 1. Install a rubbish bin	Picnic Table 1. Low Rubbish Bin 1. Maintenance

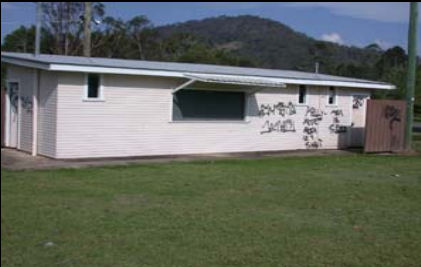
LOCATION Kyogle Anzac Park	AUDIT FINDINGS	ACCESS RECOMMENDATIONS	PRIORITY

Parking 1. No designated parking bay	Parking 1. Allocate a designated parking bay (with ground and elevated signage) in close proximity to the facilities	Parking 1. Low

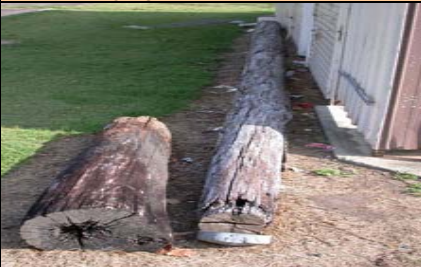
LOCATION Kyogle Anzac Park	AUDIT FINDINGS	ACCESS RECOMMENDATIONS	PRIORITY

Rear of Toilet Block 1. Timber logs at the rear of the toilet block - trip hazard	Rear of Toilet Block 1. Remove timber logs	Rear of Toilet Block Maintenance

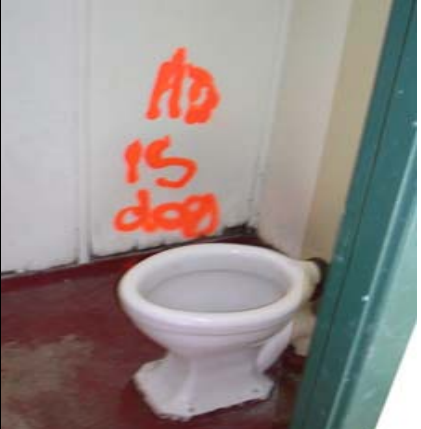
Toilet - Regular Female 1. No accessible features 2. No toilet seat or lid 3. No signage on cubicle 4. No directional signage	Toilet - Regular Female Upgrade toilet facilities to assist people with ambulant disabilities 1. Install toilet seat/lid 2. Install grab rail 3. Install signage on toilet block 4. Install directional signage in park	Toilet - Female 1. Maintenance 2. High 3. High 4. Medium

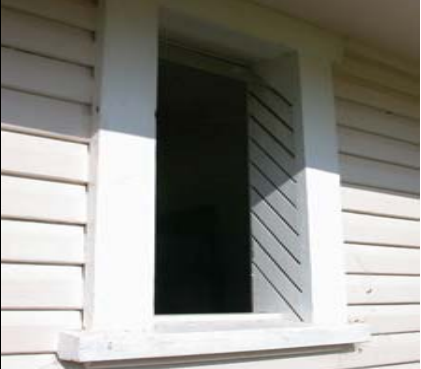
Toilet - Regular Female 1. Louvers missing from window	Toilet - Regular Female 1. Replace louvers	Toilet - Female Maintenance

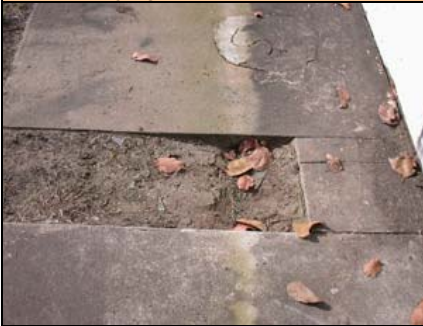
LOCATION Kyogle Anzac Park	AUDIT FINDINGS	ACCESS RECOMMENDATIONS	PRIORITY

Pathway 1. Section missing on pathway between male and female regular toilet facilities - trip hazard	Pathway 1. Repair pathway	Pathway 1. High

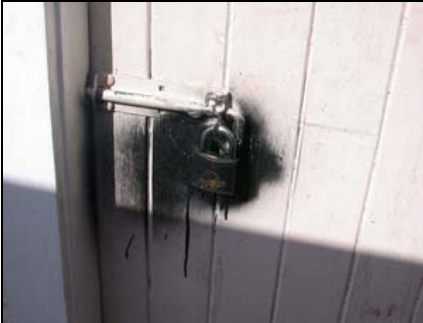
Toilet - Regular Male 1. Locked 2. No signage on cubicle 3. No directional signage	Toilet - Regular Male Upgrade toilet facilities to assist people with ambulant disabilities 1. Install grab rail 2. Install signage on toilet block 3. Install directional signage in park	Toilet - Male 1. High 2. High 3. Medium

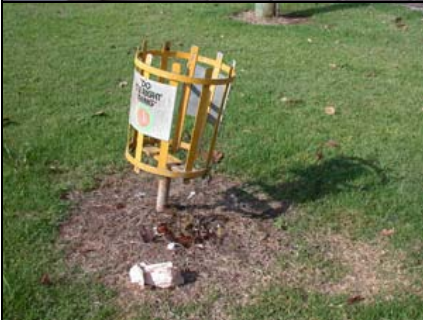
Rubbish Bin 1. Rubbish bin missing from holder (broken glass)	Rubbish Bin 1. Install rubbish bin	Rubbish Bin Maintenance

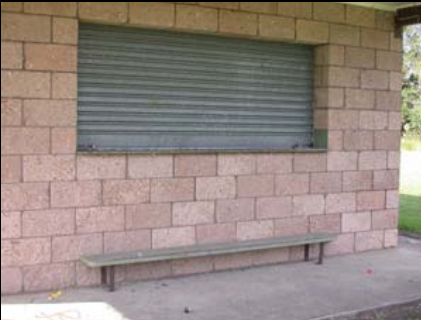
LOCATION Kyogle Anzac Park	AUDIT FINDINGS	ACCESS RECOMMENDATIONS	PRIORITY

General Broken glass in front of canteen Canteen <ol style="list-style-type: none"> 1. Canteen counter height is 1050 mm 2. Step in front of counter, securely attached to concrete 	General Broken glass in front of canteen Canteen <ol style="list-style-type: none"> 1. Lower a section of the canteen counter 2. Remove 800 mm from the step length 	General Maintenance Canteen <ol style="list-style-type: none"> 1. Low 2. Low

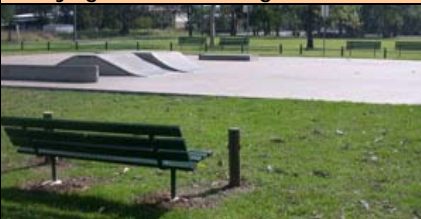
LOCATION Kyogle - Anzac Lagoon Park	AUDIT FINDINGS	ACCESS RECOMMENDATIONS	PRIORITY

Parking <ol style="list-style-type: none"> 1. No designated parking bay Pathway <ol style="list-style-type: none"> 1. No internal pathway (footpath runs along one side of park) 	Parking No recommendation Pathway <ol style="list-style-type: none"> 1. Construct a pathway from the existing footpath and to the skate area 	Pathway <ol style="list-style-type: none"> 1. Medium

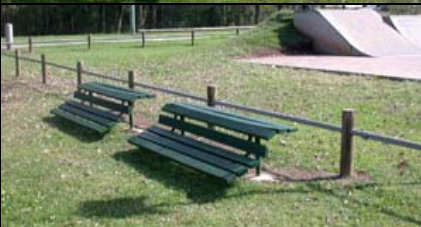
Seating <ol style="list-style-type: none"> 1. Damaged seats 	Seating <ol style="list-style-type: none"> 1. Replace damaged seats 	Seating Maintenance

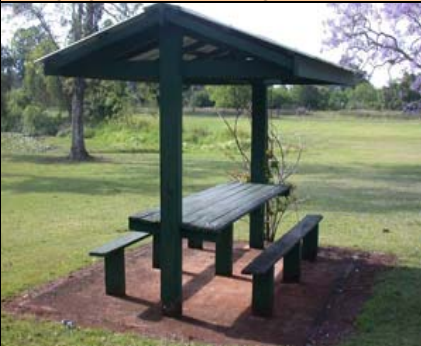
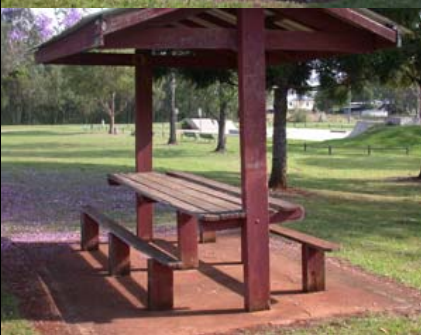
LOCATION Kyogle - Anzac Lagoon Park	AUDIT FINDINGS	ACCESS RECOMMENDATIONS	PRIORITY

<p>Pathway</p> <ol style="list-style-type: none"> No pathway (Moderately steep to access from the road - the most direct path of travel to the shelter would require a pathway with steps and handrails. The location of the picnic shelter is suitable only for ambulant disabilities, unless a pathway is constructed across the park extending from a recommended pathway to skating area) <p>Picnic Table (1 & 2)</p> <ol style="list-style-type: none"> Table height is 870 mm - accessible Knee clearance is 825 mm - accessible <p>Toilet</p> <ol style="list-style-type: none"> No toilet facilities <p>BBQ</p> <ol style="list-style-type: none"> No BBQ 	<p>Pathway</p> <ol style="list-style-type: none"> Construct a pathway to one picnic shelter across the park extending from a recommended pathway to skating area <p>Toilet</p> <p>No recommendation</p> <p>BBQ</p> <p>No recommendation</p> <p>Picnic Table (1 & 2)</p> <ol style="list-style-type: none"> Remove one half of seat to allow table edge access (Ensure concrete pad's circulation space from table edge is 1200 mm) 	<p>Pathway</p> <ol style="list-style-type: none"> Low <p>Picnic Table (1 & 2)</p> <ol style="list-style-type: none"> Low

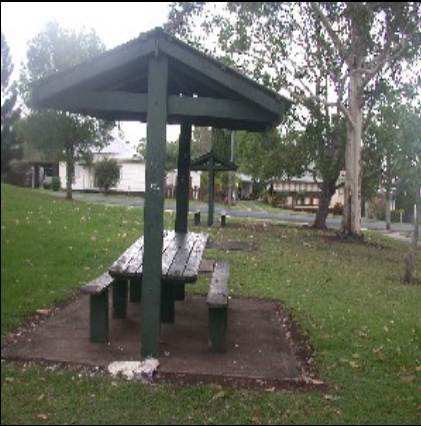
General 1. No rubbish bins Parking 1. No designated parking bay Pathway 1. No pathway to picnic shelters Picnic Table (1) 1. Table and seat damage	General Install rubbish bins Parking No recommendation Pathway Construct pathway to and between picnic shelters Picnic Table (1) 1. Repair/replace picnic table and seating	General Maintenance Pathway 1. Low Picnic Table(1) Maintenance

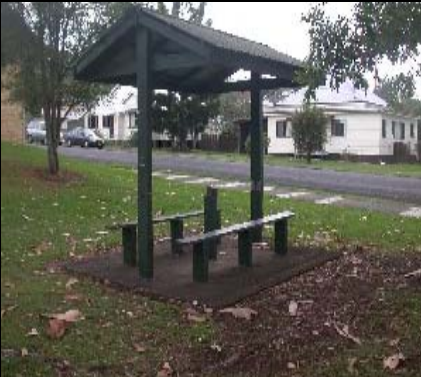
Picnic Table (2) 1. Table top missing	Picnic Table (2) 1. Replace table top	Picnic Table (2) Maintenance

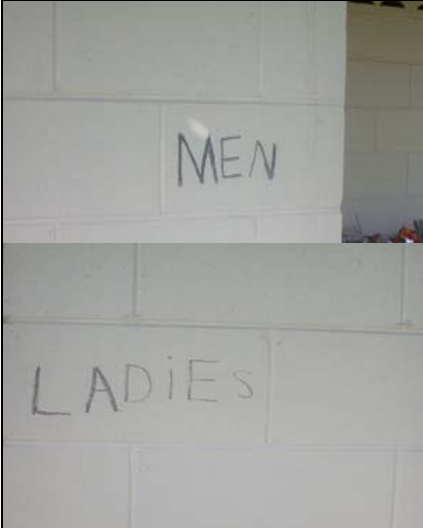
<p>Parking No designated parking bay</p> <p>Toilet - Regular Male/Female</p> <ol style="list-style-type: none"> Entrance is accessible No accessible toilet features <p>Signage</p> <ol style="list-style-type: none"> Signage on toilet and change room facilities has been written on the walls <p>Bathroom Male/Female</p> <ol style="list-style-type: none"> Entrance is accessible No accessible shower features Shower hob has no colour contrast Shower taps are located on an overhead rail 	<p>Parking</p> <ol style="list-style-type: none"> Allocate a designated parking bay (with ground and elevated signage) on flat ground at the rear of the building <p>Toilet - Regular Male/Female</p> <ol style="list-style-type: none"> Install grab rail <p>Signage</p> <ol style="list-style-type: none"> Install male/female signage on toilet and change room facilities <p>Bathroom Male/Female</p> <ol style="list-style-type: none"> Paint shower hob with high contrast/luminance colour (safety yellow) Relocate shower taps to ensure independent use 	<p>Parking</p> <ol style="list-style-type: none"> Low <p>Toilet Regular</p> <ol style="list-style-type: none"> High <p>Signage</p> <ol style="list-style-type: none"> Medium Medium <p>Bathroom</p> <ol style="list-style-type: none"> High Medium

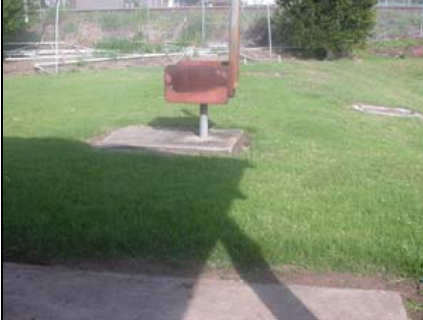
<p>BBQ</p> <ol style="list-style-type: none"> BBQ height is 760 mm - accessible <p>Pathway</p> <ol style="list-style-type: none"> No pathway to BBQ 	<p>BBQ</p> <p>No recommendation</p> <p>Pathway</p> <ol style="list-style-type: none"> Construct pathway from BBQ to meet with building's concrete slab 	<p>Pathway</p> <ol style="list-style-type: none"> Low

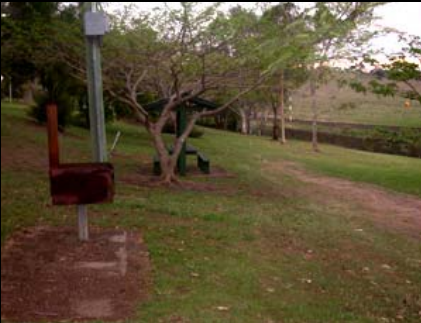
LOCATION Kyogle Dr David Reid Park / Helipad	AUDIT FINDINGS	ACCESS RECOMMENDATIONS	PRIORITY

Parking 1. No designated parking bay BBQ 1. BBQ height is 820 mm - inaccessible	Parking 1. Allocate a designated parking bay (with ground and elevated signage) in close proximity to to pathway leading to helipad BBQ 1. Lower BBQ height	Parking 1. High BBQ 1. Low

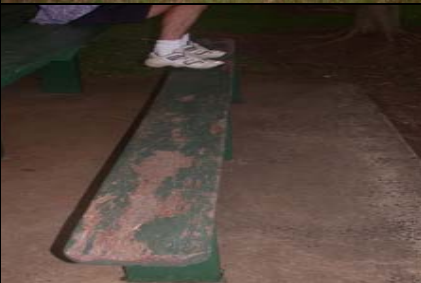
Picnic Table (Closest to BBQ) 1. Seat damaged 2. Concrete pad is 75 mm above ground level	Picnic Table (Closest to BBQ) 1. Repair seat 2. Remove one half of seat to allow table edge access (Ensure concrete pad's circulation space from table edge is 1200 mm)	Picnic Table (1) 1. Maintenance 2. Medium

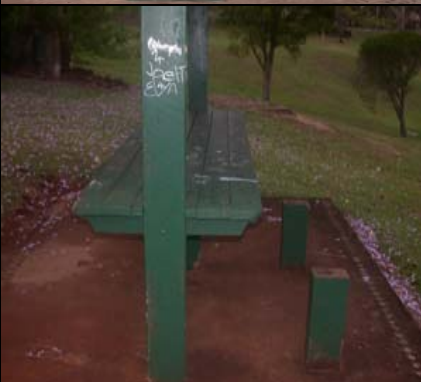
Picnic Table (Closest to Toilet) 1. Table edge is accessible 2. One seat removed, one seat damaged Path of Travel from Toilet to Picnic Shelter 1. Two steps off pathway to shelter 2. No handrail 3. No colour contrast	Picnic Table (Closest to Toilet) 1. Repair Seating Path of Travel from Toilet to Picnic Shelter 1. Paint step nosing with high contrast/luminance colour (safety yellow) 2. Install handrails on stairs	Picnic Table (Toilet) 1. Maintenance Path of Travel to Shelter 1. High 2. High

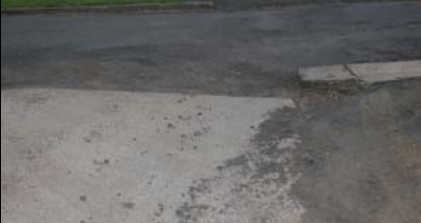
Pathway (Helipad) Entry <ol style="list-style-type: none"> 1. Uneven road surface at entry point of the helipad pathway 	Pathway (Helipad) Entry <ol style="list-style-type: none"> 1. Repair roadway at the entry point of helipad pathway 	Pathway (Helipad) Entry <ol style="list-style-type: none"> 1. High

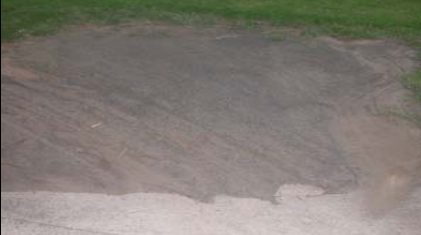
Pathway (Helipad) Exit <ol style="list-style-type: none"> 1. Uneven and loose ground surface at exit point of the helipad pathway 	Pathway (Helipad) Exit <ol style="list-style-type: none"> 1. Address soft surface at the exit point of helipad pathway 	Pathway (Helipad) Exit <ol style="list-style-type: none"> 1. High

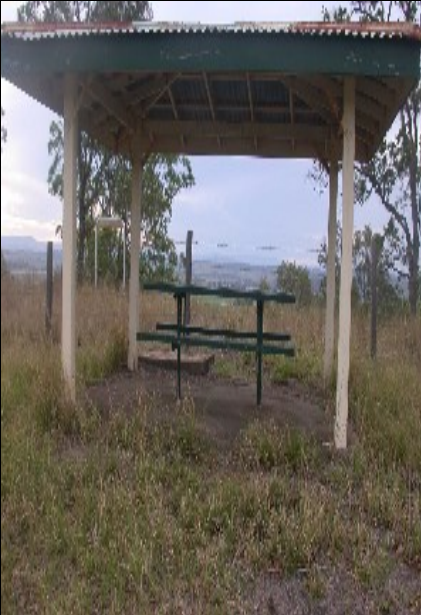
<p>General Ground surface is uneven and moderately steep to access from road - most direct path of travel to the shelter would require a pathway with stairs and handrails.</p> <p>1. General area not maintained</p> <p>Location Signage No directional signage on major road</p> <p>Parking 1. No designated parking bay</p> <p>Pathway 1. No pathway to the picnic shelter</p> <p>Picnic Table 1. Picnic table on concrete pad</p> <p>BBQ 1. No BBQ</p> <p>Toilet 1. No toilet facilities</p> <p>Rubbish Bin 1. No rubbish bin</p>	<p>General 1. Maintain general area</p> <p>Location Signage 1. Install directional signage on major road</p> <p>Parking No recommendation</p> <p>Pathway 1. Construct pathway to picnic shelter</p> <p>Picnic Table No recommendation</p> <p>BBQ No recommendation</p> <p>Toilet No recommendation</p> <p>Rubbish Bin 1. Install a rubbish bin</p>	<p>General 1. Maintenance</p> <p>Signage 1. Medium</p> <p>Pathway 1. Low</p> <p>Rubbish Bin 1. Maintenance</p>

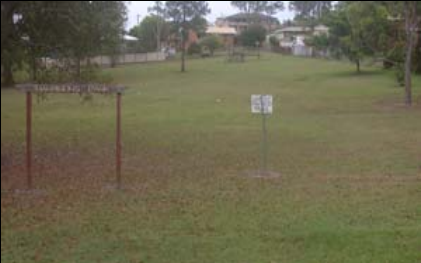
LOCATION Kyogle - Harrison Park	AUDIT FINDINGS	ACCESS RECOMMENDATIONS	PRIORITY

Parking 1. No designated parking bay Curb cut/Ramp 1. No curb cut Toilet 1. No toilet facilities	Parking No recommendation Curb cut/Ramp 1. Construct curb cut Toilet No recommendation	Curb cut/Ramp 1. Low

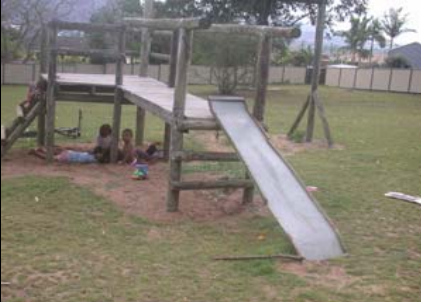
Playground Equipment 1. Structure is damaged - sharp edges - high risk	Playground Equipment 1. Replace playground equipment	Playground Equipment 1. Maintenance

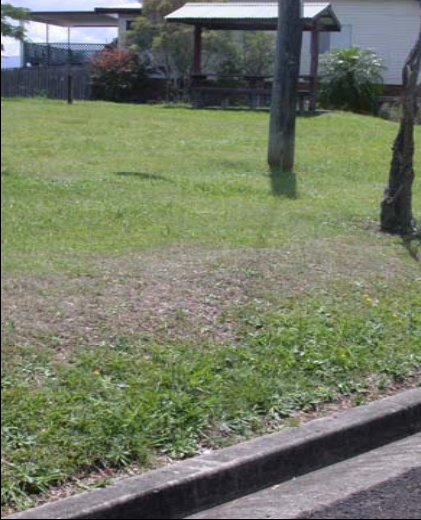
<p>Parking</p> <ol style="list-style-type: none"> No designated parking bay <p>Curb cut/ramp</p> <ol style="list-style-type: none"> No curb access <p>Pathway</p> <ol style="list-style-type: none"> Terrain from street to picnic table is moderately steep <p>Toilet</p> <ol style="list-style-type: none"> No toilet facilities <p>BBQ</p> <ol style="list-style-type: none"> No BBQ 	<p>Parking</p> <p>Location not suitable for designated parking bay (corner and crest of hill)</p> <p>Curb cut/ramp</p> <ol style="list-style-type: none"> Construct curb cut/ramp <p>Pathway</p> <ol style="list-style-type: none"> Construct pathway from curb cut to meet picnic shelter's concrete pad <p>Toilet</p> <p>No recommendation</p> <p>BBQ</p> <p>No recommendation</p>	<p>Curb cut/ramp</p> <ol style="list-style-type: none"> Low <p>Pathway</p> <ol style="list-style-type: none"> Low

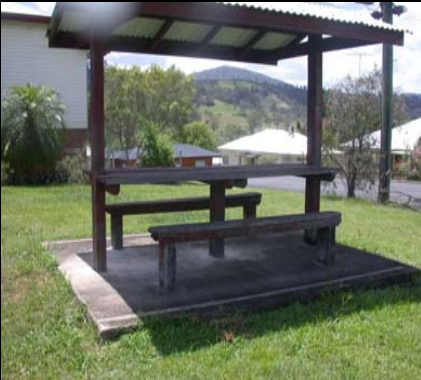
<p>Picnic Table</p> <ol style="list-style-type: none"> Table height is 870 mm - accessible Knee clearance height is 825 mm - accessible 	<p>Picnic Table</p> <ol style="list-style-type: none"> Remove one half of seat to allow table edge access (Ensure concrete pad's circulation space from table edge is 1200 mm) 	<p>Picnic Table</p> <ol style="list-style-type: none"> Low

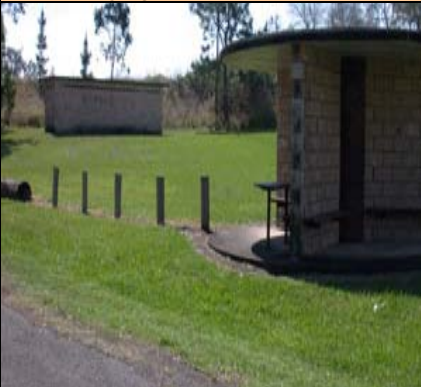
LOCATION Kyogle - Lions Park	AUDIT FINDINGS	ACCESS RECOMMENDATIONS	PRIORITY

General <ol style="list-style-type: none"> 1. One rubbish bin for four shelters 2. Graffiti present on shelters 3. No water available within toilet facilities 4. The shelter closest to toilet facilities to be flagged for disability access when toilet facilities are upgraded Parking <ol style="list-style-type: none"> 1. No designated parking bay 	General <ol style="list-style-type: none"> 1. Install wash basins and water to toilet facilities 2. Install additional rubbish bins Parking <p>No recommendation</p>	General <ol style="list-style-type: none"> 1. High 2. Medium

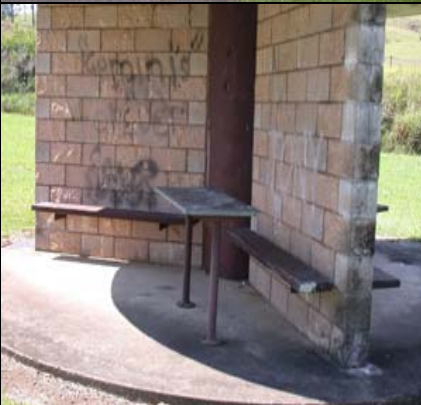
Pathway <ol style="list-style-type: none"> 1. No pathway to or between facilities 	Pathway <ol style="list-style-type: none"> 1. Construct pathway between picnic shelter and toilet facilities (shelter adjacent to toilet block) 	Pathway <ol style="list-style-type: none"> 1. Low

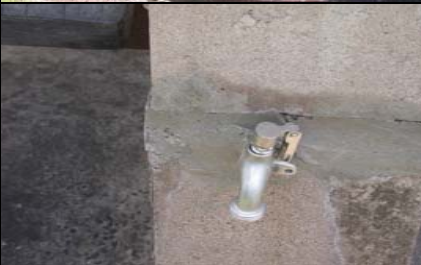
Tap <ol style="list-style-type: none"> 1. Tap located at the picnic shelter opposite toilet block does not function 	Tap <ol style="list-style-type: none"> 1. Repair faulty tap 	Tap <ol style="list-style-type: none"> 1. Maintenance

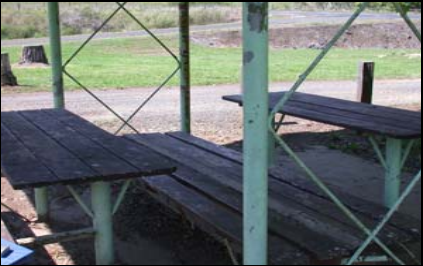
LOCATION Kyogle - Lions Park	AUDIT FINDINGS	ACCESS RECOMMENDATIONS	PRIORITY

Picnic Table 1. Picnic table in relation to the shelter design is not user friendly	Picnic Table 1. Remove picnic table and seats	Picnic Table 1. Maintenance

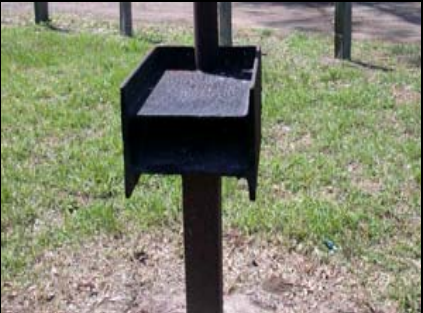
BBQ 1. BBQ hotplate height is 800 mm - accessible Rubbish Bin 1. Rubbish bin is located 5 Mt from a BBQ (one only)	BBQ 1. Install BBQ beside picnic shelter flagged for access upgrade (closest to toilet facilities) Rubbish Bin 1. Install additional rubbish bins in close proximity to all picnic shelters	BBQ 1. Medium Rubbish Bin 1. Maintenance

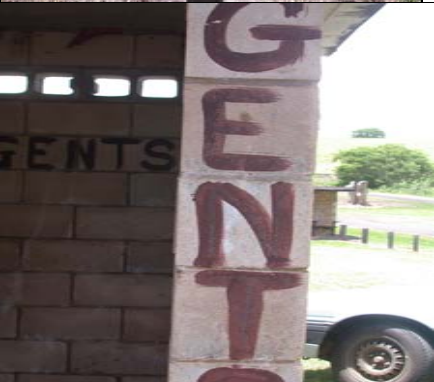
Signage 1. Signage is indicative of the Park's general condition

Signage 1. Replace male/female signage	Signage 1. Medium

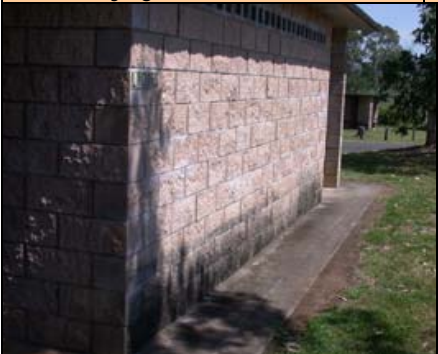
Toilet - Regular Male/Female <ol style="list-style-type: none"> 1. Composting toilet 2. No wash basin 3. No water to toilet block 	Toilet - Regular Male/Female Address water availability to the toilet block Install wash basins	Toilet - Regular <ol style="list-style-type: none"> 1. High 2. High

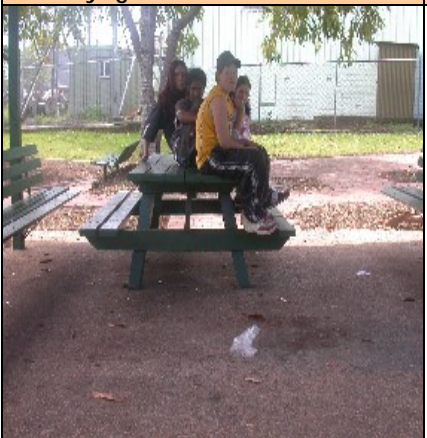
General Large shelter suitable for full access providing the table top is extended into the shelter Picnic Table <ol style="list-style-type: none"> 1. Table height is accessible 2. Knee clearance height - accessible (though obstructed by table legs) BBQ <ol style="list-style-type: none"> 1. No BBQ Toilet <ol style="list-style-type: none"> 1. No toilet facilities Rubbish Bin <ol style="list-style-type: none"> 1. No rubbish bin 	Picnic Table <ol style="list-style-type: none"> 1. Extend table top BBQ No recommendation Toilet No recommendation Rubbish Bin <ol style="list-style-type: none"> 1. Install rubbish bin 	Picnic Table <ol style="list-style-type: none"> 1. Medium Rubbish Bin <ol style="list-style-type: none"> 1. Maintenance

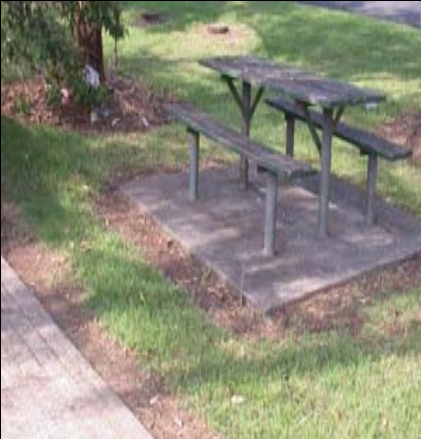
Parking 1. No designated parking bay Picnic Table 1. No shelter over picnic table Pathway 1. Pathway runs adjacent to the picnic table (firm ground surface gap approx 1 Mt) BBQ 1. No BBQ Toilet 1. No toilet facilities Rubbish Bin 1. No rubbish bin	Parking No recommendation Picnic Table No recommendation Pathway No recommendation BBQ No recommendation Toilet No recommendation Rubbish Bin 1. Install a rubbish bin	Rubbish Bin 1. Maintenance

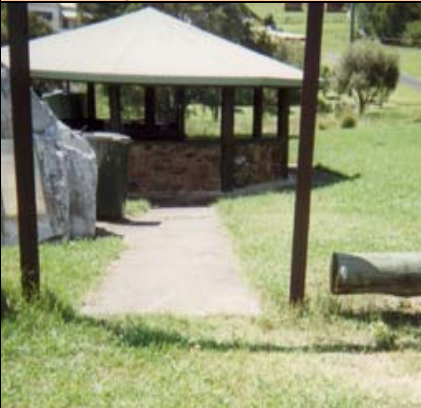
Parking 1. No designated parking bay Pathway 1. Pathway from park boundary to picnic shelter Picnic Shelter 1. Lip at entrance to shelter - 65 mm 2. Table height is 820 mm - accessible 3. Knee clearance height is 780 mm - accessible 4. Wheelchair space available in shelter Toilet 1. No toilet facilities - facilities located across street at Memorial Park	Parking 1. No recommendation Pathway 1. Extend pathway to street 2. Construct curb cut Picnic Shelter 1. Paint picnic shelter lip with high contrast/luminance colour (safety yellow) or install lip cover	Pathway 1. Medium 2. Medium Picnic Table 1. High

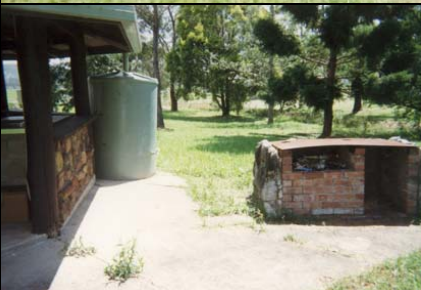
BBQ 1. Pathway to BBQ 2. BBQ height is 930 mm	BBQ 1. Address BBQ height	BBQ 1. Medium

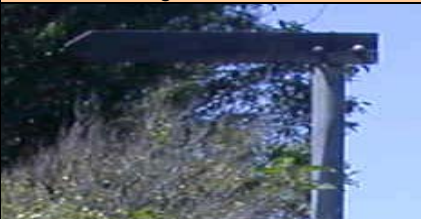
Signage - Bruxner Highway 1. No information symbols on signage Signage 1. Wording is no longer visible on sign - left hand turn - gravel road	Signage 1. Install signage with information symbols on Bruxner Highway 2. Install directional signage with information symbols	Signage 1. High 2. High

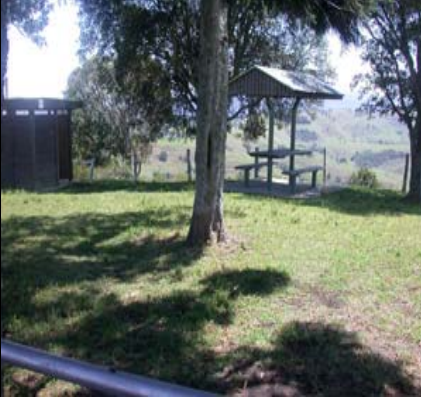
Parking 1. No designated parking bay Pathway 1. No pathways between facilities or to entrance gate Picnic Table 1. Shelter over picnic table 2. Shelter has concrete pad	Parking No recommendation Pathway 1. Construct pathway from gate entrance to picnic table shelter 2. Construct pathway from picnic table shelter to toilet facility Picnic Table 1. Remove one half of seat to allow table edge access (800 mm) (Ensure concrete pad's circulation space from table edge is 1200 mm)	Pathway 1. Low 2. Low Picnic Table 1. Low

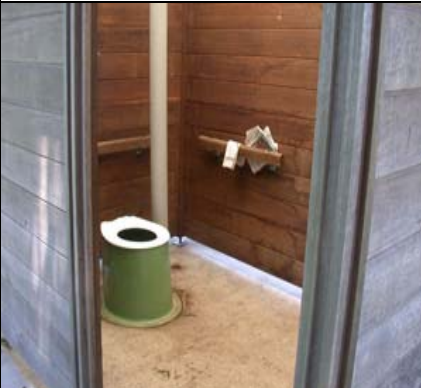
Toilet - Regular Male/Female 1. Composing toilet 2. Entrance lip 3. Grab rails do not assist access (distance of the toilet bowl from the walls) 4. Circulation space both sides of toilet bowl is not accessible for wheelchairs 5. No toilet roll holder (newspaper) 6. No toilet seat lid 7. No wash basin or water available	Toilet - Regular Male/Female Upgrade toilet facility to be suitable for ambulant disabilities by: 1. Extend side grab rail from the wall to be closer to the bowl 2. Install toilet roll holder 3. Replace missing seat lid 4. Install wash basin 5. Install water tank	Toilet Regular 1. High 2. High 3. High 4. High 5. High

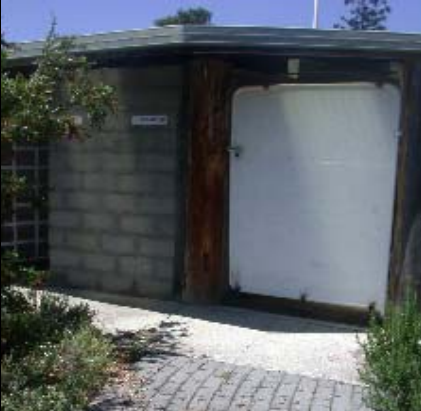
Pathway 1. Pathway to 'disable signed facility from driveway 2. No pathway from toilet facility to picnic shelter	Pathway No recommendation

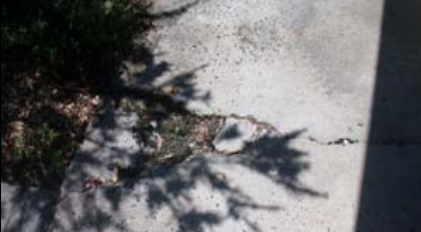
Pathway between toilet facilities 1. Pathway surface is cracked and uneven	Pathway between toilet facilities 1. Repair broken section of pathway	Pathway 1. Medium

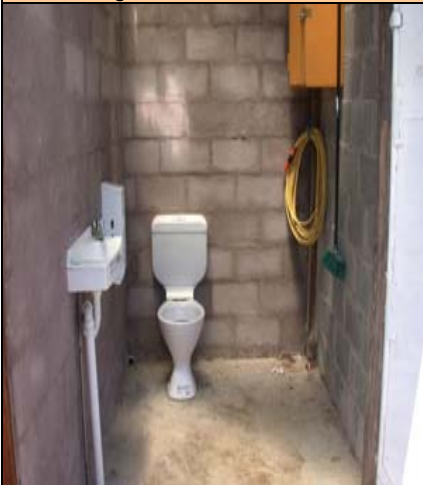
Toilet <ol style="list-style-type: none"> Signed as 'Disable' - no access symbol Door latch is very difficult to operate (slide bolt into wooden post) Door latch height is inaccessible Doorway width is accessible Toilet bowl height is inaccessible Circulation space both sides of toilet bowl is inaccessible Circulation space in front of toilet bowl is accessible No grab rails Wash basin inside cubicle No colour contrasts between walls and floor 	Toilet <p>The width of the toilet cubicle will prevent this facility being fully accessible i.e. for wheelchairs - suitable for ambulant disabilities only</p> <ol style="list-style-type: none"> Remove 'disable' sign Address difficult to operate door latch Address the height of door latch Install grab rail Address colour contrasts between wall and floor 	Toilet <ol style="list-style-type: none"> High High High High High

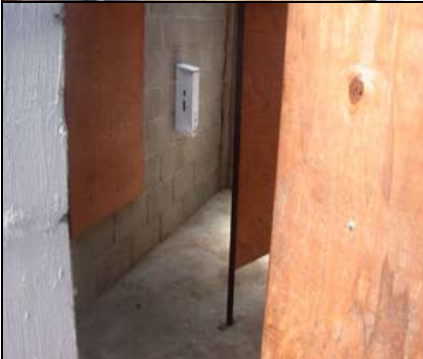
Toilet - Regular Male/Female <ol style="list-style-type: none"> Signs - faded on male/female toilets Entrance width is 580 mm (female) Entrance width is 630 mm (male) Both entrance widths do not meet regular A.S. Cubicle doorway width is 760 mm 	Toilet - Regular Male/Female <ol style="list-style-type: none"> Replace faded signs Address entrance widths to male and female toilet facilities 	Toilet - Regular Male/Female <ol style="list-style-type: none"> Medium High

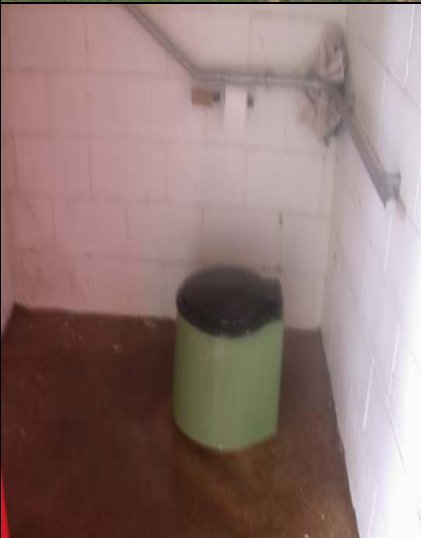
Toilet 1. Access symbol displayed 2. Composting toilet 3. Height of toilet bowl is 360 mm -inaccessible 4. Back wall to front of toilet bowl is 800 mm - accessible 5. Circulation space in front of toilet bowl is 960 mm - inaccessible 6. Circulation space beside toilet bowl is 1050 mm - accessible 7. Ramp width is 1040 mm 8. Ramp landing width is 1230 mm diagonally 9. Door swings outward 10. No door handle 11. "Occupied latch" is broken	Toilet 1. Construct a ramp handrails and ramp curb - (ensure ramp minimum width is 1000 mm, 1200 mm preferred)) 2. Install door handle 3. Install a bi-directional hinge to cubicle door 4. Repair "Occupied latch" 5. Raise height of toilet bowl 6. Increase circulation space in front of toilet bowl	Toilet 1. High 2. Maintenance 3. High 4. Maintenance 5. High 6. Low

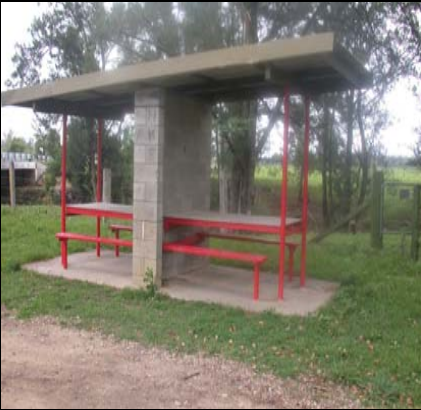
Picnic Table 1. Picnic table height is 770 mm - accessible 2. Knee clearance height is 680 mm - inaccessible Pathway 1. No pathway between facilities	Picnic Table 1. Remove one seat (closest to facilities) to allow table side access 2. Extend concrete pad to ensure circulation space from table edge is 1200 mm 3. Address knee clearance (710 mm minimum A.S.) Pathway 1. Construct pathway between facilities	Picnic Table 1. Medium 2. Medium 3. Medium Pathway 1. Low

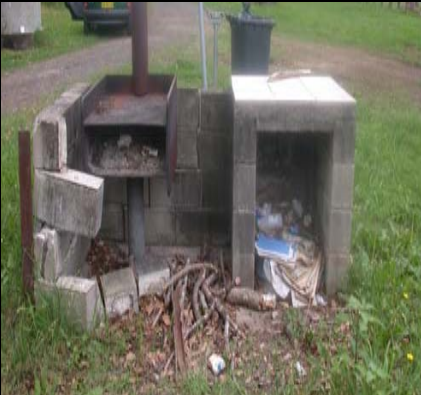
BBQ 1. BBQ in disrepair 2. BBQ height is 800 mm	BBQ 1. Repair BBQ - ensure height is 760 mm maximum - A.S.	BBQ 1. Maintenance

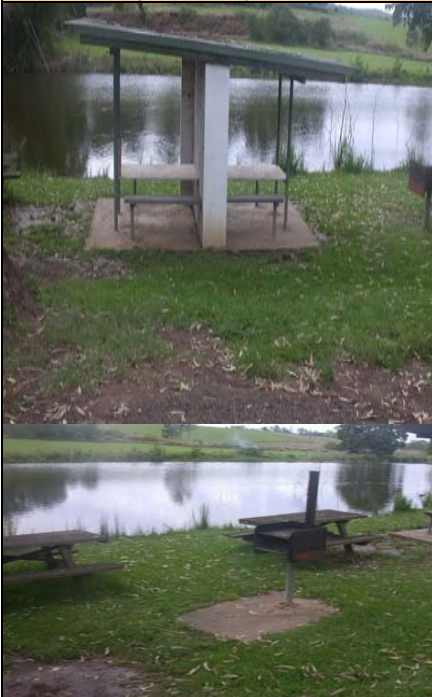
<p>General</p> <ol style="list-style-type: none"> 1. Rubbish bins overflowing 2. Low lying ground tends to be wet <p>Parking</p> <ol style="list-style-type: none"> 1. No designated parking bay <p>Pathway</p> <ol style="list-style-type: none"> 3. No pathway to facilities <p>BBQ</p> <ol style="list-style-type: none"> 1. Two BBQ's - one BBQ located on concrete pad 2. BBQ height is 1010 mm 3. BBQ located between picnic tables <p>Picnic Table</p> <ol style="list-style-type: none"> 1. Picnic table height is 690 mm 	<p>General</p> <p>Attend to rubbish bins and litter</p> <p>Parking</p> <ol style="list-style-type: none"> 1. Allocate a designated parking bay (with ground and elevated signage) in close proximity to the facilities <p>Pathway</p> <ol style="list-style-type: none"> 1. Construct pathway to picnic shelter (closest to BBQ) from roadway 2. Construct pathway to BBQ from picnic table or extend shelter's concrete pad <p>BBQ</p> <ol style="list-style-type: none"> 1. Address BBQ height <p>Picnic Table</p> <ol style="list-style-type: none"> 1. Adjust height table (Extend concrete pad to allow circulation space at table end - 1200 mm) 	<p>General Maintenance</p> <p>Parking</p> <ol style="list-style-type: none"> 1. Low <p>Pathway</p> <ol style="list-style-type: none"> 1. Medium 2. Medium <p>BBQ</p> <ol style="list-style-type: none"> 1. Medium <p>Picnic Table</p> <ol style="list-style-type: none"> 1. Medium

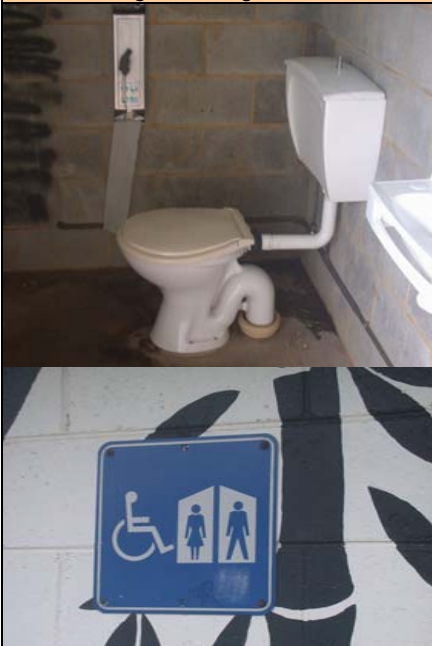
<p>Toilet</p> <ol style="list-style-type: none"> 1. Access symbol incorrectly identifies toilet facilities 2. Door swings outward 3. Door handle is colour contrasted against door 4. Door handle height is 1200 mm - inaccessible 5. No door locking device 6. Entrance width is accessible 7. No grab rails 8. Wash basin located within toilet cubicle 9. Wash basin height is 820 mm - inaccessible 10. Tap control missing 11. Flush control height is accessible 12. Toilet bowl height is inaccessible 13. Toilet bowl from side wall is inaccessible 14. Toilet bowl from rear wall is accessible 15. Circulation space in front of toilet bowl is accessible 16. Circulation space beside toilet bowl is accessible 17. No colour contrast between walls and floor 18. Rubbish bin located within toilet cubicle 	<p>Toilet</p> <p>Toilet cubicle requires upgrading to be considered an accessible facility</p> <ol style="list-style-type: none"> 1. Install a bi-directional hinge to cubicle door 2. Install locking device, able to be operated using one hand and gross motor skills 3. Lower door handle height 4. Address height of toilet bowl 5. Address distance from closest wall to bowl 6. Install grab rails (rear & side) 7. Adjust wash basin height 8. Install flick tap control 9. Address colour contrast between walls and floor 10. Install a shelf 	<p>Toilet</p> <ol style="list-style-type: none"> 1. High 2. High 3. High 4. High 5. Low 6. High 7. High 8. High 9. High 10. Medium

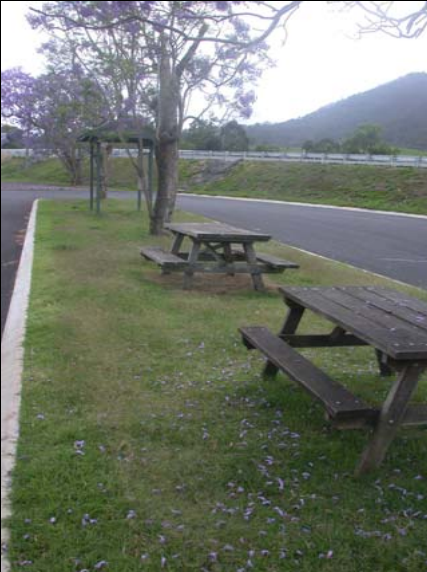
<p>Parking 1. No designated parking bay</p> <p>Curb Cut 1. No curb cut for access to information shelter</p> <p>Pathway 1. No pathway to picnic tables 2. No pathway to information shelter</p> <p>Picnic Table 1. No shelter over picnic tables</p>

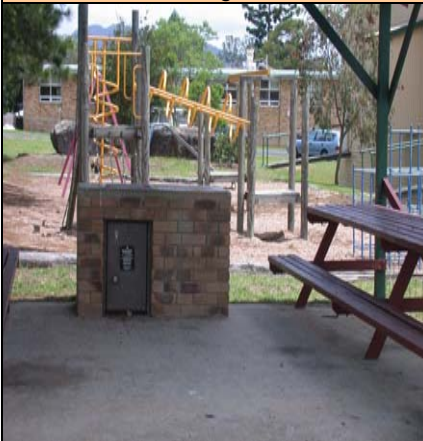
Parking 1. No designated parking bay BBQ 1. Height of BBQ is 920 mm Picnic Shelter 1. Concrete pad is level with ground surface 2. Picnic table height is 780 mm - accessible 3. Knee clearance is 730 mm - accessible 4. Circulation space between tables is accessible	Parking 1. Allocate a designated parking bay (with ground and elevated signage) in close proximity to the facilities BBQ 1. Address height of BBQ Picnic Shelter 1. Remove 800 mm of seat (between table legs) to allow table side access	Parking 1. Low BBQ 1. Low Picnic Table 1. High

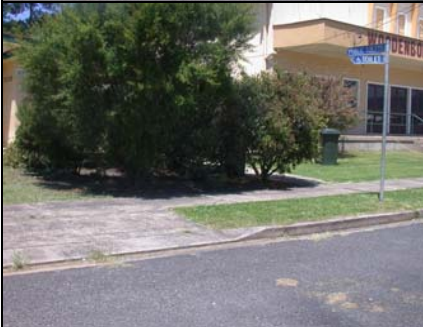
Pathway 1. Three directional changes on path of travel to the accessible toilet facility	Pathway 1. Construct a <u>direct</u> pathway from curb cut to accessible toilet facility - existing pathway's three directional changes	Pathway 1. Medium

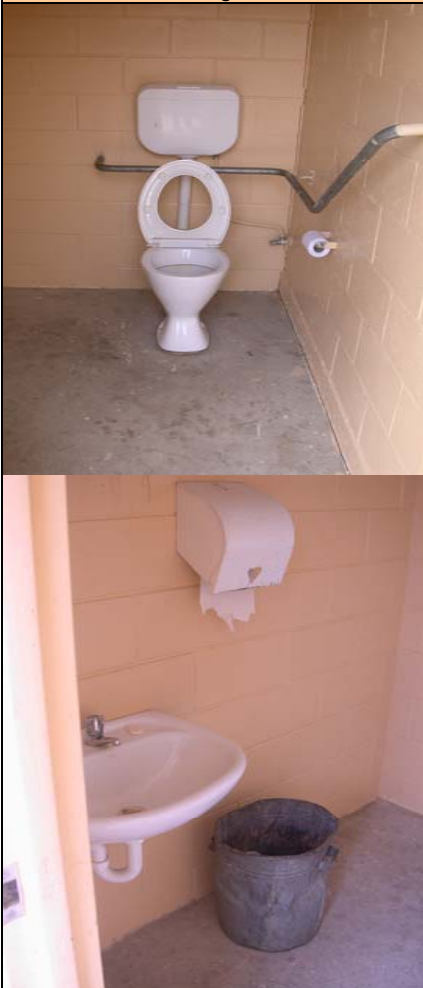
<p>Toilet</p> <ol style="list-style-type: none"> 1. Access symbol displayed 2. Doorway width is 800 mm 3. Door swings outward 4. Wash basin in toilet cubicle - height is 770 mm - accessible 5. Rubbish bin in toilet cubicle 6. Grab rail height is 820 mm (A.S. - 800 -810 mm) 7. Rear wall to front of toilet bowl is 800 mm - accessible 8. Flushing control height is 1230 mm - inaccessible (A.S. - 1100 mm maximum height) 9. Circulation space beside toilet bowl is 970 mm - accessible 10. Circulation space in front of toilet is 1200 mm - accessible 11. Door Locking device requires small motor skills 12. Twist tap 13. Colour contrast between wall and floor could be increased 14. Lighting levels are adequate 15. Door has delay closer 16. No shelf 17. No baby change table <p>Toilet - Regular Male/Female</p> <ol style="list-style-type: none"> 1. Entrance step height is 160 mm 2. No colour contrast on step nose <p>Pathway to Toilet Block</p> <ol style="list-style-type: none"> 1. Pathway width is 1200 mm - accessible <p>Pathway between Accessible Toilet to Regular Toilet</p> <ol style="list-style-type: none"> 1. Pathway width is 1040 mm - accessible 	<p>Toilet</p> <p>Toilet cubicle requires upgrades to be considered as an accessible facility</p> <ol style="list-style-type: none"> 1. Install a bi-directional hinge to cubicle door 2. Install locking device, able to be operated using one hand and gross motor skills 3. Adjust flushing control height 4. Install flick tap control 5. Install shelf 6. Install fold up baby change table <p>Toilet - Regular Male/Female</p> <ol style="list-style-type: none"> 1. Paint step nosing with high contrast/luminance colour (safety yellow) 	<p>Toilet -</p> <ol style="list-style-type: none"> 1. Medium 2. Medium 3. Medium 4. High 5. Low 6. Medium <p>Toilet - Regular Male/Female</p> <ol style="list-style-type: none"> 1. High

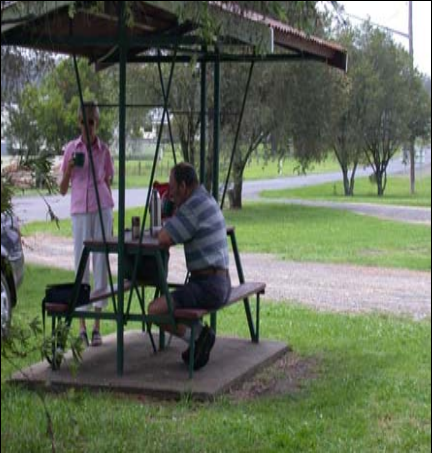
<p>Parking 1. No designated parking bay</p> <p>Pathway 1. No pathway between facilities</p> <p>Picnic Table (Closest to BBQ) 1. Picnic table height is 750 mm 2. Knee clearance height is 725 mm</p>	<p>Parking 1. Allocate a designated parking bay (with ground and elevated signage) in close proximity to the facilities</p> <p>Pathway 1. Construct pathway from picnic shelter to BBQ</p> <p>Picnic Table (Closest to BBQ) 1. Remove one seat to allow table side access (Ensure concrete pad's circulation space from table edge is 1200 mm)</p>	<p>Parking 1. Low</p> <p>Pathway 1. Low</p> <p>Picnic Table 1. Low</p>

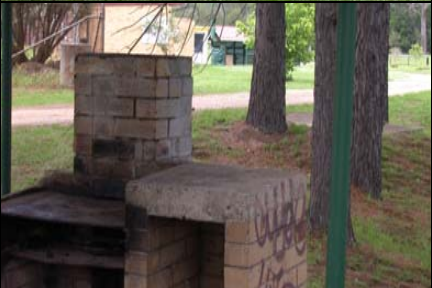
<p>BBQ 1. Shelter over BBQ 2. BBQ height is 680 mm - accessible 3. No concrete pad</p>	<p>BBQ 1. Construct concrete pad for BBQ shelter</p>	<p>BBQ 1. Low</p>

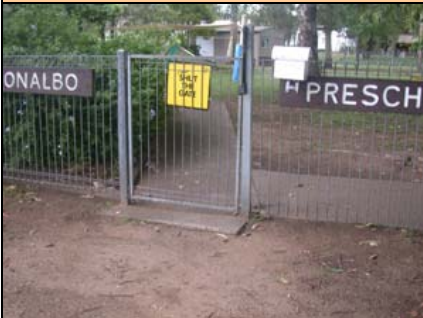
Parking 1. General parking area 2. No designated parking bay Entrance Gate 1. No colour contrast to define gate opening - yellow sign will assist	Parking No recommendation Entrance Gate No recommendation

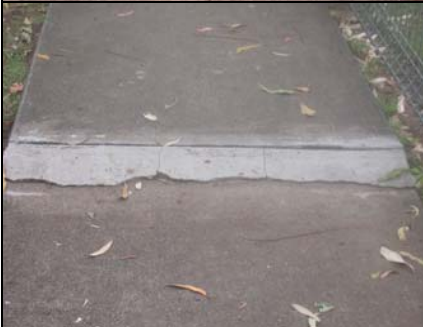
Pathway 1. Pathway has broken edges and obstacle (log) 2. An attempt to address uneven pathway levels	Pathway 1. Repair broken edges of pathway 2. Address uneven pathway levels 3. Remove obstacle (log)	Pathway 1. Medium 2. Medium 3. Medium

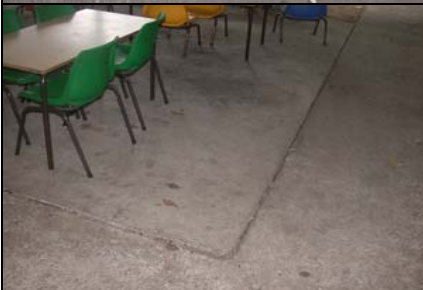
Undercover Area 1. Concrete slab addition is not level with surrounding concrete (20 mm) Does not hinder wheelchair use - trip hazard	Undercover Area 1. Address the difference in levels by highlighting with colour contrast strip or through grinding down the difference	Undercover Area 1. Medium

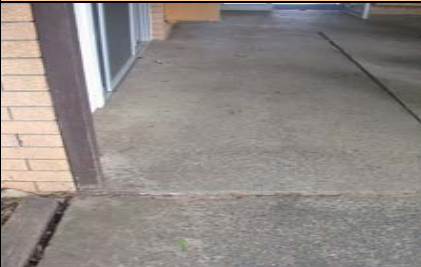
Undercover Area 1. Uneven concrete joins - trip hazard	Undercover Area 1. Address level difference at concrete joins	Undercover Area 1. Low

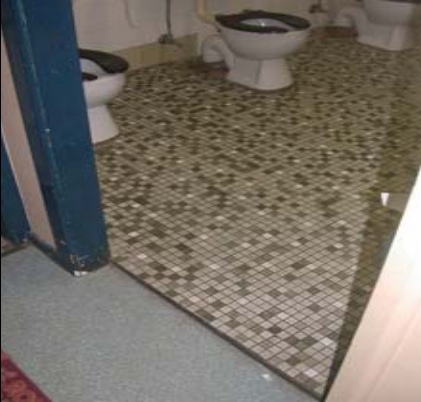
Toilet 1. Floor level difference to toilet facility does not hinder wheelchair use - could pose as a trip hazard	Toilet 1. Install cover strip at differing floor surfaces	Toilet 1. Low

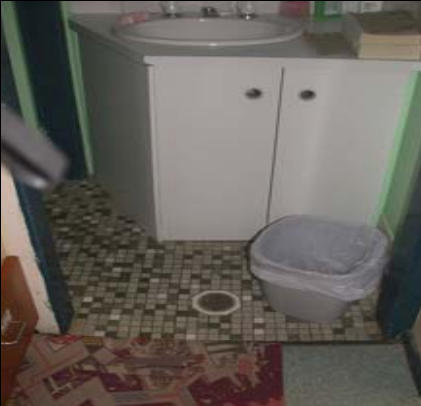
Toilet - Regular 1. Wash basin obstructs path of travel to toilet cubicle	Toilet - Regular 1. Address the location, style and size of the wash basin	Toilet Regular 1. High

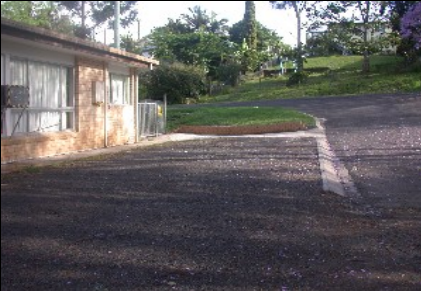
Parking <ol style="list-style-type: none"> 1. No designated parking bay 2. No traffic sign - children crossing at Fawcett Street or kindergarten Lane 	Parking <ol style="list-style-type: none"> 1. Allocate designated parking bay (with ground and elevated signage) in close vicinity to the accessible entrance 2. Install traffic sign - children crossing 	Parking <ol style="list-style-type: none"> 1. Low 2. High

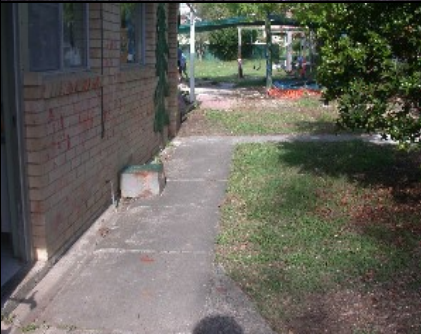
Entrance (from Car Park) <ol style="list-style-type: none"> 1. No colour contrast to define side & front gateways 2. Covered maintenance box and pipe encroaches on pathway width 3. Pathway width is 900 mm - inaccessible 4. Concrete is cracked 	Entrance (from Car Park) <ol style="list-style-type: none"> 1. Install yellow 'shut the gate' sign 2. Widen pathway width (1200 mm A.S.) 3. Relocate maintenance box & pipe or provide colour contrast 	Entrance (from Car Park) <ol style="list-style-type: none"> 1. High 2. Medium 3. High

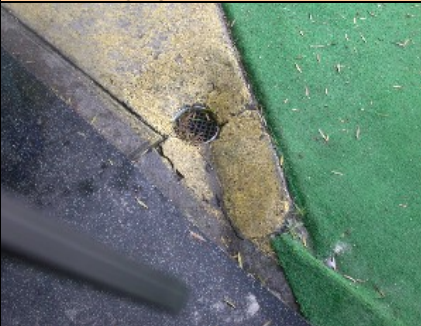
<p>Exterior Floor Surface</p> <ol style="list-style-type: none"> 1. Differing floor surface levels - trip hazard 2. Area has been painted yellow 	<p>Exterior Floor Surface</p> <ol style="list-style-type: none"> 1. Address the differing floor surface levels - repaint 	<p>Exterior Floor Surface</p> <ol style="list-style-type: none"> 1. Medium

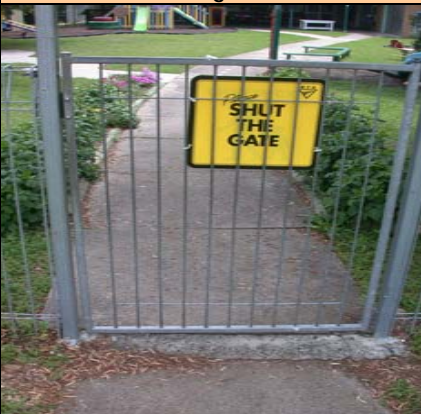
Parking 1. General parking area 2. No designated parking bay Entrance Gate 1. Gate knob cover is missing 2. No colour contrast to define gate opening - yellow sign will assist	Parking No recommendation Entrance Gate 1. Replace the gate knob cover	Entrance Gate 1. Maintenance

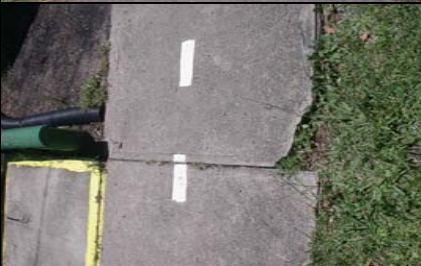
Pathway 1. Pathway edge has broken edge	Pathway 1. Address broken pathway edge	Pathway 1. Low

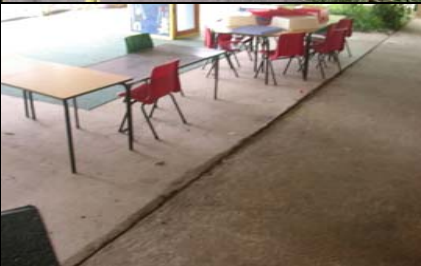
Undercover Area 1. Concrete slab is not level with surrounding concrete (20 mm) (An attempt to grind down the difference is evident)	Undercover Area 1. Address the difference in levels by highlighting with colour contrast strip or through grinding down the difference	Undercover Area 1. Medium

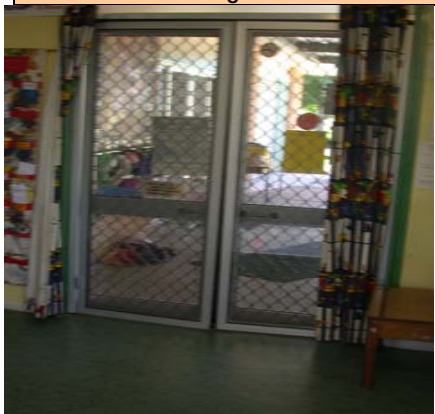
<p>Entrance (Main) 1. Main entrance is accessible</p> <p>Entrance (to foyer) 1. Foyer doorway width is 730 mm (hindered by door butting up against partition) Target group can use alternative entrance</p> <p>Internal doorway - Library 1. Doorway width is 730 mm - inaccessible Does not meet regular A.S.</p>	<p>Entrance(Main) No recommendation</p> <p>Entrance (Foyer) 1. Address doorway width to meet regular Standards (760 mm)</p> <p>Internal doorway - Library 1. Address door opening width to meet Access Standards (800 mm 850 mm preferred)</p>	<p>Foyer Entrance 1. Low</p> <p>Library Entrance 1. High</p>

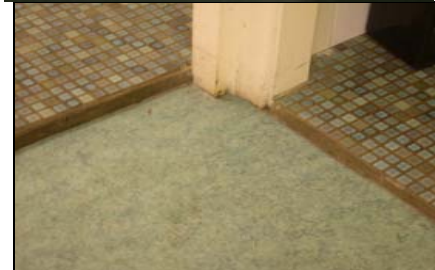
<p>Floor Levels 1. Lip at entrance to toilet facility does not hinder wheelchair use - could pose as a trip hazard</p>	<p>Floor Levels 1. Install lip cover at floor surfaces differences</p>	<p>Floor Levels 1. Low</p>

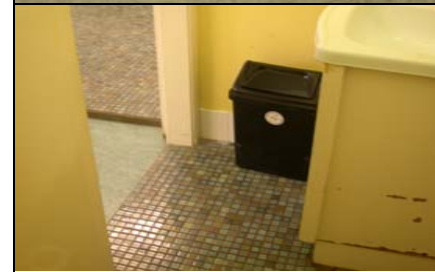
<p>Toilet 1. Doorway width is 740 mm - inaccessible Does not meet regular A.S. 2. Wash basin obstructs path of travel to toilet cubicle 3. Path of travel width is 480 mm 4. There are two regular toilet facilities both obstructed by the wash basin's location, style and size</p>	<p>Toilet 1. Address the location, style and size of the wash basin of the toilet facilities 2. Address doorway width</p>	<p>Toilet 1. High 2. Medium</p>

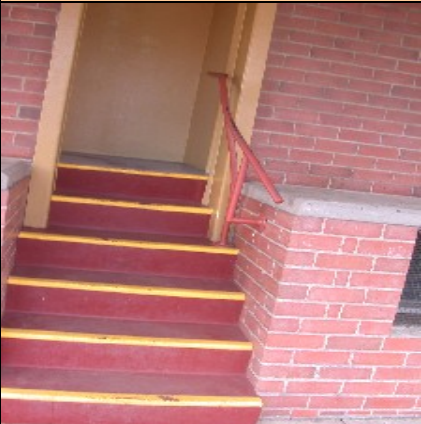
Stairs - Female 1. Stairs are narrow 2. Handrail one side only 3. Colour contrast on step nosing Entrance 1. Entrance doorway widths do not meet regular A.S. Toilet - Regular Female 1. No grab rails	Stairs - Female 1. Extend handrail to length of stairs 2. Install 2 nd handrail Entrance 1. Consider entrance doorway widths Toilet - Regular Female 1. Install grab rail in one cubicle	Stairs - Female 1. High 2. High Entrance 1. Medium Toilet Regular Female 1. High

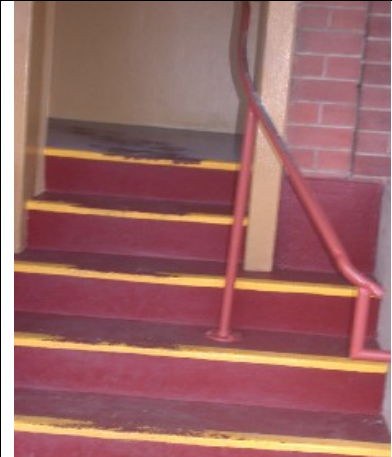
Stairs - Male 1. Stairs are wider at entry point 2. Handrail one side of stairs 3. Colour contrast on step nosing Toilet - Regular Male 1. No grab rails 2. No toilet seats or lids in either cubicle 3. Toilet roll holders broken in both cubicles	Stairs - Male 1. Install 2 nd handrail Toilet - Regular Male 1. Install grab rail in one cubicle and at urinal 2. Replace toilet seats/lids 3. Replace/repair toilet roll holders	Stairs - Male 1. High Toilet - Regular Male 1. High 2. Maintenance 3. Maintenance

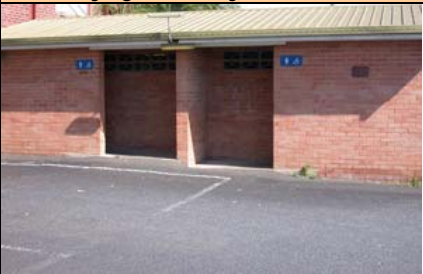
General 1. Evidence of vandalism Parking 1. No designated parking bay	General 1. Secure toilet block between 6 pm and 6 am Parking 2. Allocate a designated parking bay (with ground and elevated signage) in close proximity to the facilities	General Maintenance Parking 1. High

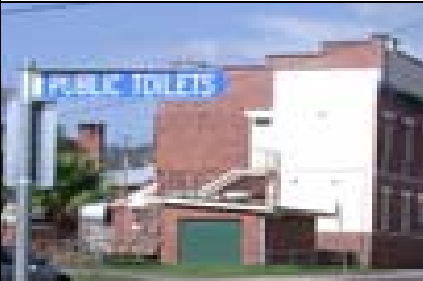
Signage 1. Sign - regular male/female toilet - located corner of Geneva Street and Summerland Way 2. Elevated signage at entry to car park (Public Toilet)- no access symbol 3. Access symbol on wall (male/female entrances)	Signage 1. Include access symbol to elevated signs (a) Car park entrance (b) Geneva Street & Summerland Way	Signage 1. High (a & b)

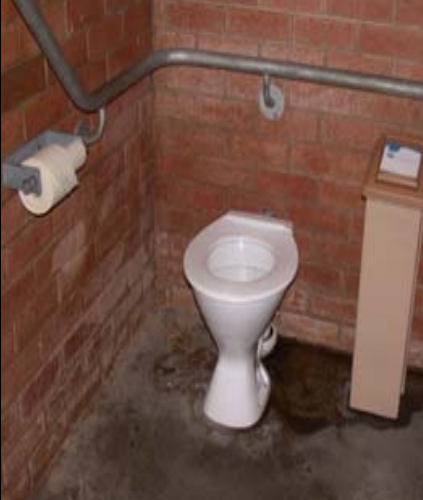
Toilet 1 Male 1 Female 1. Door swings outwards 2. Doorway width is 800 mm - accessible 3. No toilet seat lid 4. Grab rail height is 840 mm - inaccessible 5. Toilet Bowl height is 420 mm - inaccessible 6. Front of bowl to rear wall is 560 mm - inaccessible 7. Circulation space beside bowl is 850 mm - inaccessible 8. Circulation space in front of bowl is 2300 mm - accessible 9. Flush control height is 1170 mm - inaccessible 10. Flush control button missing Note: Second visit - seat is no longer attached to toilet bowl (female). No seat or lid (male)	Toilet 1 Male 1 Female 1. Install bidirectional hinge to door 2. Install toilet seat/lid 3. Adjust grab rail height (800 - 810 mm A.S.) 4. Address toilet bowl height (460 - 480 mm A.S.) 5. Address toilet bowl position 6. Address circulation space beside bowl (950 mm A.S.) 7. Address flush control height (1100 mm A.S.) 8. Replace flush button	Toilet 1. High 2. Maintenance 3. Medium 4. High 5. High 6. Medium 7. High 8. Maintenance

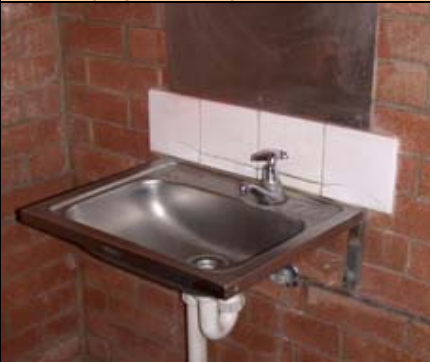
Wash basin - Male/Female <ol style="list-style-type: none"> Cracked tiles above washbasin - sharp edges (Male/Female) Second washbasin smashed from wall leaving exposed bolts. Strip of tiles also cracked with sharp edges (Female) Tiles cracked above urinal 	Wash basin - Male/Female <ol style="list-style-type: none"> Remove exposed bolts Replace cracked tiles above remaining, missing washbasins and urinal 	Wash basin <ol style="list-style-type: none"> Maintenance

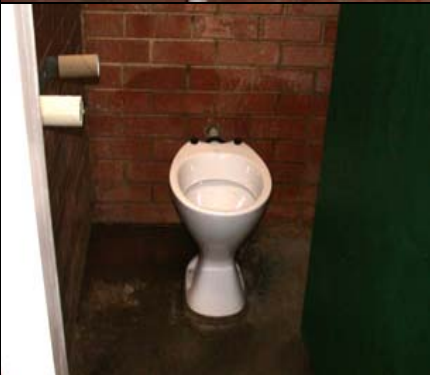
Toilet Regular Male/Female <ol style="list-style-type: none"> No toilet seat or lid (Male/Female) No grab rails Broken toilet roll holder (Male) 	Toilet Regular Male/Female <ol style="list-style-type: none"> Install toilet seat and lid Install a grab rail in regular male/female cubicles and at urinal Replace toilet roll holder(male) 	Toilet Regular Male/Female <ol style="list-style-type: none"> Maintenance High Maintenance
