Mobility Access - 2005

MOBILITY ACCESS -

Management and Implementation Plan 2005

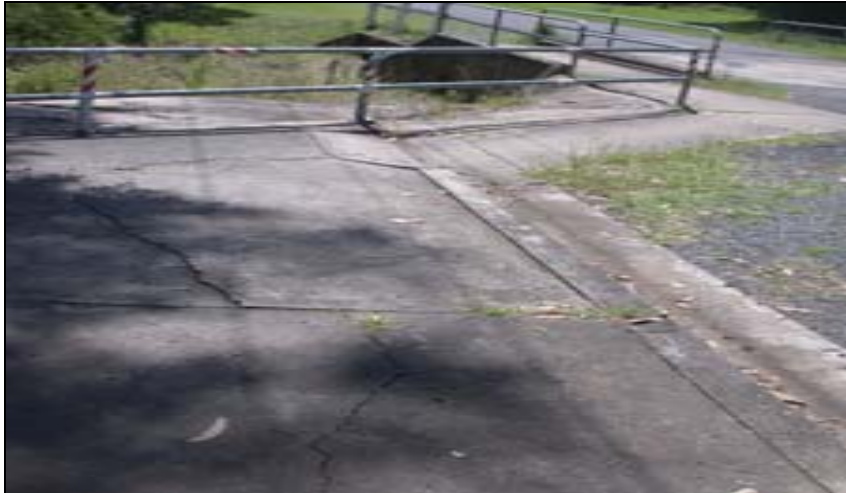
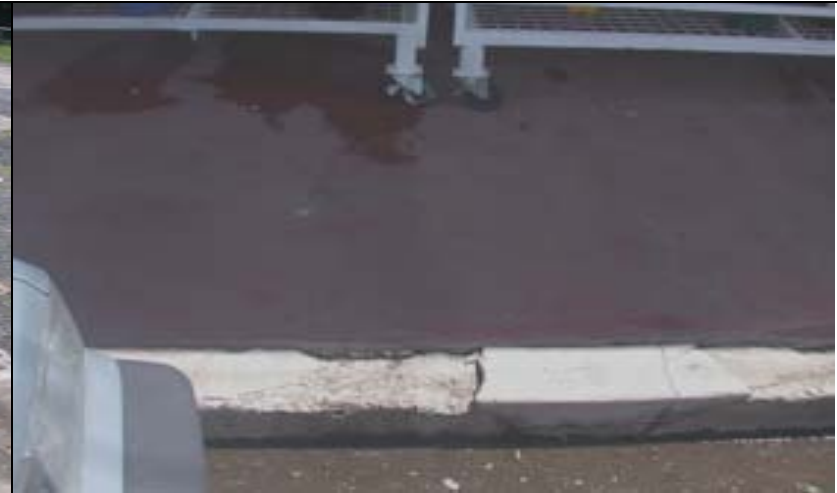
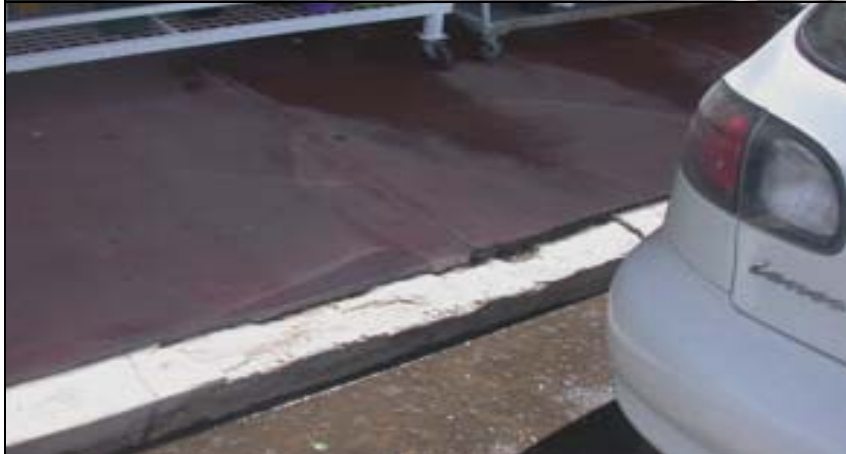
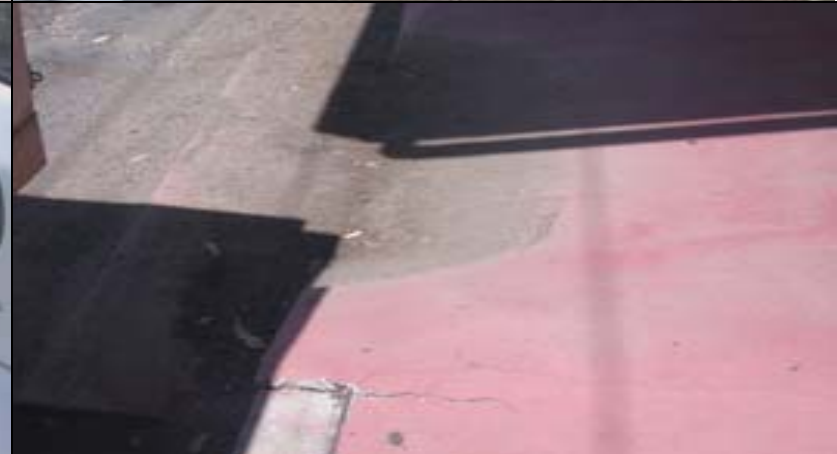
BONALBO - Sandilands Street - Hardward Store

BONALBO - Sandilands Street - Water pools in guttering

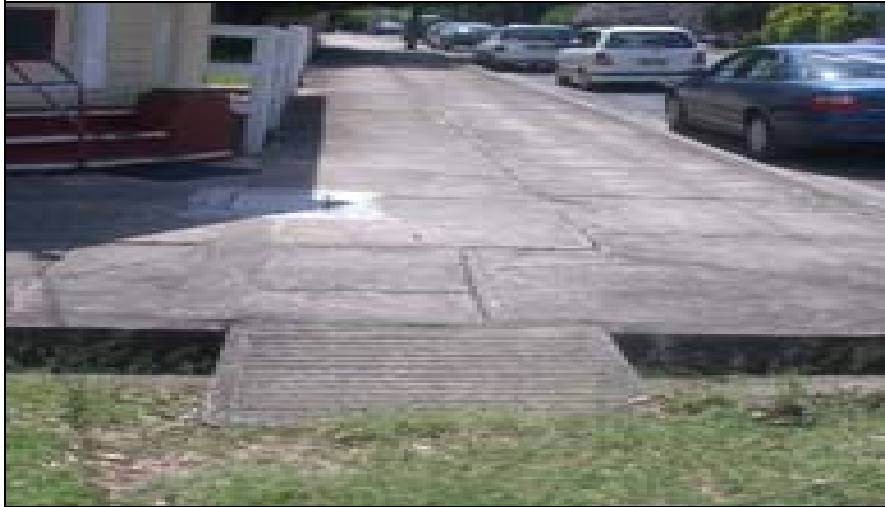
BONALBO - Sandilands Street

Corner Sandilands and Peacock Sts

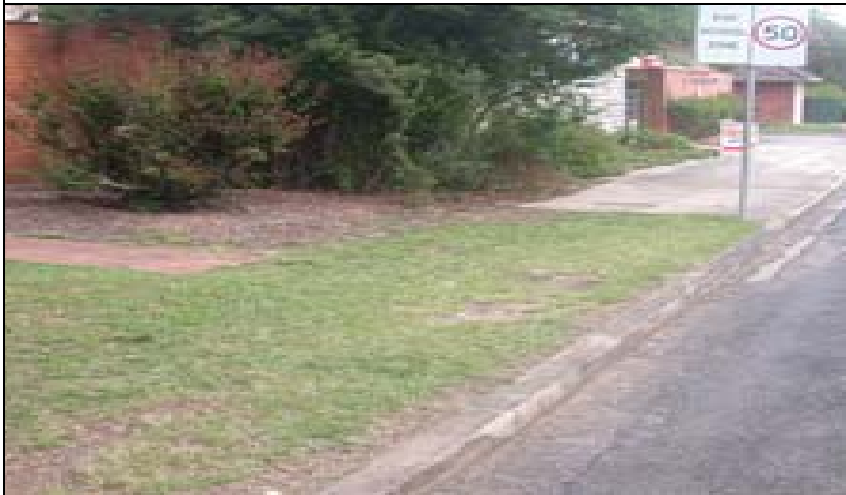
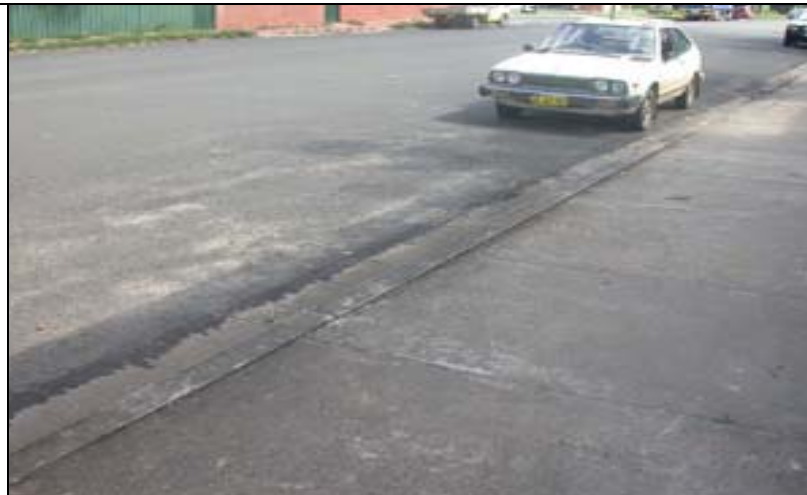
BONALBO - Koreelah Street

No footpath to police station

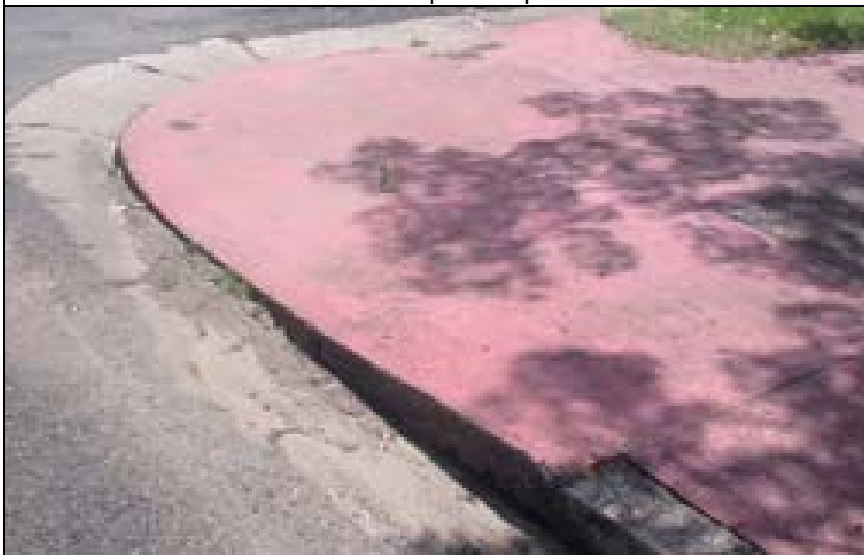
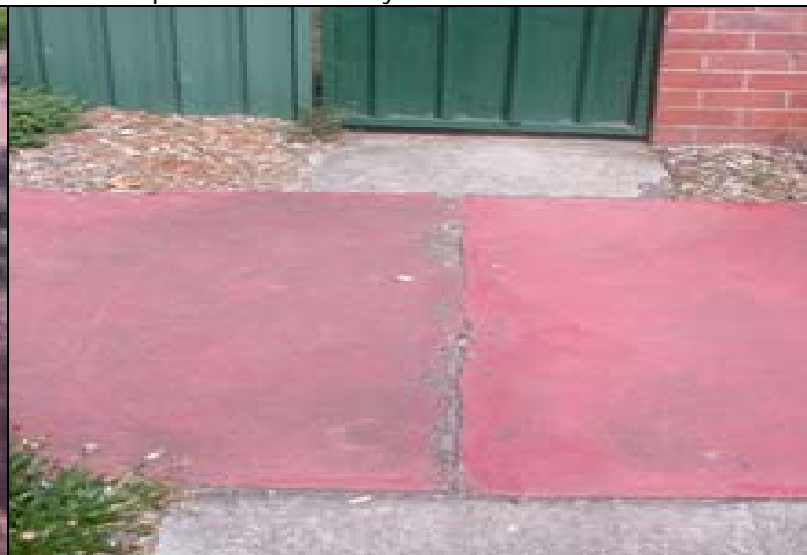
Curb cut required at Community Centre

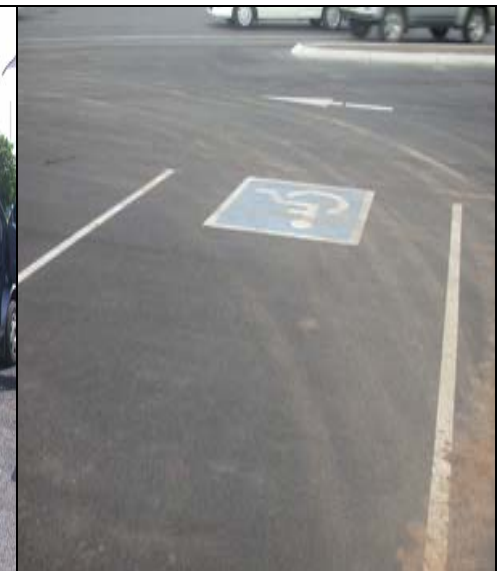
Amphitheatre

1. Bay width is not to Standards. A set-down area is adjacent
2. The space used when transferring from the rear of a vehicle is 7.8 Mt and therefore passengers will be in the line of cross vehicle traffic. Though not required by Standards, the recommendation is 'keep clear' ground signage at cross vehicle traffic flow

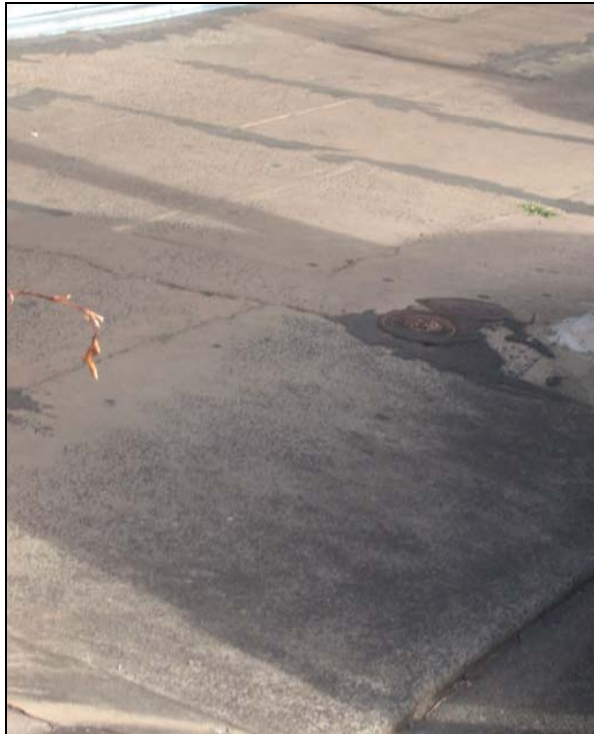
Adjacent to Roxy Gallery

Accessible curb cut - Access can be hindered by parked vehicles

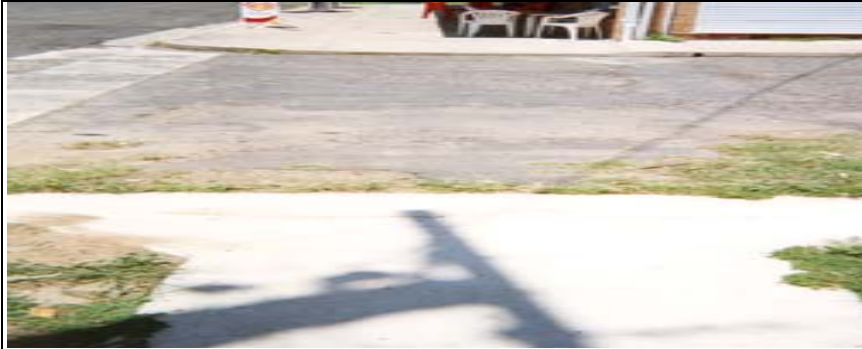
Court Street Laneway (No curb cut)

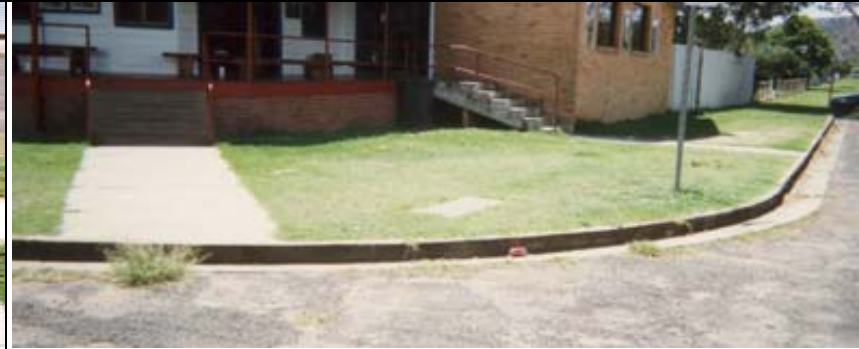
Cnr Court and Clarence Streets (No curb cut)

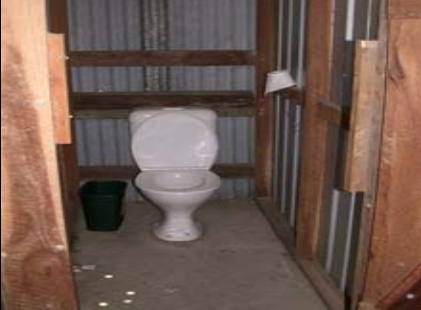
Toilet - Regular Male/Female <ol style="list-style-type: none"> 1. Cubicle doorway width is 570 mm (female) 2. Cubicle doorway width 590 mm (male) Both doorways do not meet regular A.S.	Toilet - Regular Male/Female <ol style="list-style-type: none"> 1. Address the cubicle doorway widths 2. Install grab rail 	Toilet -Regular <ol style="list-style-type: none"> 1. Medium 2. Medium

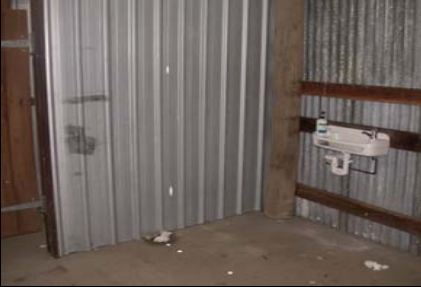
Wash Basin Area <ol style="list-style-type: none"> 1. Available room to create an accessible toilet facility or to widen existing cubicle 	Wash Basin Area <ol style="list-style-type: none"> 1. Address available space to increase existing cubicle size to access standards or regular building standards 	Wash Basin Area <ol style="list-style-type: none"> 1. Medium

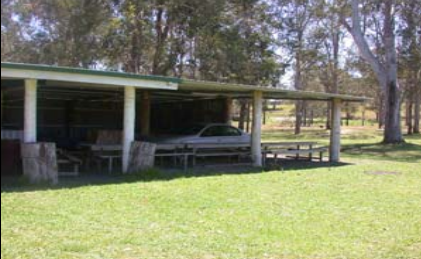
Canteen <ol style="list-style-type: none"> 1. No concrete slab in table and seating area 	Canteen <ol style="list-style-type: none"> 1. Address ground surface in table and seating area 2. Address table edge access 	Canteen <ol style="list-style-type: none"> 1. Medium 2. Medium

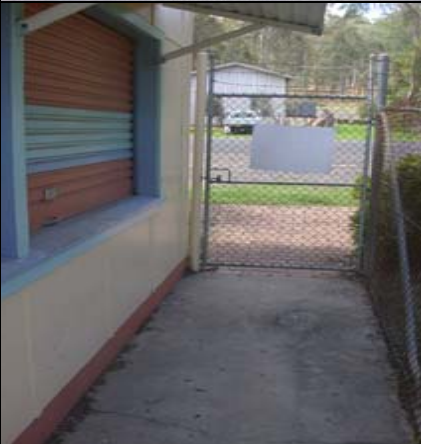
Entrance <ol style="list-style-type: none"> 1. Entrance width is accessible 2. No TGSi at entrance 	Entrance <ol style="list-style-type: none"> 1. Install TGSi at entrance 	Entrance <ol style="list-style-type: none"> 1. Low

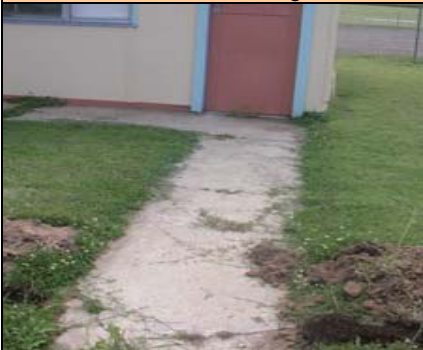
Pathway (Swim Club) <ol style="list-style-type: none"> 1. Pathway is cracked and uneven 2. Pathway width is 970 mm 	Pathway (Swim Club) <ol style="list-style-type: none"> 1. Replace uneven pathway to and in front of swim club rooms (ensure width of pathway is 1200 mm) 	Pathway (Swim Club) <ol style="list-style-type: none"> 1. Medium

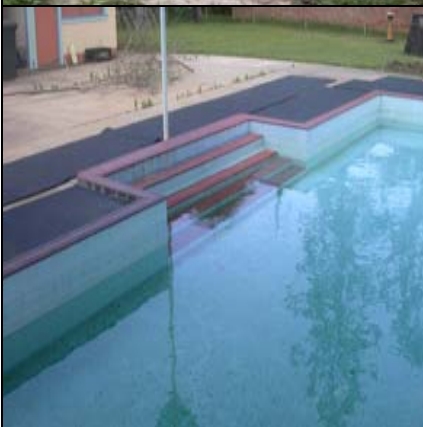
Wading Pool <ol style="list-style-type: none"> 1. Black matting around pool 2. Pool has a shade canopy 3. No inner pool perimeter rails 	Wading Pool <ol style="list-style-type: none"> 1. Remove black matting surrounding pool - (trip and burn hazard) 2. Paint shade supports over pool with a strip of high contrast/luminance colour (safety yellow) - especially pole at steps 3. Install inner pool perimeter rails 	Wading Pool <ol style="list-style-type: none"> 1. Medium 2. Medium 3. High

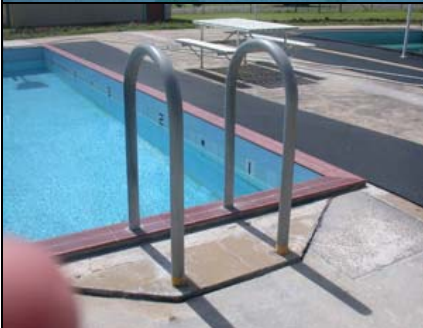
Metre Pool <ol style="list-style-type: none"> 1. Raised concrete lip at pool step handrails - could pose as a trip hazard 	Metre Pool <ol style="list-style-type: none"> 1. Paint three sided concrete lip, surrounding step rails with high contrast/luminance colour (safety yellow) 	Metre Pool <ol style="list-style-type: none"> 1. High

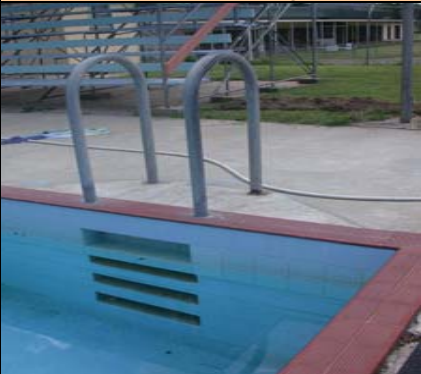
Metre Pool 1. No inner perimeter pool grab rails	Metre Pool 1. Install inner pool perimeter rails	Metre Pool 1. High

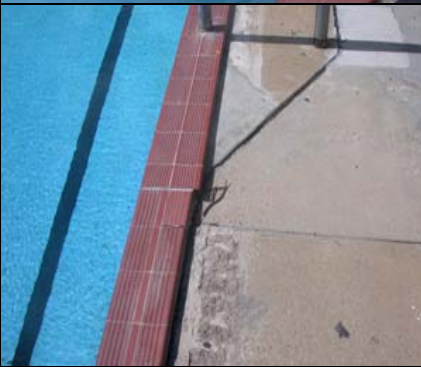
Metre Pool 1. Tactile tiles on pool edge differ in width	Metre Pool 1. Address tactile edge tiles - width difference (trip hazard)	Metre Pool 1. Low

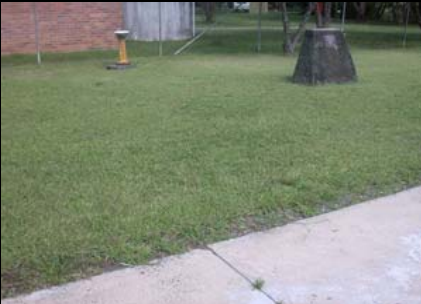
Water fountain 1. Water fountain (yellow)	Water fountain 1. Relocate water fountain to be accessible by a concrete path of travel and adjacent to a fixed wall - Ensure height is 800 - 900 mm A.S.	Water fountain 1. Medium

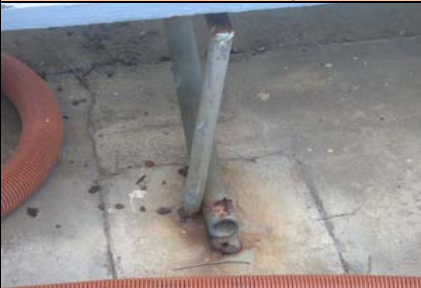
Grandstand 1. Rusty, damaged structural supports on 3 grandstands	Grandstand 1. Address all grandstand's rusty, damaged and exposed structural supports and uneven concrete surrounds	Grandstand 1. Maintenance

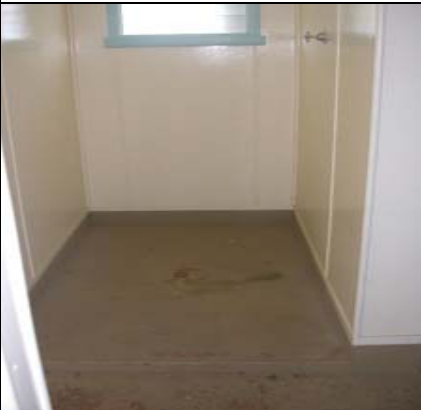
Shower - Female/ Male 1. No accessible shower facilities 2. Shower step nosing has no colour contrast 3. Shower step height is 50 mm 4. Colour contrast between wall and floor could be improved	Shower - Female/ Male 1. Construct unisex accessible shower facilities 2. Paint shower step nosing with high contrast/luminance colour (safety yellow) 3. Address colour contrast between floor and walls by painting "shirting board" with high contrast/luminance colour (safety yellow)	Shower 1. Medium 2. High 3. Low

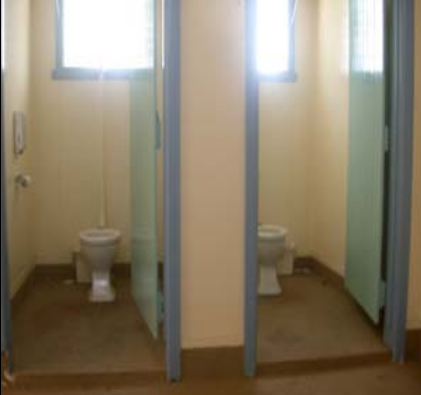
Toilet - Regular Female/ Male 1. No colour contrast on step nosing 2. Male toilets have missing toilet seats 3. No grab rail at urinal 4. No grab rail in regular cubicles	Toilet - Regular Female/Male 1. Construct unisex accessible toilet facilities 2. Paint step nosing with high contrast/luminance colour (safety yellow) 3. Replace missing toilet seat (male) 4. Install grab rail at urinal 5. Install grab rail in one regular cubicle (Male/female)	Toilet 1. Medium 2. High 3. Maintenance 4. High 5. High

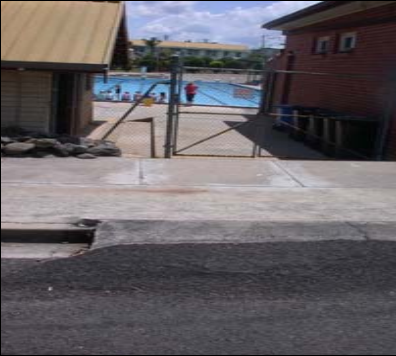
Parking <ol style="list-style-type: none"> 1. No designated parking bay 2. Curb ramp located at the pool maintenance gateway 	Parking <ol style="list-style-type: none"> 1. Allocate a parallel designated parking bay (3.2 wide, 7.8 length with ground and elevated signage) in close proximity to curb ramp located at the pool maintenance gateway 	Parking <ol style="list-style-type: none"> 1. High

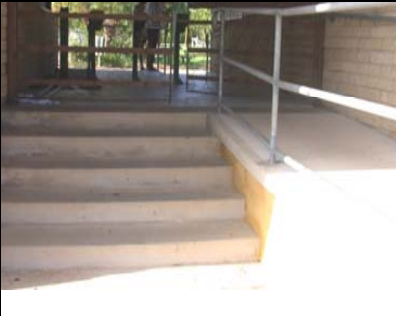
Entrance - Main - Stairs <ol style="list-style-type: none"> 1. Stairs have no handrails (Handrails on the ramp give some assistance) 2. No colour contrast or tactile strip on step nosing 3. No TGSi at entry/exit points of stairs 	Entrance - Main - Stairs <ol style="list-style-type: none"> 1. Paint entrance stair nosing with high contrast/luminance colour (safety yellow) or install tactile strips 2. Install TGSi at entry and exit points of stairs 3. Install hand rails on stairs 	Entrance - Main - Stairs <ol style="list-style-type: none"> 1. High 2. Low 3. High

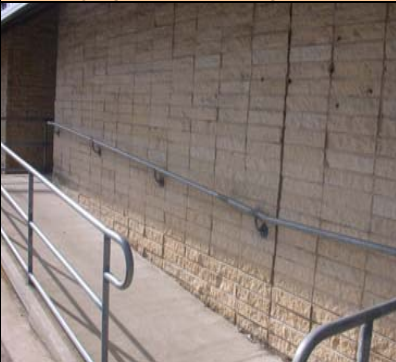
Entrance Ramp 1. Entrance ramp is accessible 2. No TSGI at entry and exit points	Entrance Ramp 1. Install TSGI at ramp's entry and exit points	Entrance Ramp 1. Low

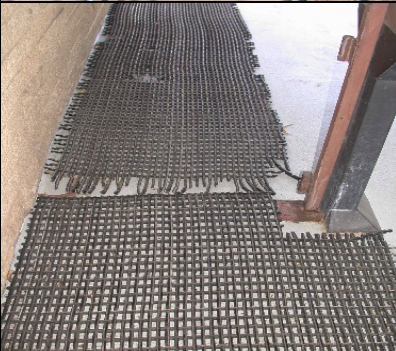
Canteen 1. Canteen counter height is 1040 mm (front) and 1180 mm (side) 2. Frayed rubber matting at entrance beside canteen counter Ramp from Turnstile 1. Single handrails either side of ramp	Canteen 1. Replace frayed rubber mats at entrance beside canteen counter (trip hazard) 2. Lower section of canteen counter - (730 to 870 mm A.S.) Ramp from Turnstile 1. Install double handrails either side of ramp	Canteen 1. High 2. Low Ramp from Turnstile 1. Low

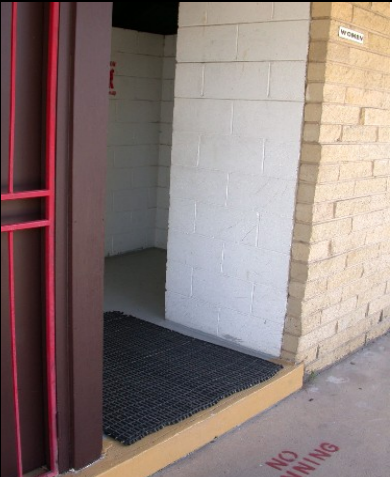
A photograph showing the entrance to the female change rooms. The entrance is a doorway with a white brick wall on the right and a dark door frame on the left. A black mat is on the floor. A yellow step is visible at the entrance.	<p>Entrance 1 - Female Change Rooms</p> <ol style="list-style-type: none"> 1. Step has been highlighted with contrasting colour - not safety yellow <p>Entrance 2 - Female Change Rooms</p> <ol style="list-style-type: none"> 1. Continuous floor surface levels at entrance 2. Entrance width is accessible 3. No directional signage to the accessible entrance 4. No sign on the accessible entrance 	<p>Entrance 1 - Female Change Rooms</p> <ol style="list-style-type: none"> 1. Paint step nosing with high contrast/luminance colour (safety yellow) or Install step ramp <p>Entrance 2 - Female Change Rooms</p> <ol style="list-style-type: none"> 1. Install directional access symbol signage <u>to</u> the accessible entrance 2. Install access symbol signage <u>on</u> entrance 2 	<p>Entrance 1 Female</p> <ol style="list-style-type: none"> 1. Medium <p>Entrance 2 Female</p> <ol style="list-style-type: none"> 1. Medium 2. High

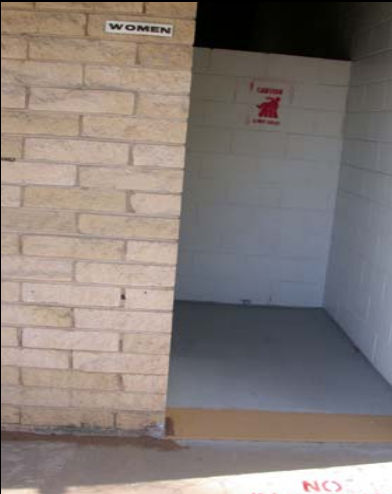
A photograph showing the entrance to the male change rooms. The entrance is a doorway with a white brick wall on the left and a dark door frame on the right. A yellow step is visible at the entrance. A sign above the door reads 'WOMEN'.	<p>Entrance (1) - Male Change Rooms</p> <ol style="list-style-type: none"> 1. Step ramp has been highlighted with contrasting colour - not safety yellow 	<p>Entrance (1) - Male Change Rooms</p> <ol style="list-style-type: none"> 1. Paint step ramp with high contrast/luminance colour (safety yellow) or Install step ramp 2. Install access symbol signage at accessible entrance 	<p>Entrance 1 Male</p> <ol style="list-style-type: none"> 1. Medium 2. High

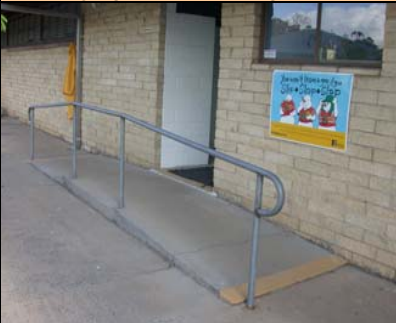
Entrance (2) Ramp- Male Change Rooms 1. Ramp has single hand rail 2. No visually defined edge (horizontal) to entrance ramp	Entrance (2) Ramp- Male Change Rooms 1. Construct 2 nd handrail at 700 mm height 2. Paint ramp edges (at the base of the handrails) with high contrast/luminance colour (safety yellow)	Entrance 2 Male 1. Low 2. Low

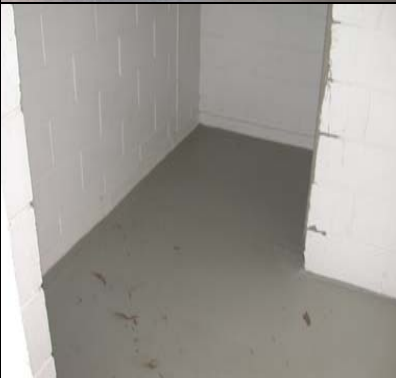
Entrance - Path of Travel Male/Female Change Rooms There are four directional changes on the path of travel into the change room 1. Passageway widths (female) are: 2. 1660 mm diagonal from 1 st partial wall to corner 3. 1200 mm horizontally - wall to wall 4. 1090 mm horizontally - wall to wall 5. 1600 mm diagonal from 2 nd partial wall to corner 6. 1160 mm horizontally - wall to wall 7. Dividing wall partition widths are 800 mm	Entrance - Path of Travel Male/Female Change Rooms 1. For ease of access, minimize width of exterior partition or remove completely to minimize directional changes	Change Rooms 1. Medium

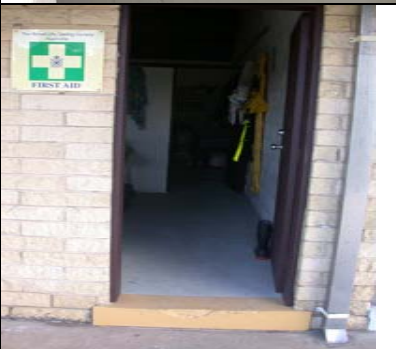
Entrance - First Aide Room Doorway width is 760 mm	Entrance - First Aide Room 1. Paint step with high contrast/luminance colour (safety yellow) or Install step ramp 2. Address doorway width (850 mm A.S.)	First Aide 1. High 2. Medium

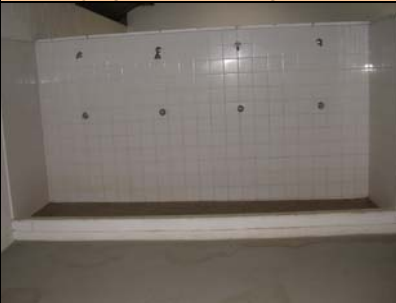
Shower Male/Female 1. No accessible shower facilities 2. Shower hob height 250 mm Tap 1. Single tap beside showers has missing controls	Shower Male/Female 1. Construct accessible shower facilities 2. Paint shower hob with high contrast/luminance colour (safety yellow) 3. Replace missing tap control	Shower 1. High 2. Medium 3. Maintenance

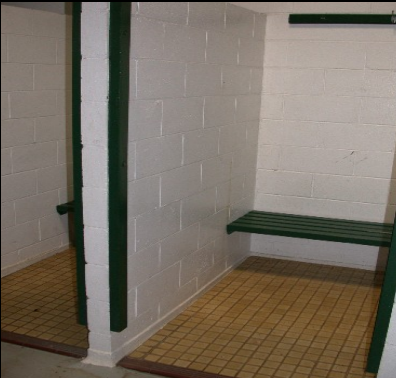
Change Room Male/Female 1. No accessible change rooms (large toilet cubicle could double as a change room, include accessible shower facilities)	Change Room Male/Female 1. Address accessible change room (Note: shower recommendation)	Change Room 1. High (Note: shower priority)

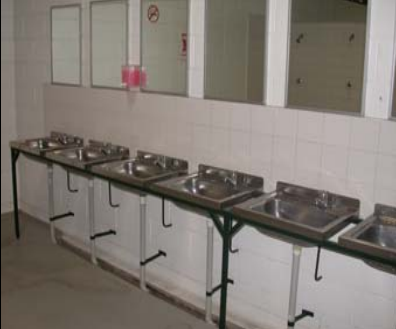
Wash Basin Male/Female 1. Drain hole beside wash basins has no cover 2. Wash basin height is 820 mm - inaccessible 3. Twist taps on all wash basins 4. Soap dispenser height 1300 mm - inaccessible	Wash Basin Male/Female 1. Cover open drain hole beside wash basin (closest to 2 nd entrance) 2. Replace <u>one</u> twist tap with flick tap 3. Install wash basin in "accessible" toilet cubicle	Wash Basin Male/Female 1. Maintenance 2. Medium 3. High

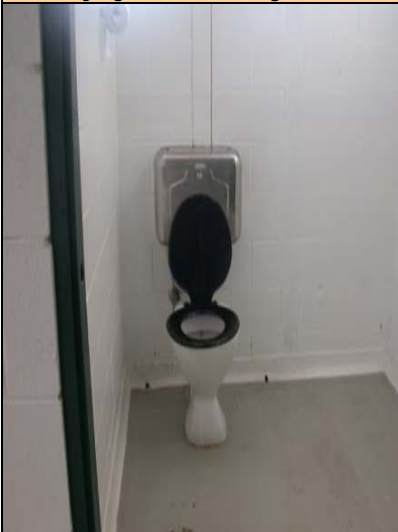
Toilet Male/Female <ol style="list-style-type: none"> 1. Door swings outward 2. Door pressure is of medium weight with a delay closer 3. Shirting board has no colour contrast 4. Door and architraves have colour contrast 5. Height of bowl is inaccessible 6. Front of toilet pan to wall is inaccessible - 600 mm 7. Circulation space beside toilet pan is accessible 8. Circulation space in front of toilet pan is accessible 9. Flush control height is accessible 10. No door locking mechanism 11. Toilet paper holder is missing (male/female) 	Toilet Male/Female Toilet cubicle requires upgrading to be considered as an accessible facility <ol style="list-style-type: none"> 1. Install a bi-directional hinge to cubicle door 2. Reposition toilet bowl to A.S. 3. Address height of bowl 4. Install grab rails (rear & side) 5. Install wash basin with flick tap control inside the toilet cubicle 6. Install locking device, able to be operated using one hand and gross motor skills 7. Install toilet paper holder 8. Install a shelf 9. Install a mirror 	Toilet <ol style="list-style-type: none"> 1. High 2. High 3. High 4. High 5. High 6. High 7. High 8. Medium 9. Low

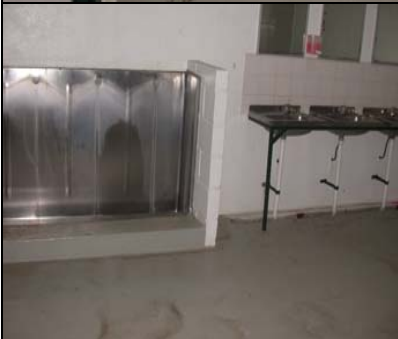
Toilet- Regular Male <ol style="list-style-type: none"> 1. No colour contrast where the urinal meets floor 2. No grab rail at urinal 3. No grab rail in regular cubicle Toilet- Regular Female <ol style="list-style-type: none"> 4. No grab rail in regular cubicle 	Toilet- Regular Male <ol style="list-style-type: none"> 1. Paint urinal hob with high contrast/luminance colour (safety yellow) 2. Install grab rail at urinal 3. Install grab rail in one regular cubicle Toilet- Regular Female <ol style="list-style-type: none"> 4. Install grab rail in one regular cubicle 	Toilet- Regular Male <ol style="list-style-type: none"> 1. High 2. High 3. High 4. High

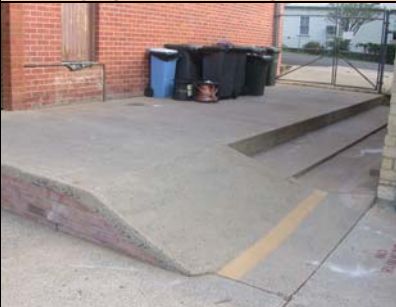
Ramp/Steps 1. No colour contrast on ramp and steps	Ramp/Steps 1. Paint ramp edges and steps with high contrast/luminance colour (safety yellow) 2. Section off this area (if designated for staff only)	Ramp/Steps 1. Medium 2. Medium

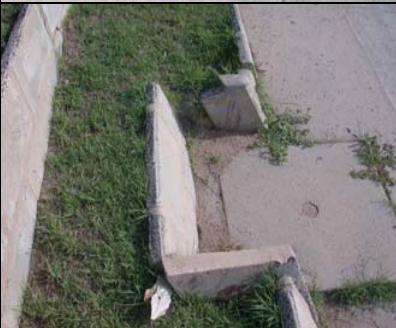
Terrace Area (1) 1. Exposed concrete edges are not level with the ground surface	Terrace Area 1. Repair loose blocks 2. Address exposed concrete edges or 3. Remove all concrete blocks	Terrace Area 1. High 2. High 3. High

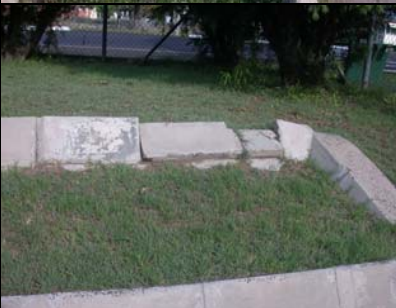
Terrace Area (2) 1. Bricks are loose and misplaced	Terrace Area 1. Address loose and misplaced bricks or remove	Terrace Area 1. Medium

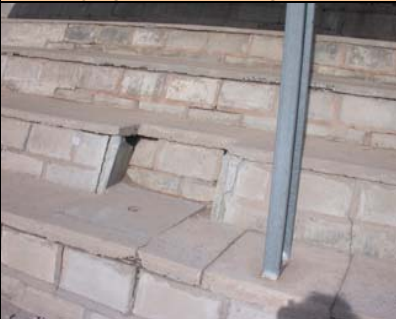
Terraced Seating (3) 1. No allocated viewing area for wheelchairs 2. Terraced levels are not visually defined	Terraced Seating 1. Allocate a wheelchair viewing area (minimum width 800 mm, depth 1900 mm A.S.) 2. Visually define terrace levels with contrasting colour strip (safety yellow)	Terraced Seating 1. Medium 2. Medium

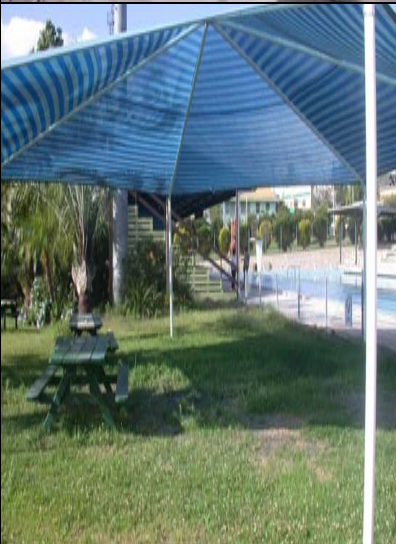
Pathway No pathway to picnic tables Picnic Table 1. No access to table top	Shade Canopy 1. Paint shade supports with high contrast/luminance colour strips (safety yellow) Pathway 1. Construct pathway to picnic table Or - Locate a shaded picnic table on the existing concrete area Picnic Table 1. Extend picnic table end Or - 2. Install accessible picnic table on existing concrete area	Shade Canopy 1. Low Pathway 1. Medium 1. Medium Picnic Table 1. Medium 2. Medium

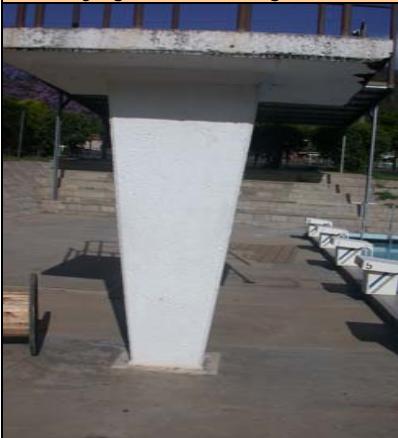
Diving Platform (if in use) <ol style="list-style-type: none"> 1. No ladder 2. No colour contrast strip on diving platform edge 	Diving Platform (if in use) <ol style="list-style-type: none"> 1. Apply a non slip strips to ladder rungs 2. Paint diving platform edge with high contrast/luminance colour (safety yellow) 	Diving Platform (if in use) <ol style="list-style-type: none"> 1. High 2. High

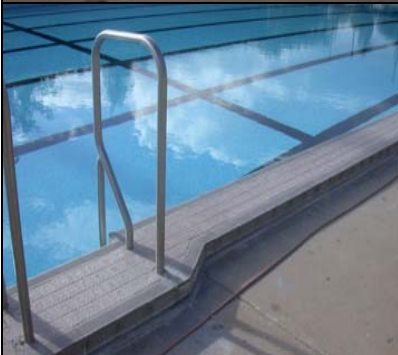
Pool - 50 Metre <ol style="list-style-type: none"> 1. No inner perimeter grab rails 2. The vertical rise of the pool edge could be emphasised 3. Handrails for pool entry/exit could have colour contrast 	Pool - 50 Metre <ol style="list-style-type: none"> 1. Install inner perimeter grab rails 2. Paint vertical rise of pool edge with high contrast/luminance colour (safety yellow) 3. Paint base of handrails with high contrast/luminance colour (safety yellow) 	Pool - 50 Metre <ol style="list-style-type: none"> 1. High 2. Medium 3. Medium

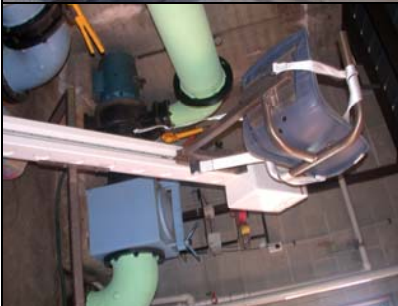
Pool Access <ol style="list-style-type: none"> 1. Chairlift (OUT OF ORDER) 2. Corrosive parts caused malfunction Note: This style of chairlift requires manual lifting from attendant and does not support dignity and independence	Pool Access <ol style="list-style-type: none"> 1. Construct water access ramp (A ramp will enable access to aged persons, parents carrying babies and people using wheelchairs) 	Pool Access <ol style="list-style-type: none"> 1. High

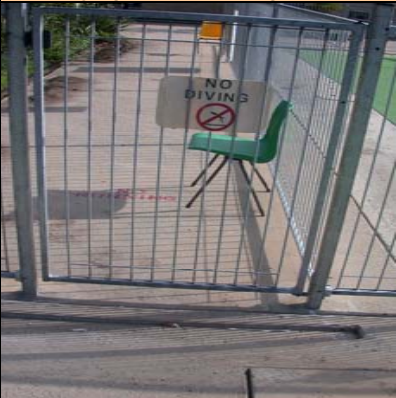
Safety Gate 1. No colour contrast on safety gate	Safety Gate 1. Paint gate opening supports with high contrast/luminance colour (safety yellow)	Safety Gate 1. Medium

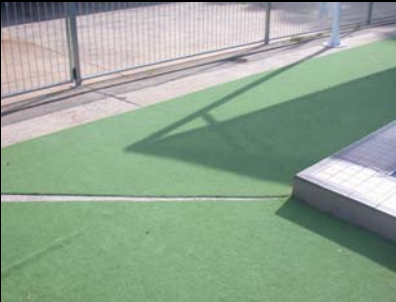
Outdoor carpet 1. Sections of carpet do not meet- could pose as a trip hazard Wading Pool 1. Inner perimeter grab rails on one side of the wading pool	Outdoor carpet 1. Address joining of carpet sections Wading Pool No recommendation	Outdoor carpet 1. Medium

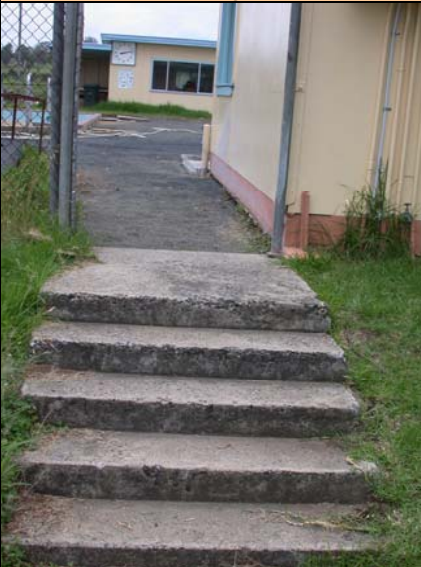
Parking <ol style="list-style-type: none"> General parking area (grass and gravel) No designated parking bay Entrance - Steps <ol style="list-style-type: none"> Access to entrance is via five steps Stairs have no handrails No colour contrast or tactile strip on step nosing No TGSi at entry/exit points of entrance stairs 	Parking <ol style="list-style-type: none"> Allocate a designated parking bay (with ground and elevated signage) in close proximity to the entrance Entrance - Steps <ol style="list-style-type: none"> Install dual handrails to entrance stairs Paint step nosings with high contrast/luminance colour (safety yellow) or install tactile strips Install TGSi at entry/exit points of stairs Construct entrance ramp Install TGSi at entry/exit points of ramp when built 	Parking <ol style="list-style-type: none"> Low Entrance - Steps <ol style="list-style-type: none"> High High Low Medium Low

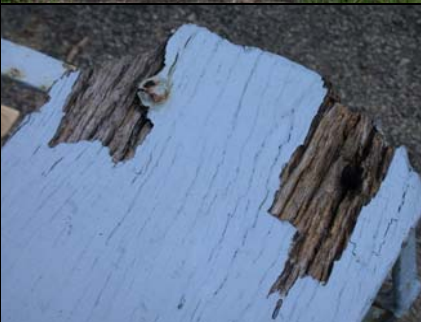
Canteen <ol style="list-style-type: none"> Canteen seat has weather damage Canteen counter has weather damage 	Canteen <ol style="list-style-type: none"> Replace damaged seat Replace damaged counter (splinter hazards) 	Canteen <ol style="list-style-type: none"> Maintenance

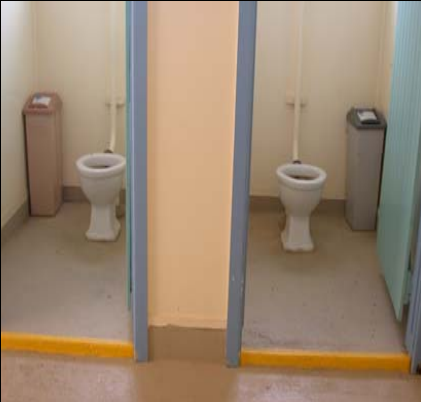
Toilet - Regular Male/Female <ol style="list-style-type: none"> 1. No accessible toilet facilities 2. Toilet seats are missing (Male) 3. No grab rail at urinal or regular cubicle Shower <ol style="list-style-type: none"> 1. No accessible shower facilities 	Toilet - Regular Male/Female <ol style="list-style-type: none"> 1. Construct unisex accessible toilet facilities 2. Replace missing toilet seats (Male) 3. Install grab rail at urinal 4. Install grab rail in one regular cubicle Shower <ol style="list-style-type: none"> 1. Construct unisex accessible shower facilities 	Toilet <ol style="list-style-type: none"> 1. Medium 2. Maintenance 3. High 4. High Shower <ol style="list-style-type: none"> 1. Medium

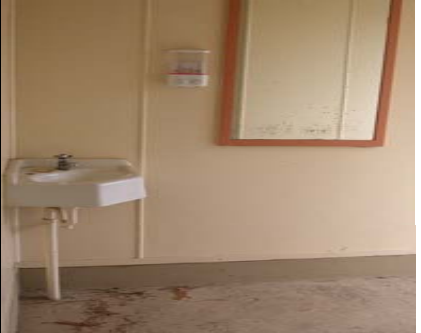
Change Room - Male/Female <ol style="list-style-type: none"> 1. Colour contrasts between the walls and the floor could be improved 2. Clothes hooks present 	Change Room - Male/Female <ol style="list-style-type: none"> 1. Address colour contrast between floor and walls by painting shirting board with high contrast/luminance colour 2. Lower several clothes hooks 	Change Room <ol style="list-style-type: none"> 1. Low 2. Medium

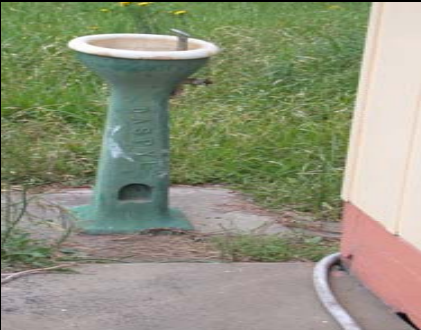
Drinking Fountain <ol style="list-style-type: none"> 1. Drinking fountain is not working 2. Drinking water is available from a water tank 3. Water tank tap height is 760 mm - accessible 	Drinking Fountain <ol style="list-style-type: none"> 1. Repair or remove faulty drinking fountain 	Drinking Fountain <ol style="list-style-type: none"> 1. Maintenance

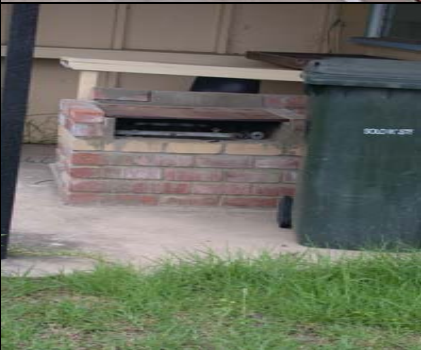
BBQ <ol style="list-style-type: none"> 1. Path of travel to BBQ is via grass 2. BBQ height is 600 mm - accessible 3. Circulation space in front of BBQ is 1400 mm - accessible 	BBQ <ol style="list-style-type: none"> 1. Construct pathway to BBQ 	BBQ <ol style="list-style-type: none"> 1. Low

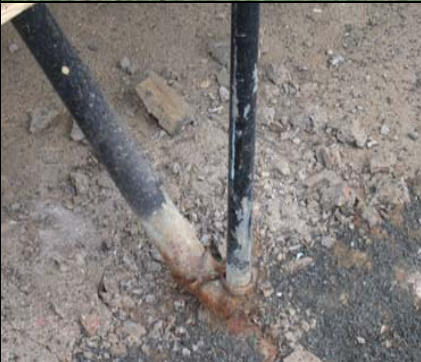
Grandstand <ol style="list-style-type: none"> 1. All grandstands have rusty, damaged and exposed structural supports Picnic Shelter <ol style="list-style-type: none"> 1. Shelter style is not suitable for access 2. Access to the shelter seating is obstructed by a tree 3. Table height is 810 mm - accessible 4. Knee clearance height is 780 mm - accessible 5. Table has a central support leg - accessible 	Grandstand <ol style="list-style-type: none"> 1. Address all grandstand's rusty, damaged and exposed structural supports Picnic Shelter <ol style="list-style-type: none"> 1. Replace shelter or adjust shelter supports to allow access to table 2. Remove section of seating to allow table edge access 	Grandstand <ol style="list-style-type: none"> 1. Maintenance Picnic Shelter <ol style="list-style-type: none"> 1. Medium 2. Medium

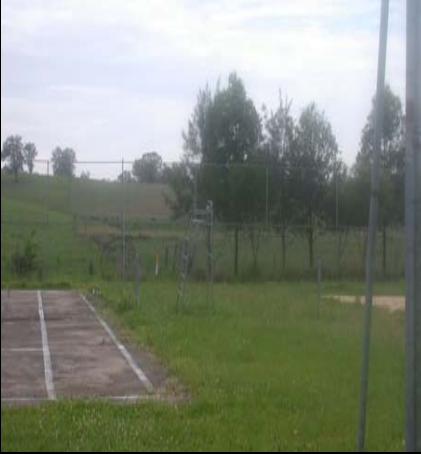
General 1. Tennis court is overgrown Parking 1. Adjacent area suitable for parking, is overgrown Pathway 1. No pathway from general parking area to tennis court entrance 2. No pathway to toilet facility	General 1. Mow general area 2. Clean courts Parking 1. Designate a general parking area 2. Allocate a designated parking bay (with ground and elevated signage) in close proximity to the facilities Pathway 1. Construct pathway to court entrance 2. Construct pathway to toilet	General 1. Maintenance 2. Maintenance Parking 1. Low 2. Low Pathway 1. Low 2. Low

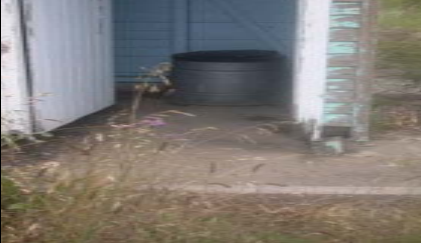
Toilet 1. Composting toilet 2. No grab rails 3. Install wash basin	Toilet 1. Upgrade toilet facility for ambulant disabilities 2. Install side grab rail 3. Install wash basin	Toilet 1. Medium 2. Medium 3. High

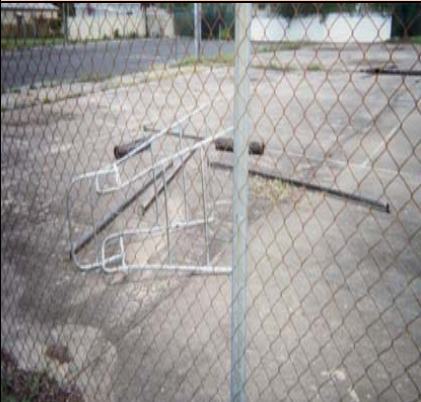
<p>General 1. Tennis court is neglected and vandalised</p> <p>Parking 1. No designated parking bay</p> <p>Tennis Court 1. Gateway width is accessible</p> <p>Sporting Centre</p> <p>Entrance 1. Entrance width is accessible</p> <p>Pathway 1. No pathway to entrance</p>	<p>General 1. Restore court</p> <p>Parking No recommendation</p> <p>Entrance No recommendation</p> <p>Pathway 1. Construct pathway to entrance from footpath</p>	<p>General 1. Maintenance</p> <p>Pathway 1. Low</p>

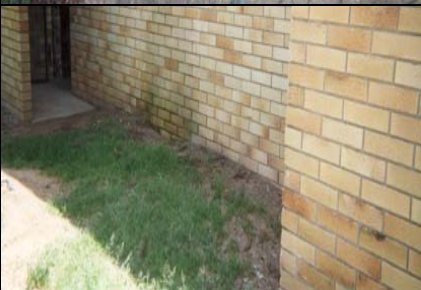
<p>Path of Travel to Toilet - Regular Male/Female 1. No pathway access from side of building to toilet entrances 2. Facilities locked</p> <p>Shower Regular Male/Female 1. Step at entrance 2. No colour contrast on step nosing 3. Facilities locked</p>	<p>Path of Travel to Toilet - Regular Male/Female 1. Construct pathway to toilet entrances</p> <p>Shower Regular Male/Female 1. Paint step nosing with high contrast colour/luminance (safety yellow)</p>	<p>Path of Travel to Toilet - Regular Male/Female 1. Medium</p> <p>Shower Regular Male/Female 1. High</p>

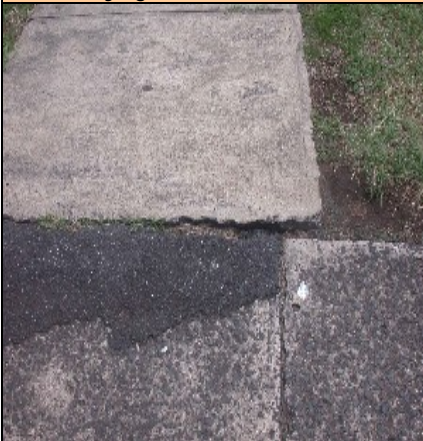
Parking 1. No designated parking bay Pathway (also Cenotaph) 1. Pathway entry point is uneven 2. Pathway is cracked and uneven (12 metres)

Parking 1. Allocate a designated parking bay (with ground and elevated signage) in close proximity to the Youth Centre/ Cenotaph Pathway 1. Address uneven pathway entry point 2. Replace 12 metres of pathway	Parking 1. Low Pathway 1. High 2. High

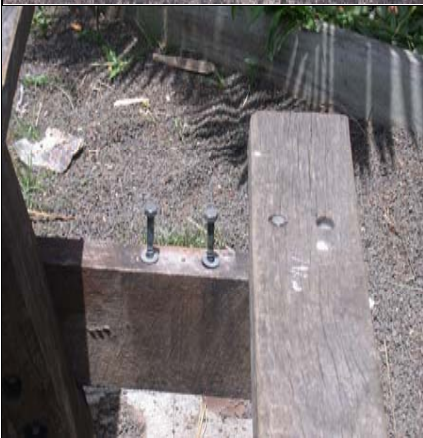
Picnic table 1. Table top is damaged 2. Seating has exposed bolts 3. Picnic table is located on loose gravel	Picnic table 1. Repair picnic table top 2. Repair seating 3. Construct a firm ground surface with a continuous path of travel to the picnic table from pathway 4. Address table end or table side access and knee clearance	Picnic table 1. Maintenance 2. Maintenance 3. Medium 4. Medium

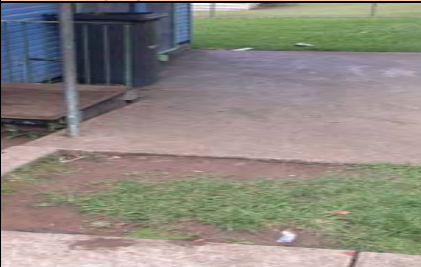
Undercover area 1. Path of travel from pathway to undercover area is not continuous 2. Wheelie bin has no lid	Undercover area 1. Extend concrete pad to meet with pathway to provide a continuous path of travel 2. Replace missing wheelie bin lid	Undercover area 1. Medium 2. Maintenance

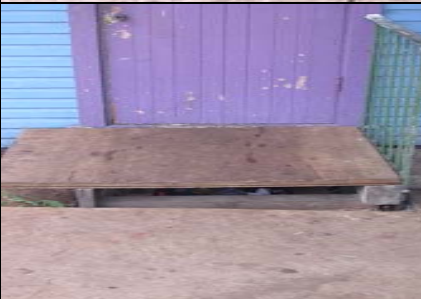
Side Entrance 1. Entrance platform does not meet standards	Side Entrance 1. Construct an entrance platform level with existing concrete pad or Extend concrete pad and construct a step	Side Entrance 1. High

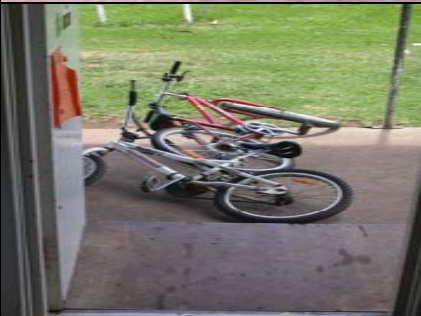
Side entrance 1. Bicycles obstruct doorway entrance	Side entrance 1. Install a bicycle stand	Side entrance 1. High

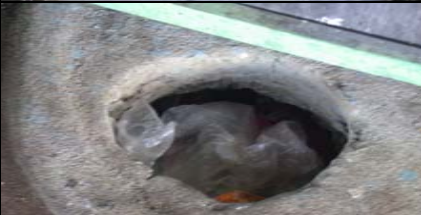
Adjacent to side entrance 1. Open drain hole collects rubbish	Adjacent to side entrance 1. Install a drain hole cover	Adjacent to side entrance 1. Maintenance

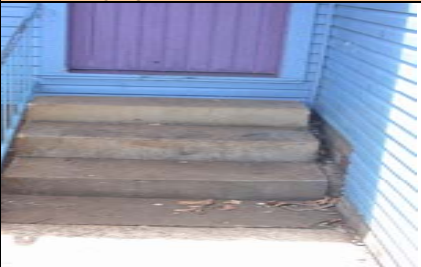
Rear Entrance (permanently closed) 1. This entrance is not used to access the building	Rear Entrance 1. Paint step nosing with high contrast/luminance colour (safety yellow)	Rear Entrance 1. Low

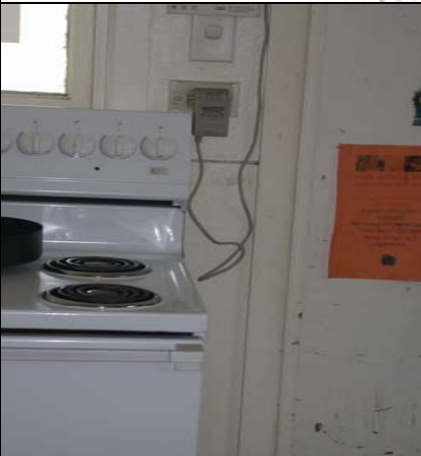
Interior - Kitchen 1. Stove is located beside rear doorway - (Hazard - accidental spillage)	Interior - Kitchen 1. Relocate stove to avoid passing traffic accidentally knocking saucepan handles Or Create a stable door (1/3, 2/3) -permanently close bottom half of door (Stable door will allow cross ventilation to the room and allow light to enter)	Interior - Kitchen 1. Maintenance

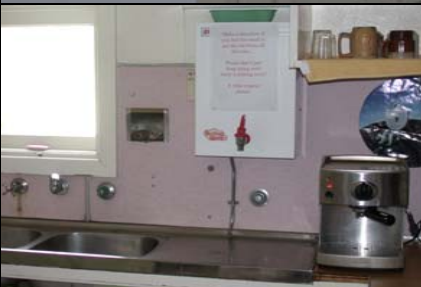
Interior - Kitchen 1. Hot water unit is out of order - this necessitates that hot water is transferred in containers - (Hazard, accidental spillage)	Interior - Kitchen 1. Restore or replace hot water unit	Interior - Kitchen 1. Maintenance

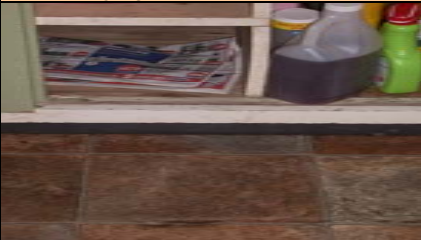
Interior - Kitchen floor 1. Floor boards in front of kitchen sink have deteriorated 2. Floor covering is ripped	Interior - Kitchen floor 1. Address the deteriorated floor boards in front of sink 2. Replace ripped floor coverings	Interior - Kitchen floor 1. Maintenance 2. Maintenance

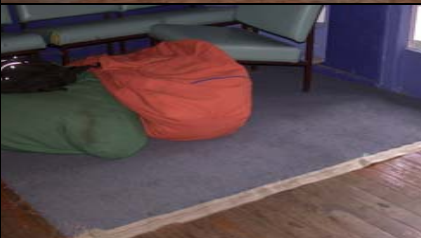
Interior - Main room 1. Carpet square does not lie flat - trip hazard	Interior - Main room 1. Adhere carpet square to the floor surface	Interior - Main room 1. Low

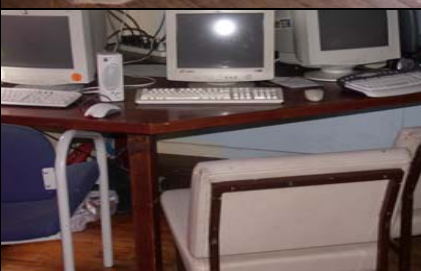
Interior - Main room 1. Computer desk height is inaccessible	Interior - Main room 1. Install a height adjustable computer desk	Interior - Main room 1. Medium

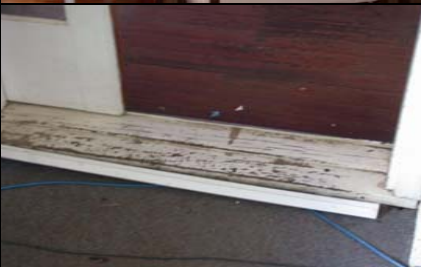
Interior - Office Entrance 1. Temporary cover for doorway lip 2. Electrical power cords run across the floor	Interior - Office Entrance 1. Install doorway lip cover 2. Install additional power sockets to address trip hazard from straying power leads	Interior - Office Entrance 1. High 2. High

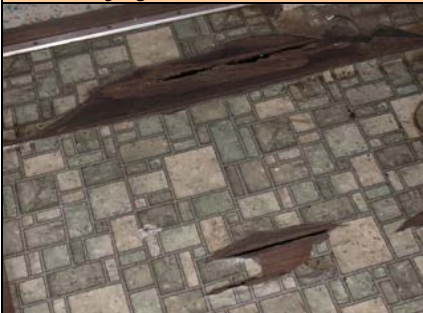
Entrance to Toilet 1. Floor boards at the entrance to the toilet facilities are deteriorated 2. Floor covering is ripped Toilet - Regular Male/Female 1. Toilet entrance doorway and cubicle doorways have doorway widths of 660 mm - does not meet regular A.S. width	Entrance to Toilet 1. Address deteriorated floor boards at toilet entrance 2. Replace ripped floor coverings Toilet - Regular Male/Female 1. Construct a unisex accessible toilet 2. Address doorway widths	Entrance to Toilet 1. Maintenance 2. Maintenance Toilet Regular Male/Female 1. Medium 2. Medium
